# FINAL REPORT

## EAST MOUNTAIN STORMWATER AND DRAINAGE STUDY

Submitted to: City of Scranton  
Lackawanna Co., PA

January 9, 2024

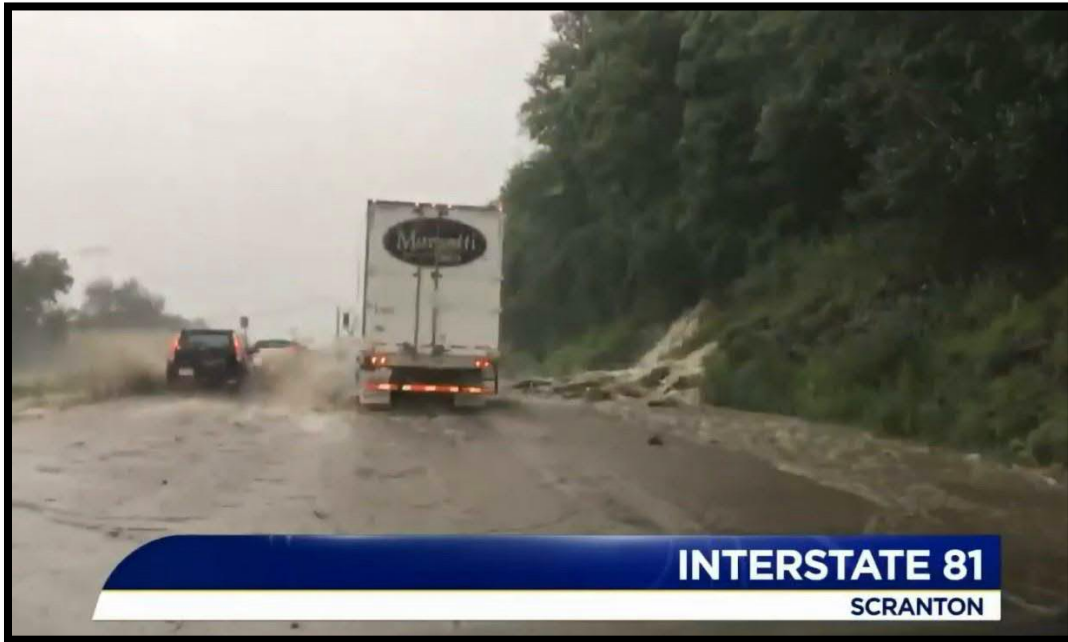
**Photo 3.1.1** TV News coverage of flooding on Route 81 which was caused by runoff from East Mountain.

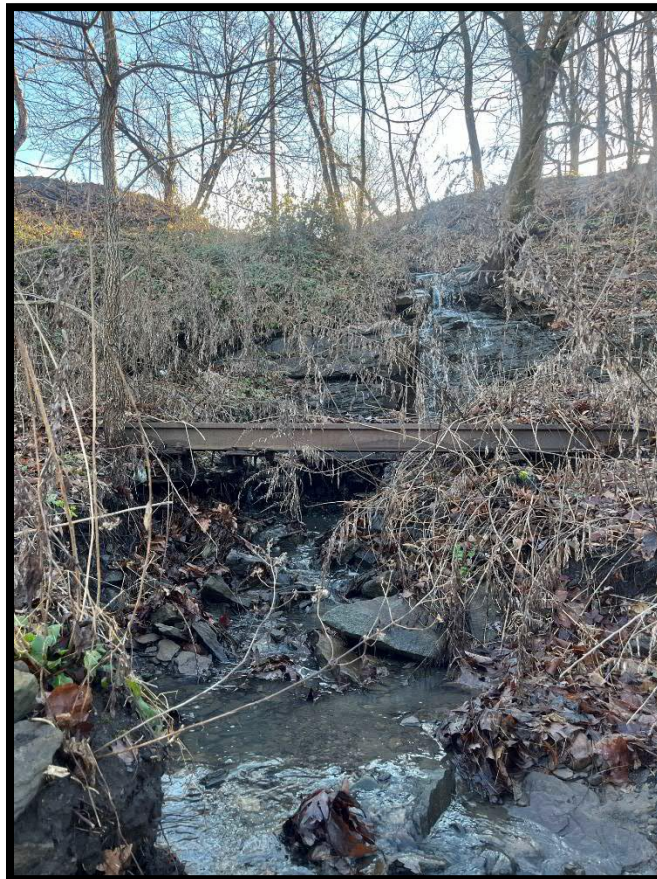
**Photo 3.1.2** Stormwater runoff from East Mountain has eroded ditches through the abandoned railroad grade which is located between Moltke Avenue and Route 81.

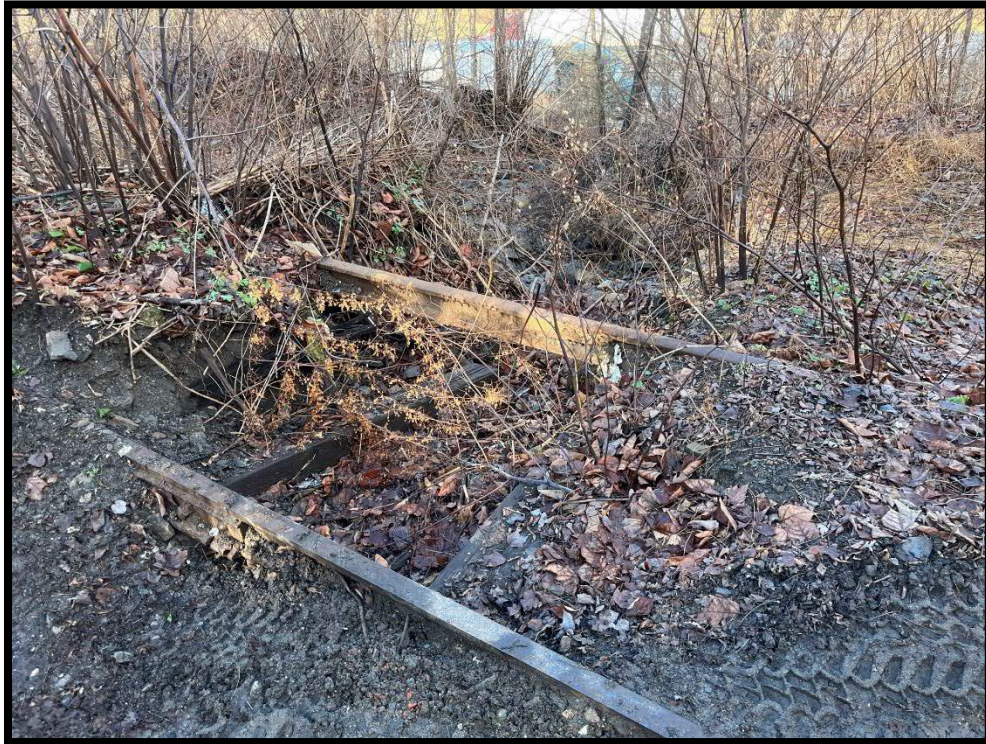
**Photo 3.1.5** The unregulated flow of stormwater runoff flows directly towards Route 81 where it has caused dangerous flooding in the past.

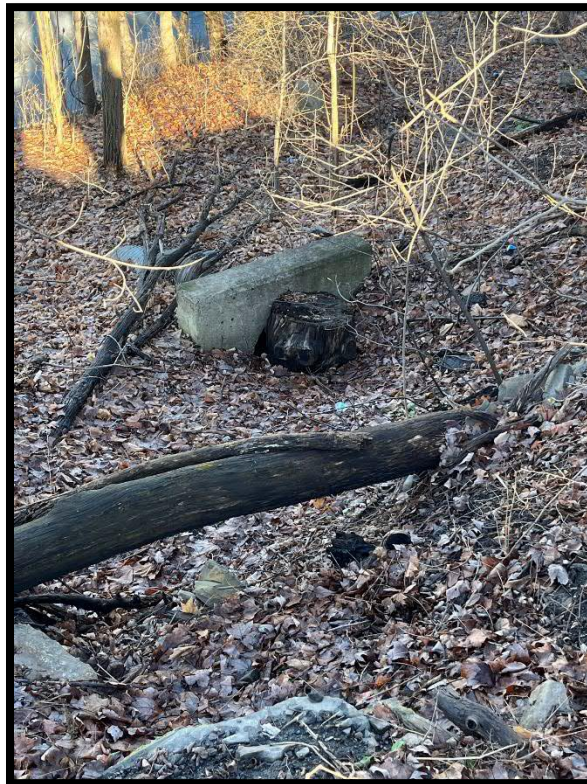
**Photo 3.1.6** Lack of maintenance of PennDOT drainage structures has also been responsible for flooding on the highway.

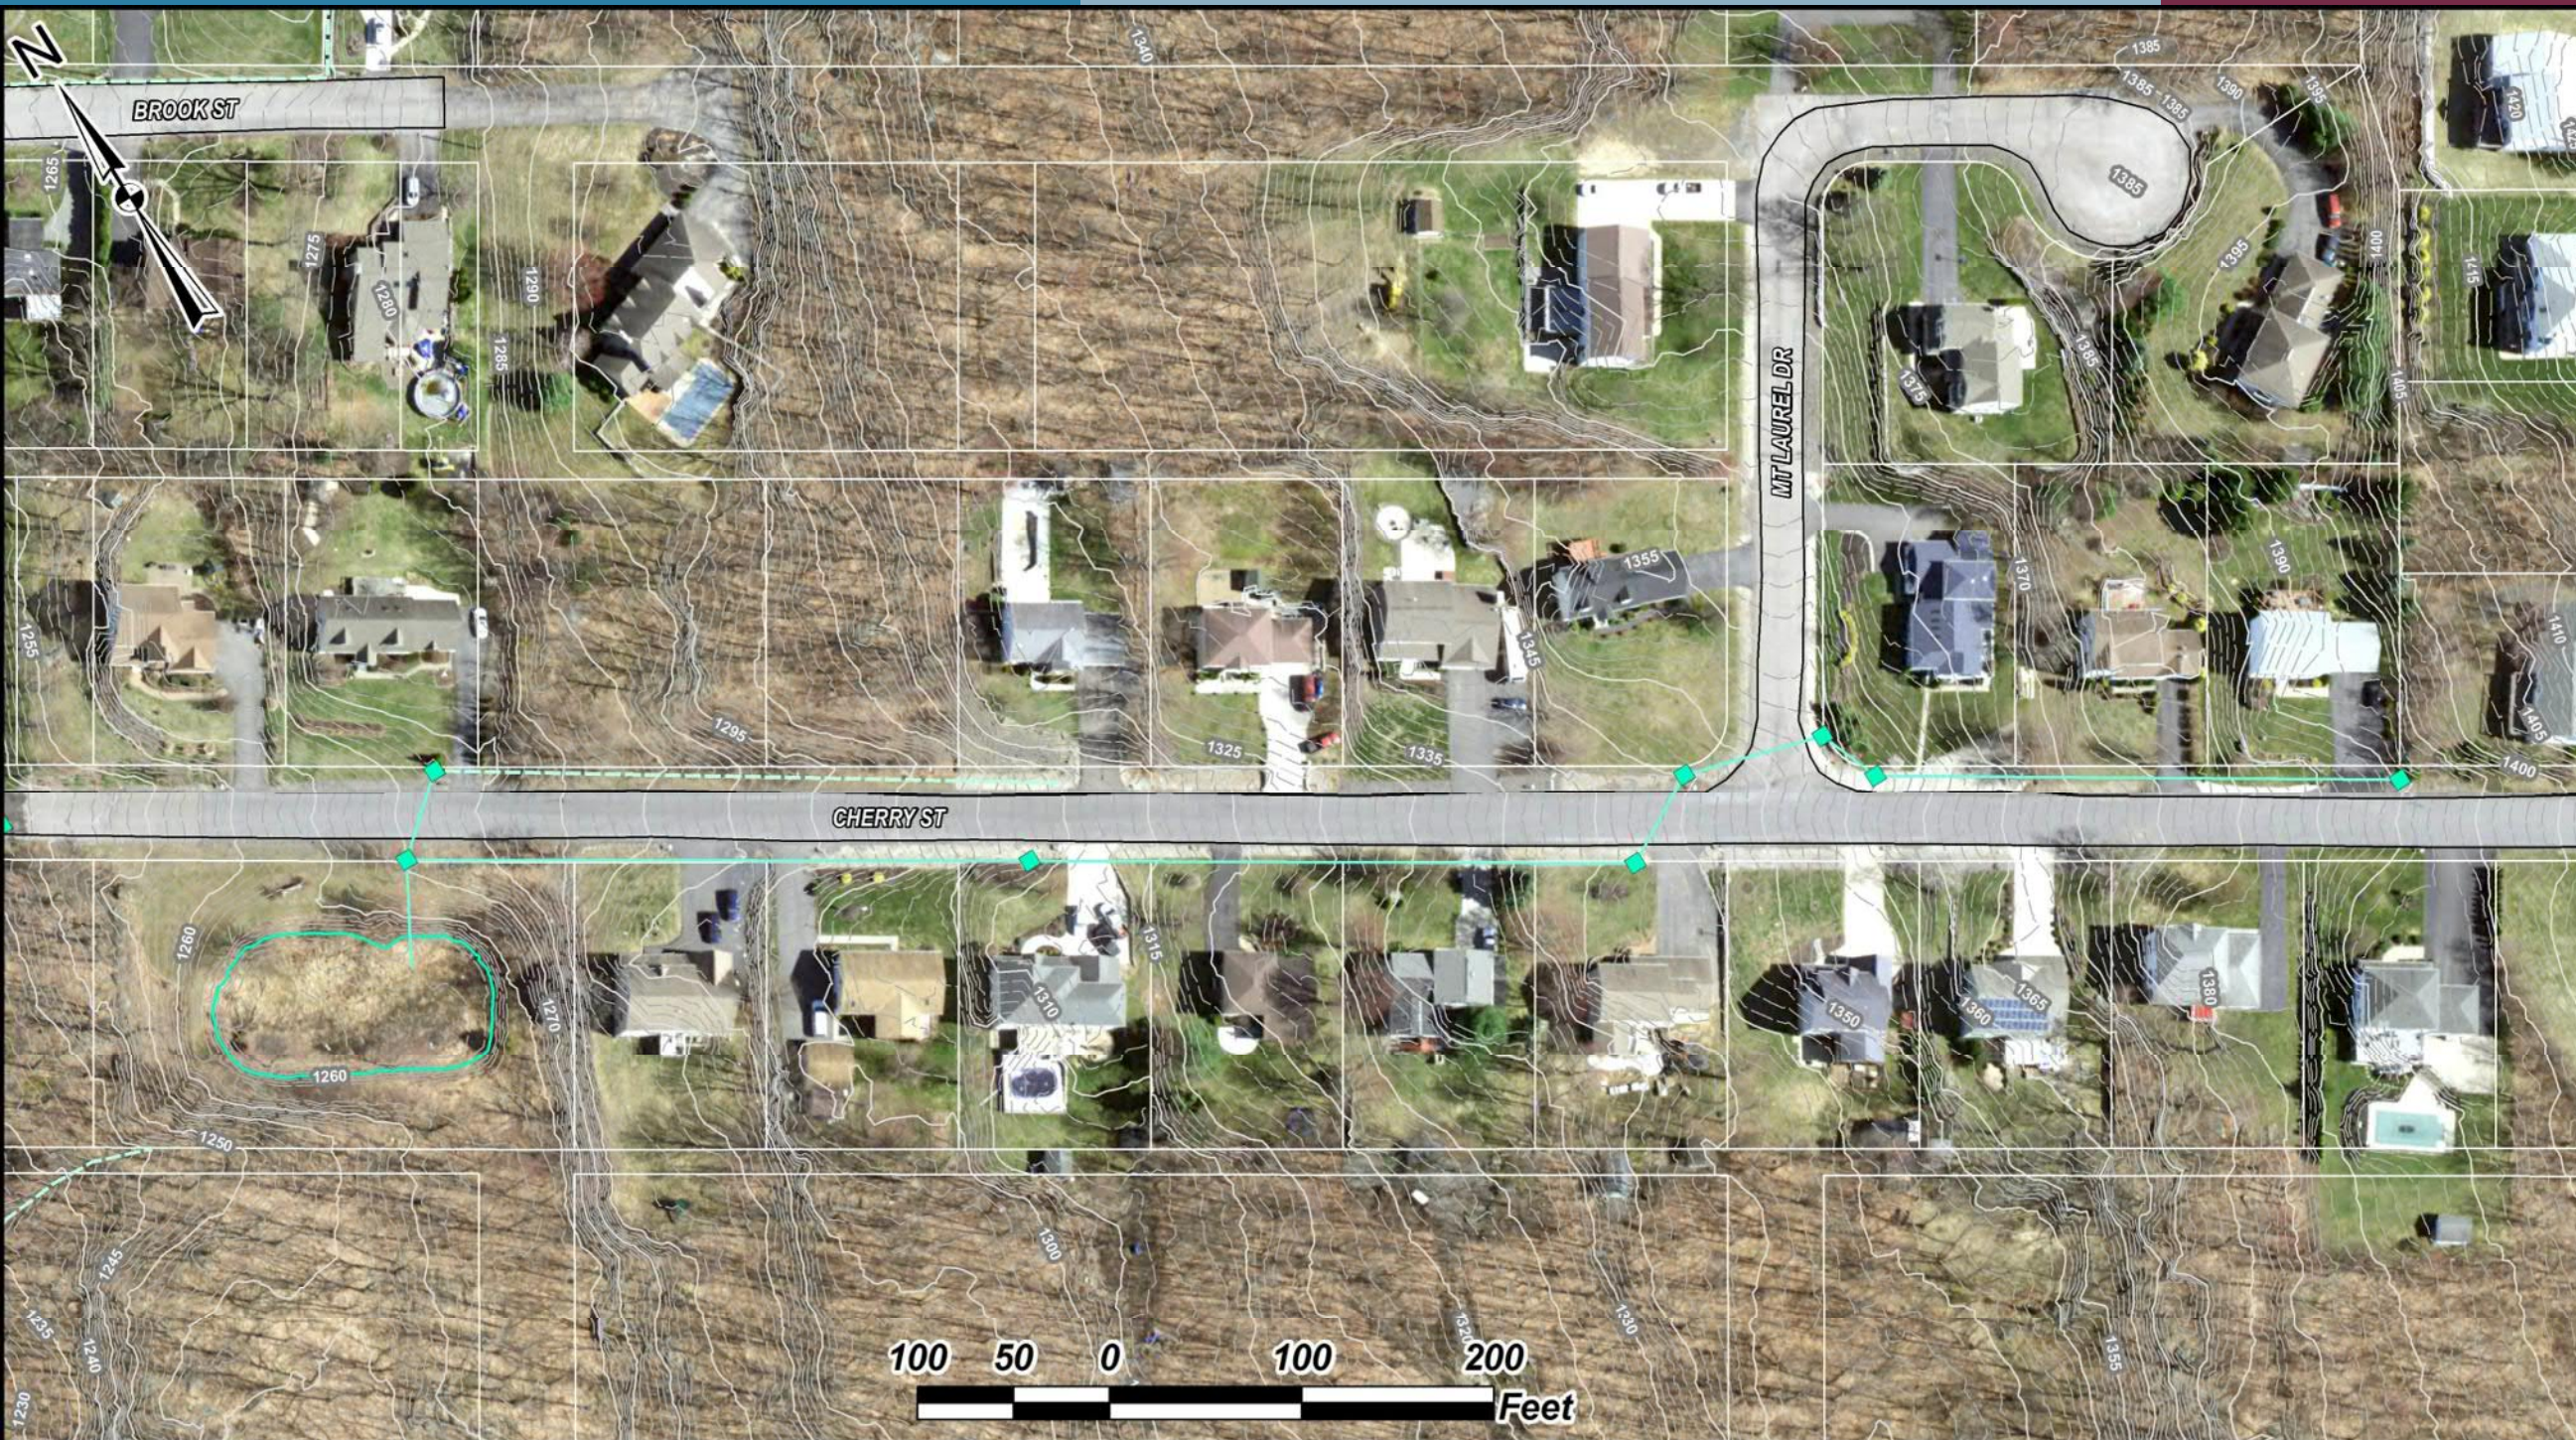
# CHERRY STREET

- Existing drainage system not collecting stormwater runoff.
- Water not getting into existing stormwater basin.
- Water continues to flow down Cherry Street past basin and creates problems at Fig Street.

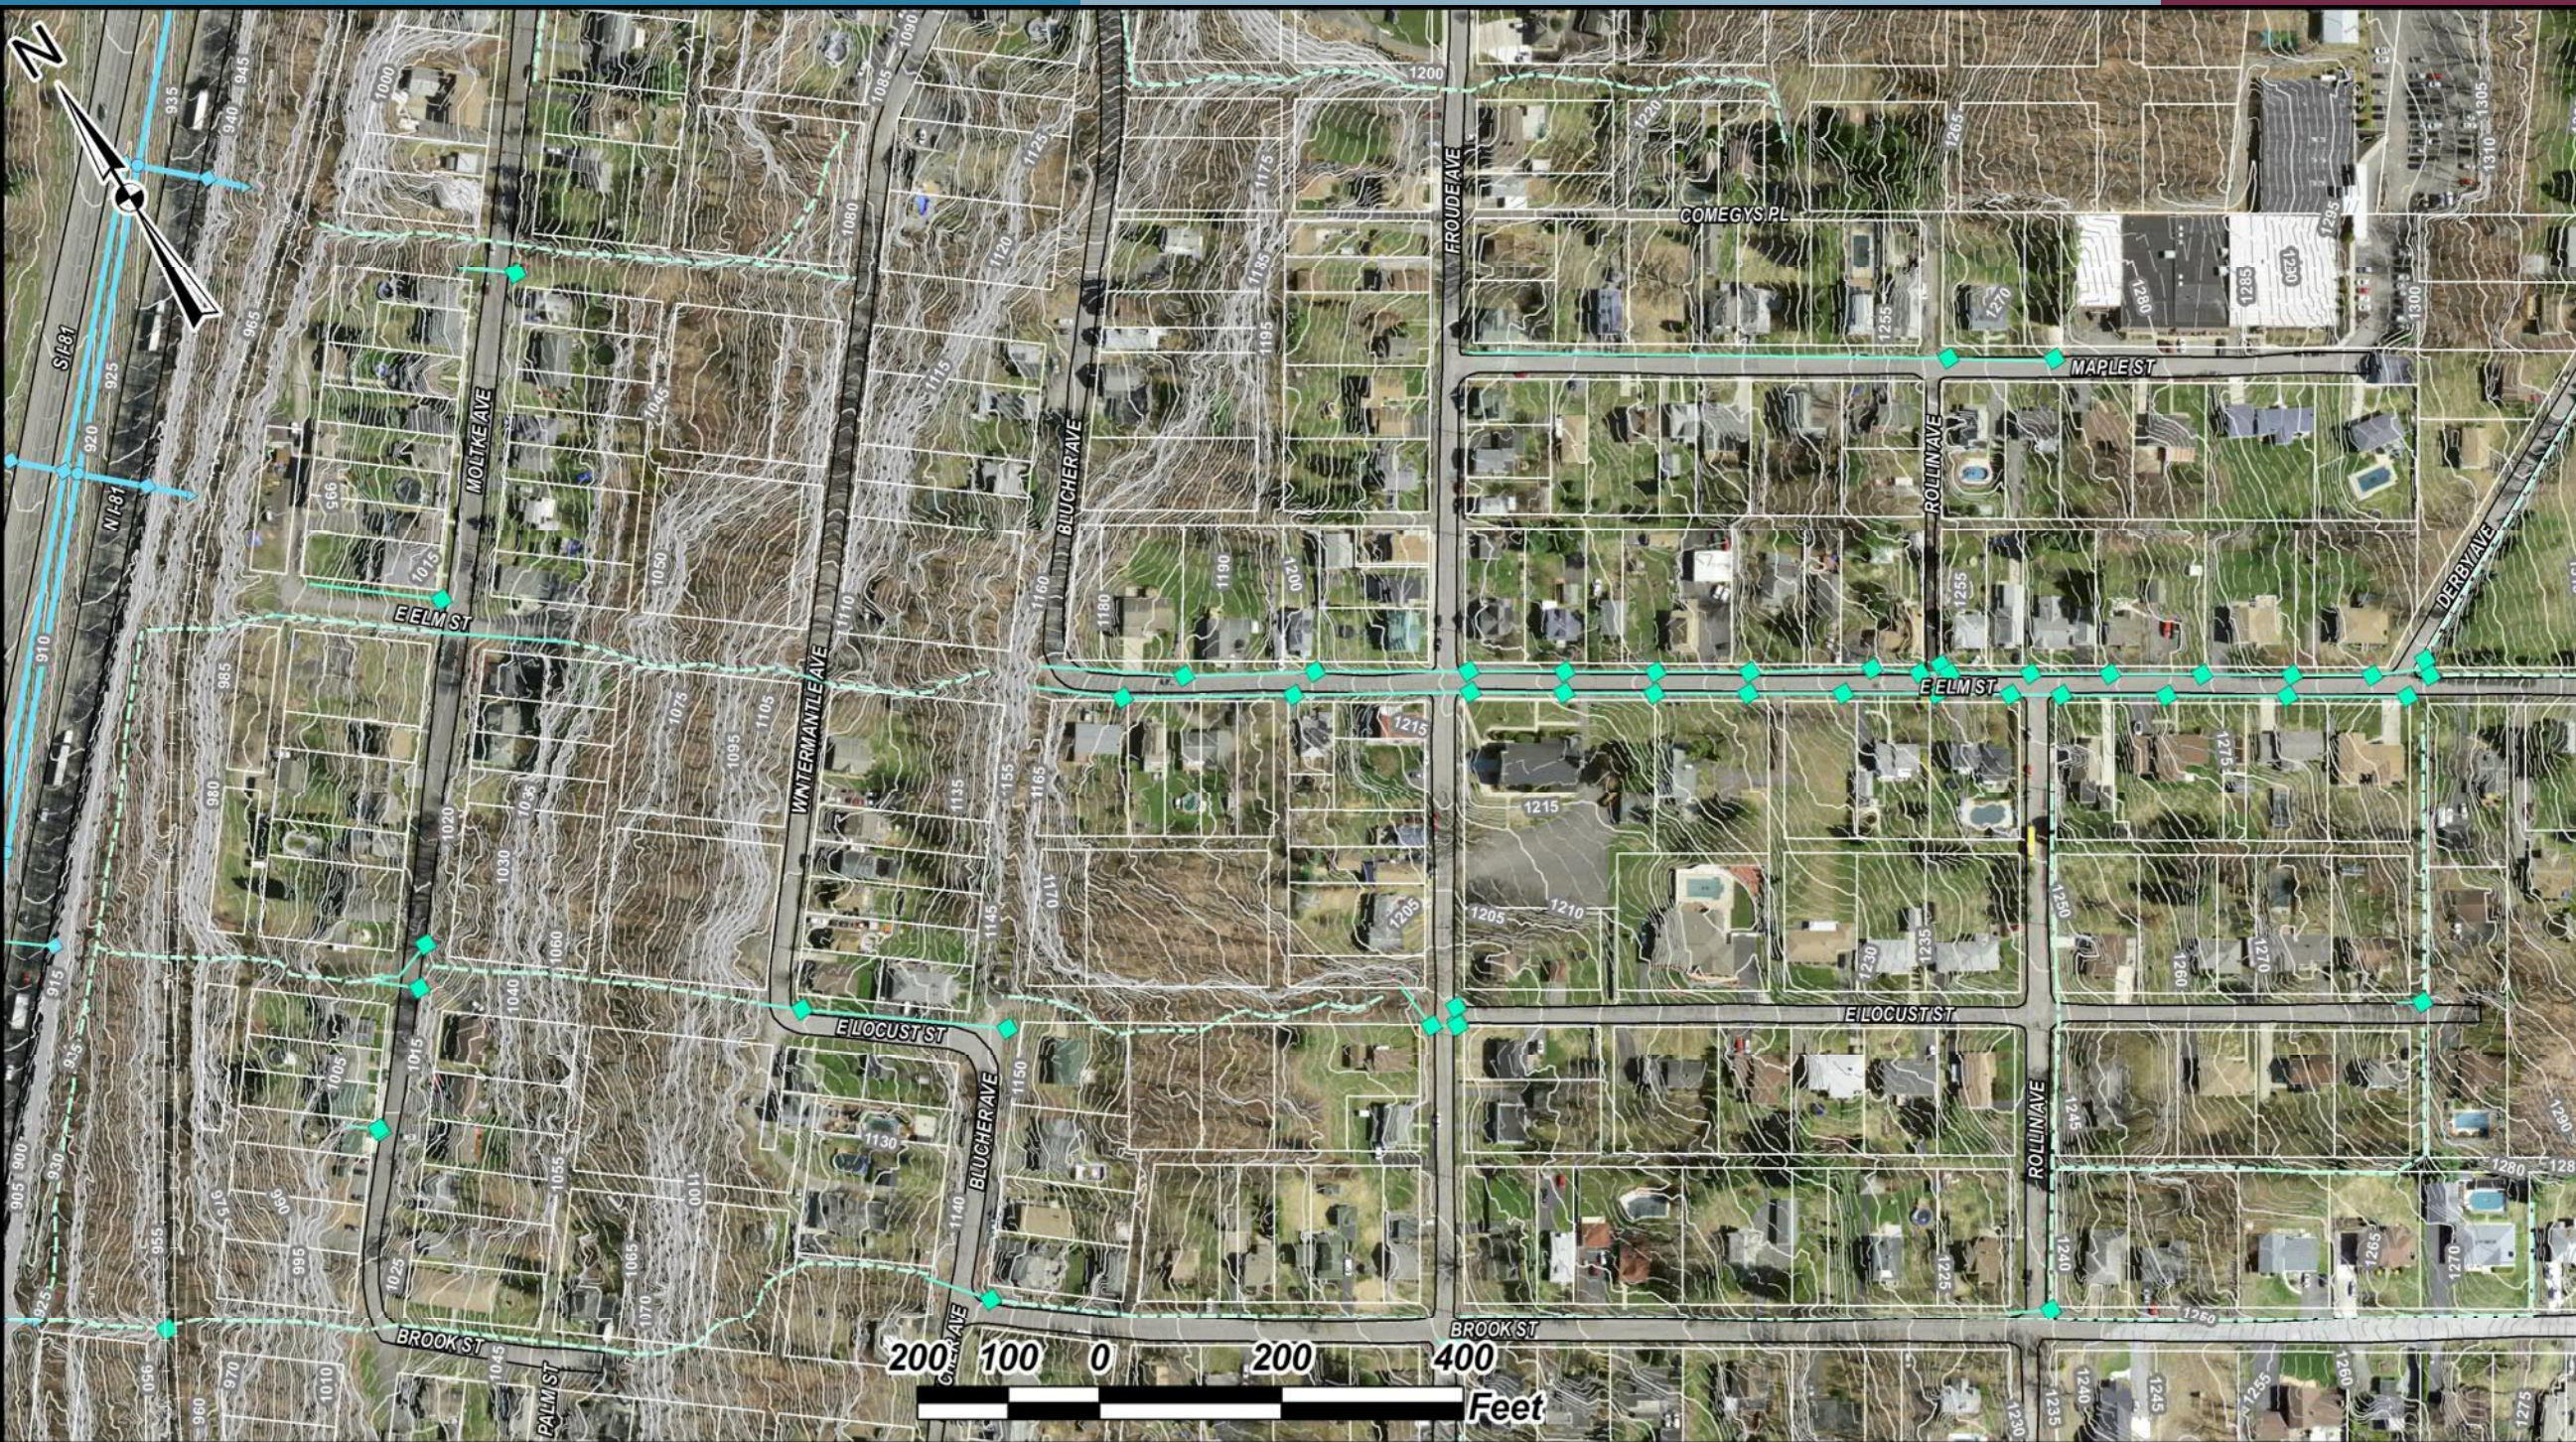
# WINTERMANTLE AVENUE & EAST ELM STREET

Drainage issues throughout this stormwater system appear to be caused by inefficient transitions between pipes and open swales, lack of maintenance of drainageways, and insufficient capacity (See Photos in Section 3.3.5). Beginning at the intersection with Derby Avenue, stormwater flow from the upstream drainage swales is not being captured by the storm sewer because there are no headwalls at the top of the pipe system. Runoff overwhelms these inlets and flows down East Elm Street. The excess flow down the roadway exceeds the capacity of the downhill inlets and the drainage problem continues to compound as it runs down the hill. The lack of a well-defined, stable channel below Wintermantle Avenue causes the culvert to become clogged with debris. In addition, the open channel below Moltke Avenue has not been maintained, so its capacity has been significantly diminished.

- Drainage from intersection of E. Elm and Derby is not getting into the existing E. Elm drainage system
- Water over-topping Wintermantle Ave.
- Swale along bottom of E Elm is eroded and in poor condition.
- Runoff eroding abandoned rail grade

The existing stone inlet at the top of lower East Elm Street should be retrofitted with a trash rack for both safety and debris protection. Below Moltke Avenue, the East Elm Street drainage swale should be cleared and stabilized all the way down to the proposed culvert under the abandoned railroad grade. The existing storm drain on the northern side of East Elm Street should also be replaced since the current corrugated metal pipe has failed.

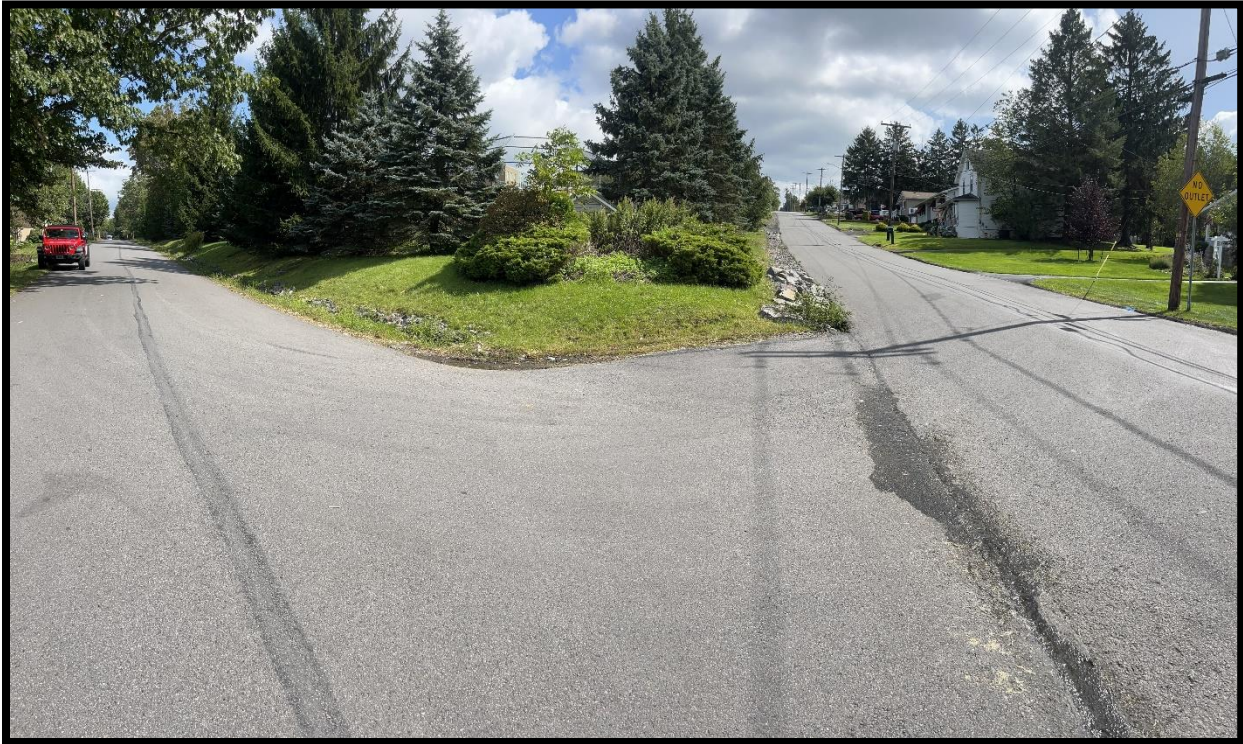
**Photo 3.3.1** View looking uphill at the intersection of East Elm and Derby where stormwater runoff has been over topping the storm sewer inlets.

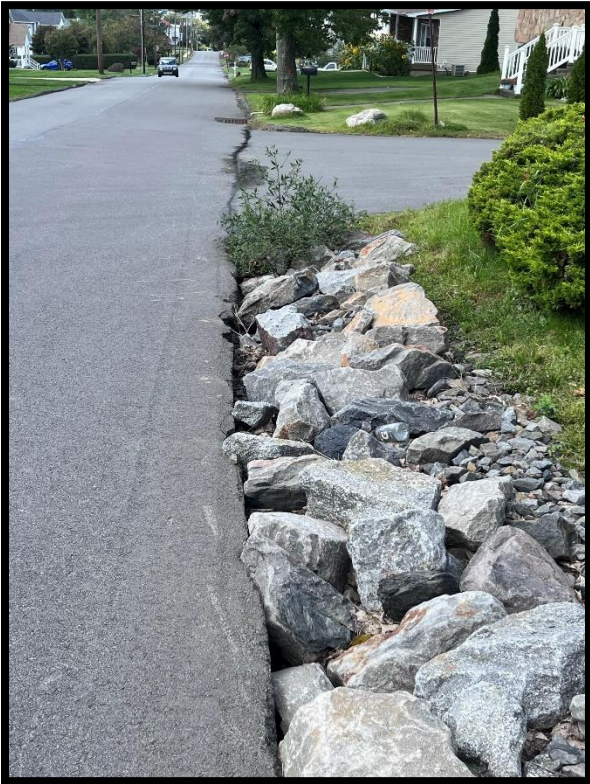
**Photo 3.3.2** Excess rock within the East Elm Street drainage swale has significantly reduced its capacity which causes the swale to regularly overflow.

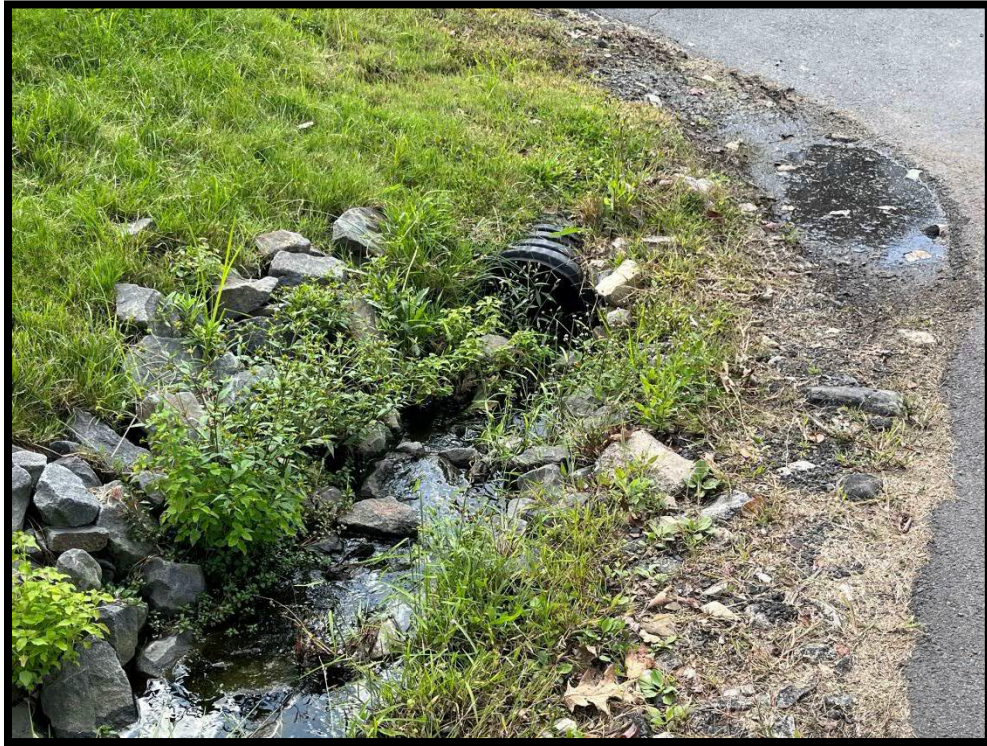
**Photo 3.3.3** The lack of a headwall at the inlets at Derby Avenue allows runoff to bypass the storm drains and run down East Elm Street.

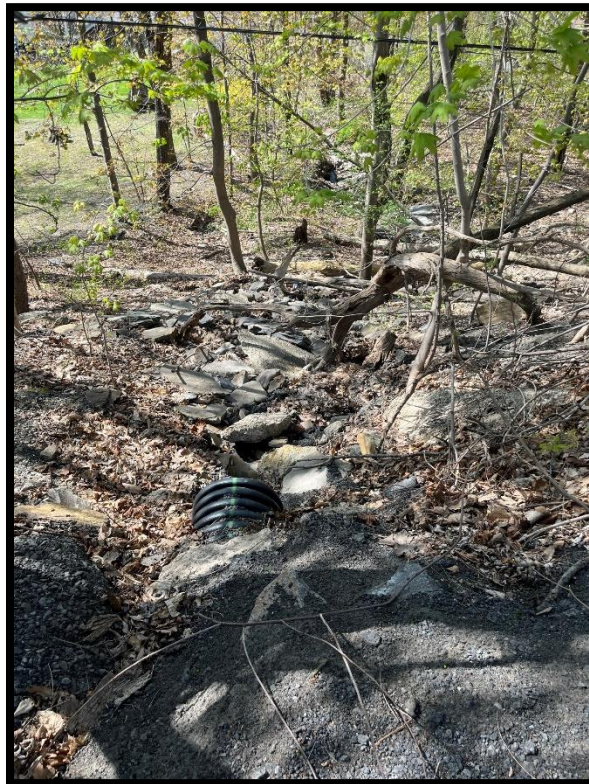
**Photo 3.3.4** The East Elm storm sewer currently discharges overland below Blucher Avenue. A stabilized channel is recommended for this discharge.

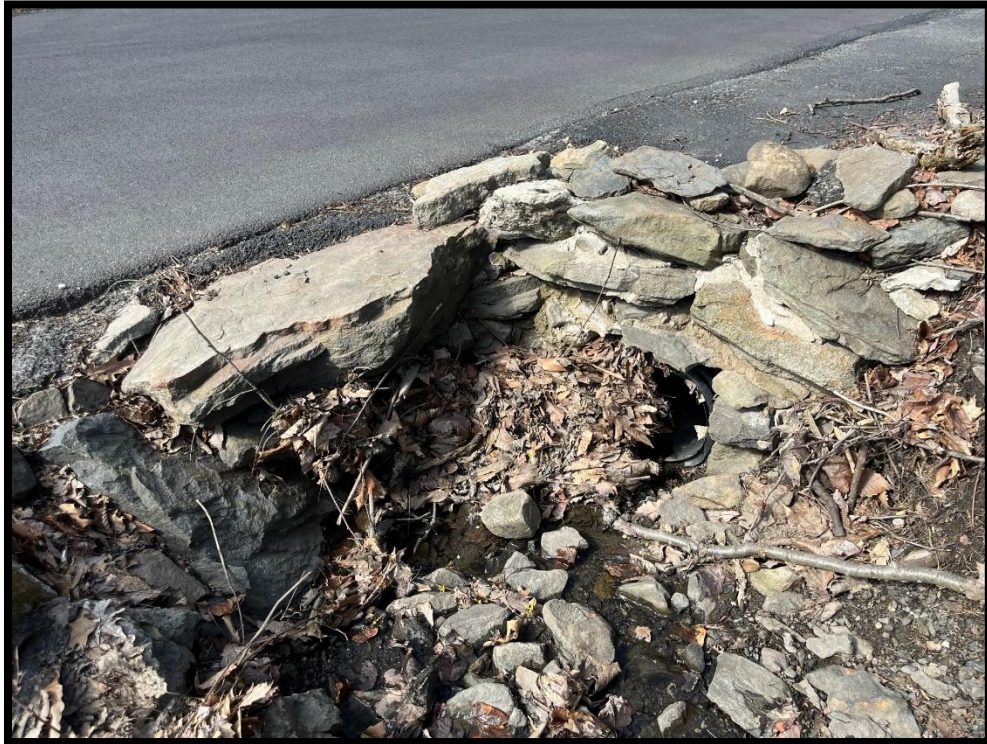
**Photo 3.3.5** The culvert under Wintermantle Avenue is currently undersized and lacks proper headwalls. It is also prone to clogging by debris.

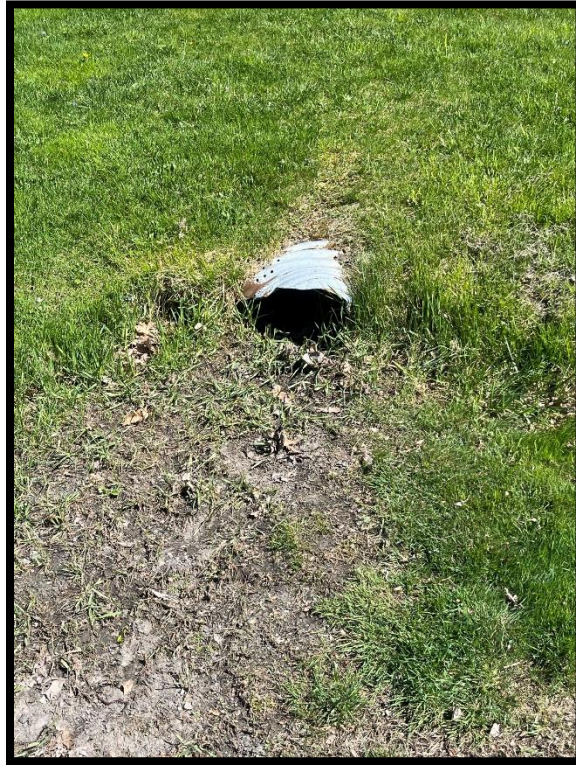
**Photo 3.3.9** The existing storm drain on the northern side of East Elm Street should also be replaced since the current corrugated metal pipe has failed.

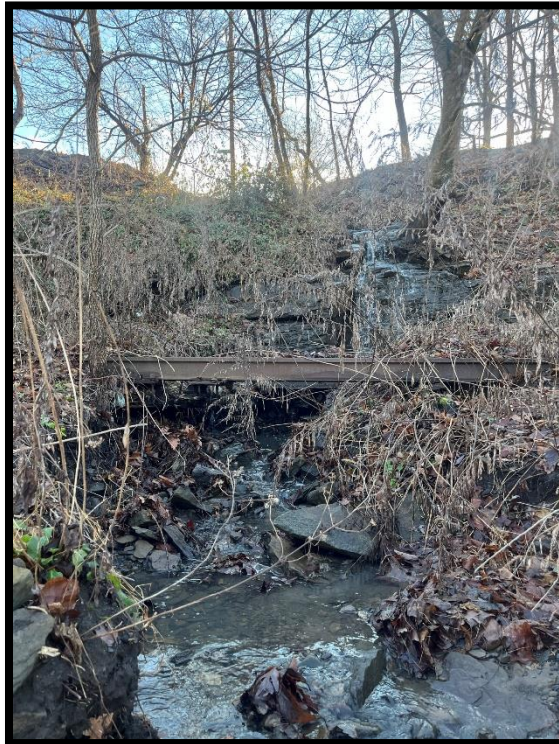
**Photo 3.3.10** At the bottom of the hill, the uncontrolled runoff from the East Elm Drainage System has undermined the abandoned railroad tracks which run parallel to Route 81.

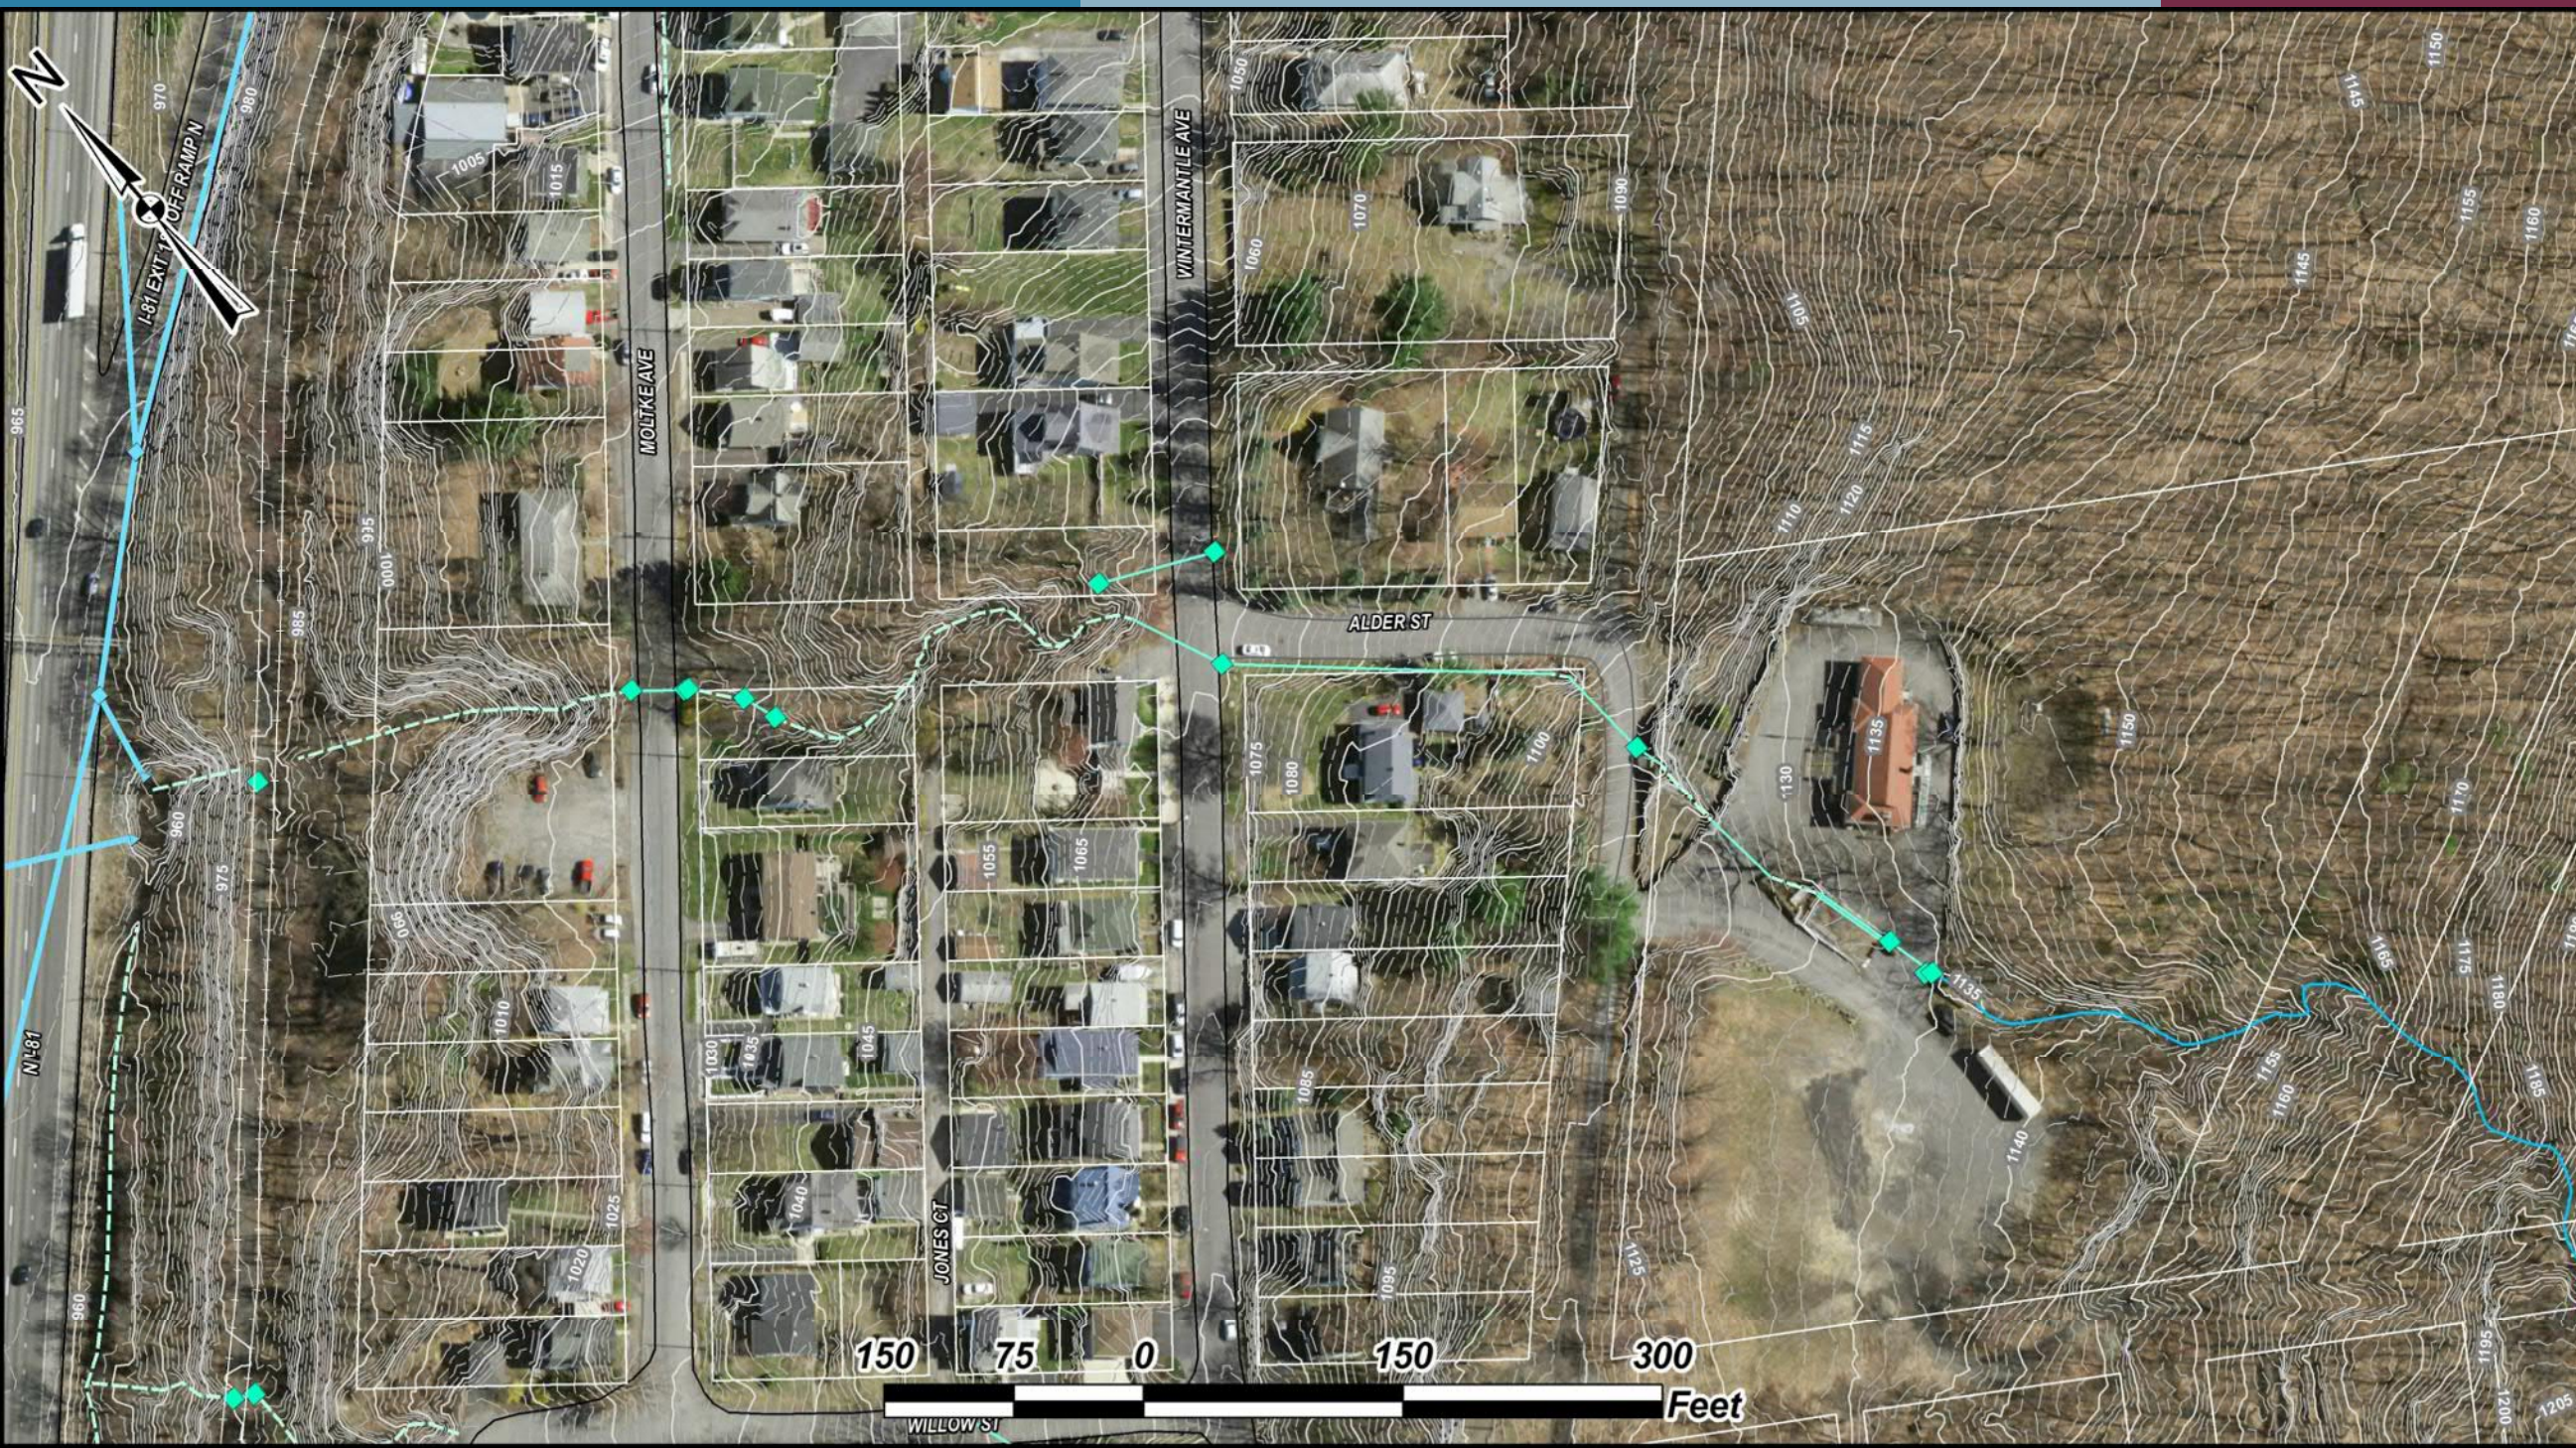
# MOUNTAIN LAKE CREEK

Increased flow volumes of this stream, due to development within the drainage area, has reach a point where it often exceeds the capacity of the culverts at the Museum. Further downstream, Mountain Lake Creek passes through a series of culverts and surface channels as it flows downhill towards Route 81. Inefficiencies and a lack of maintenance throughout this lower portion of the drainageway has resulted in flooding and damage to the public roads and residential properties.

- Storm flows are overwhelming the drainage system at the Marine Corps League Museum.
- Inlets are missing along Alder Street.
- Uncontrolled discharge below Wintermantle Ave.
- Flooding and eroding abandoned rail grade

Due to the historical significance of the stonework at the Marine Corps League Museum, HRG recommends working to limit the maximum flow rates entering the culverts, rather than removing or replacing them with larger culvert pipes. This could be accomplished by creating a stormwater detention basin where excess stormwater flow could be stored and released at a controlled rate. It is believed that there may be sufficient room along the edge of the existing gravel parking lot to build a basin, but final drainage calculations will be required to determine the size and discharge rates of this basin. Maintenance and clearing of the existing culverts are also recommended to increase their capacity.

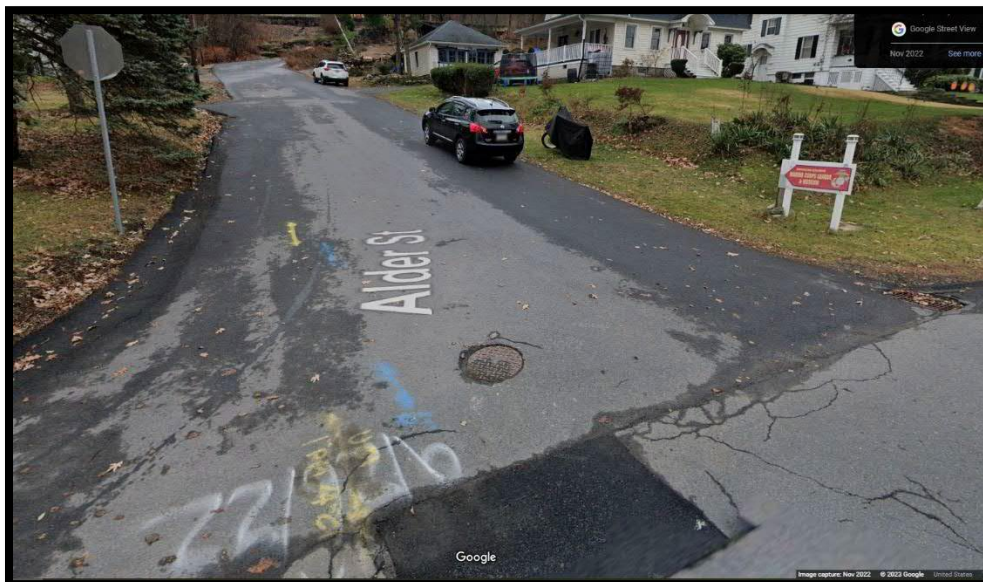
**Photo 3.4.4** View looking up Alder Street towards the Marine Corps League Museum. Two stormwater inlets will be replaced along this section of the road.

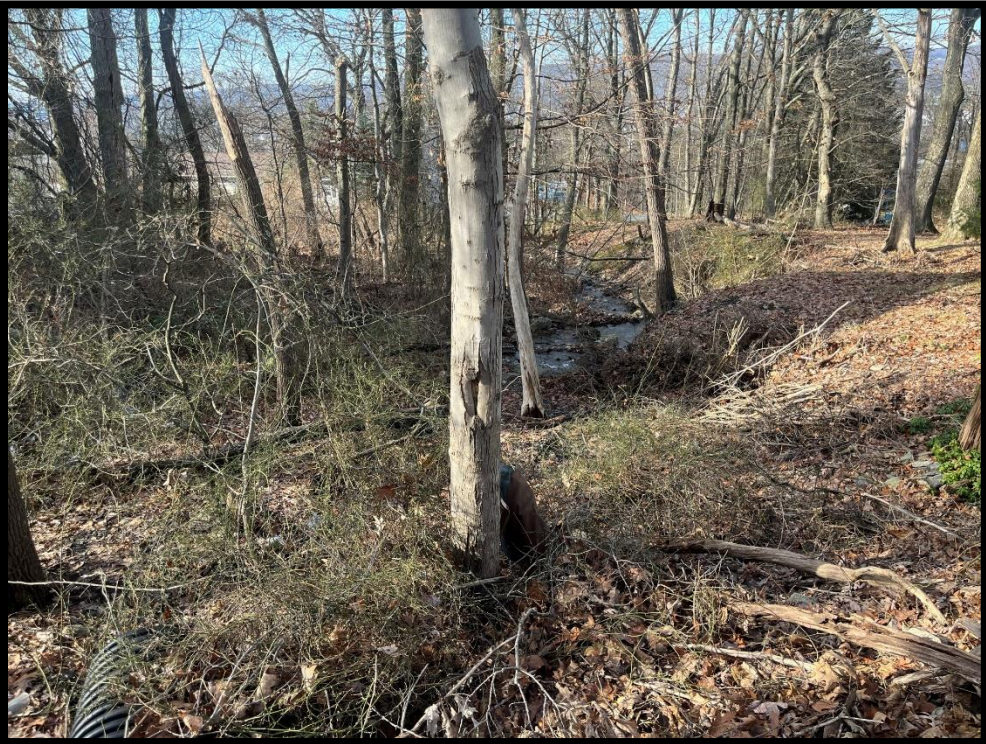
**Photo 3.4.5** The culvert discharge below Wintermantle Avenue needs to be improved with stabilization and a better defined channel.

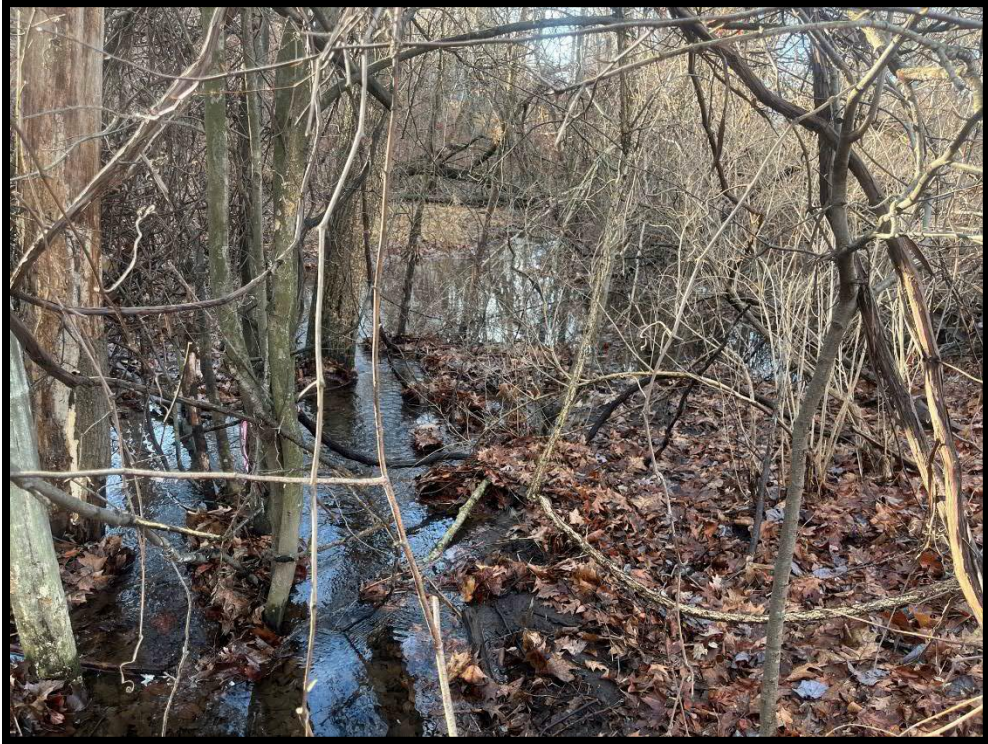
**Photo 3.4.8** The culvert under the railroad has failed and water now ponds above the rail line until it reaches a level where it over-tops the grade.
