# FINAL REPORT

## EAST MOUNTAIN STORMWATER AND DRAINAGE STUDY

Submitted to: City of Scranton  
Lackawanna Co., PA

January 9, 2024

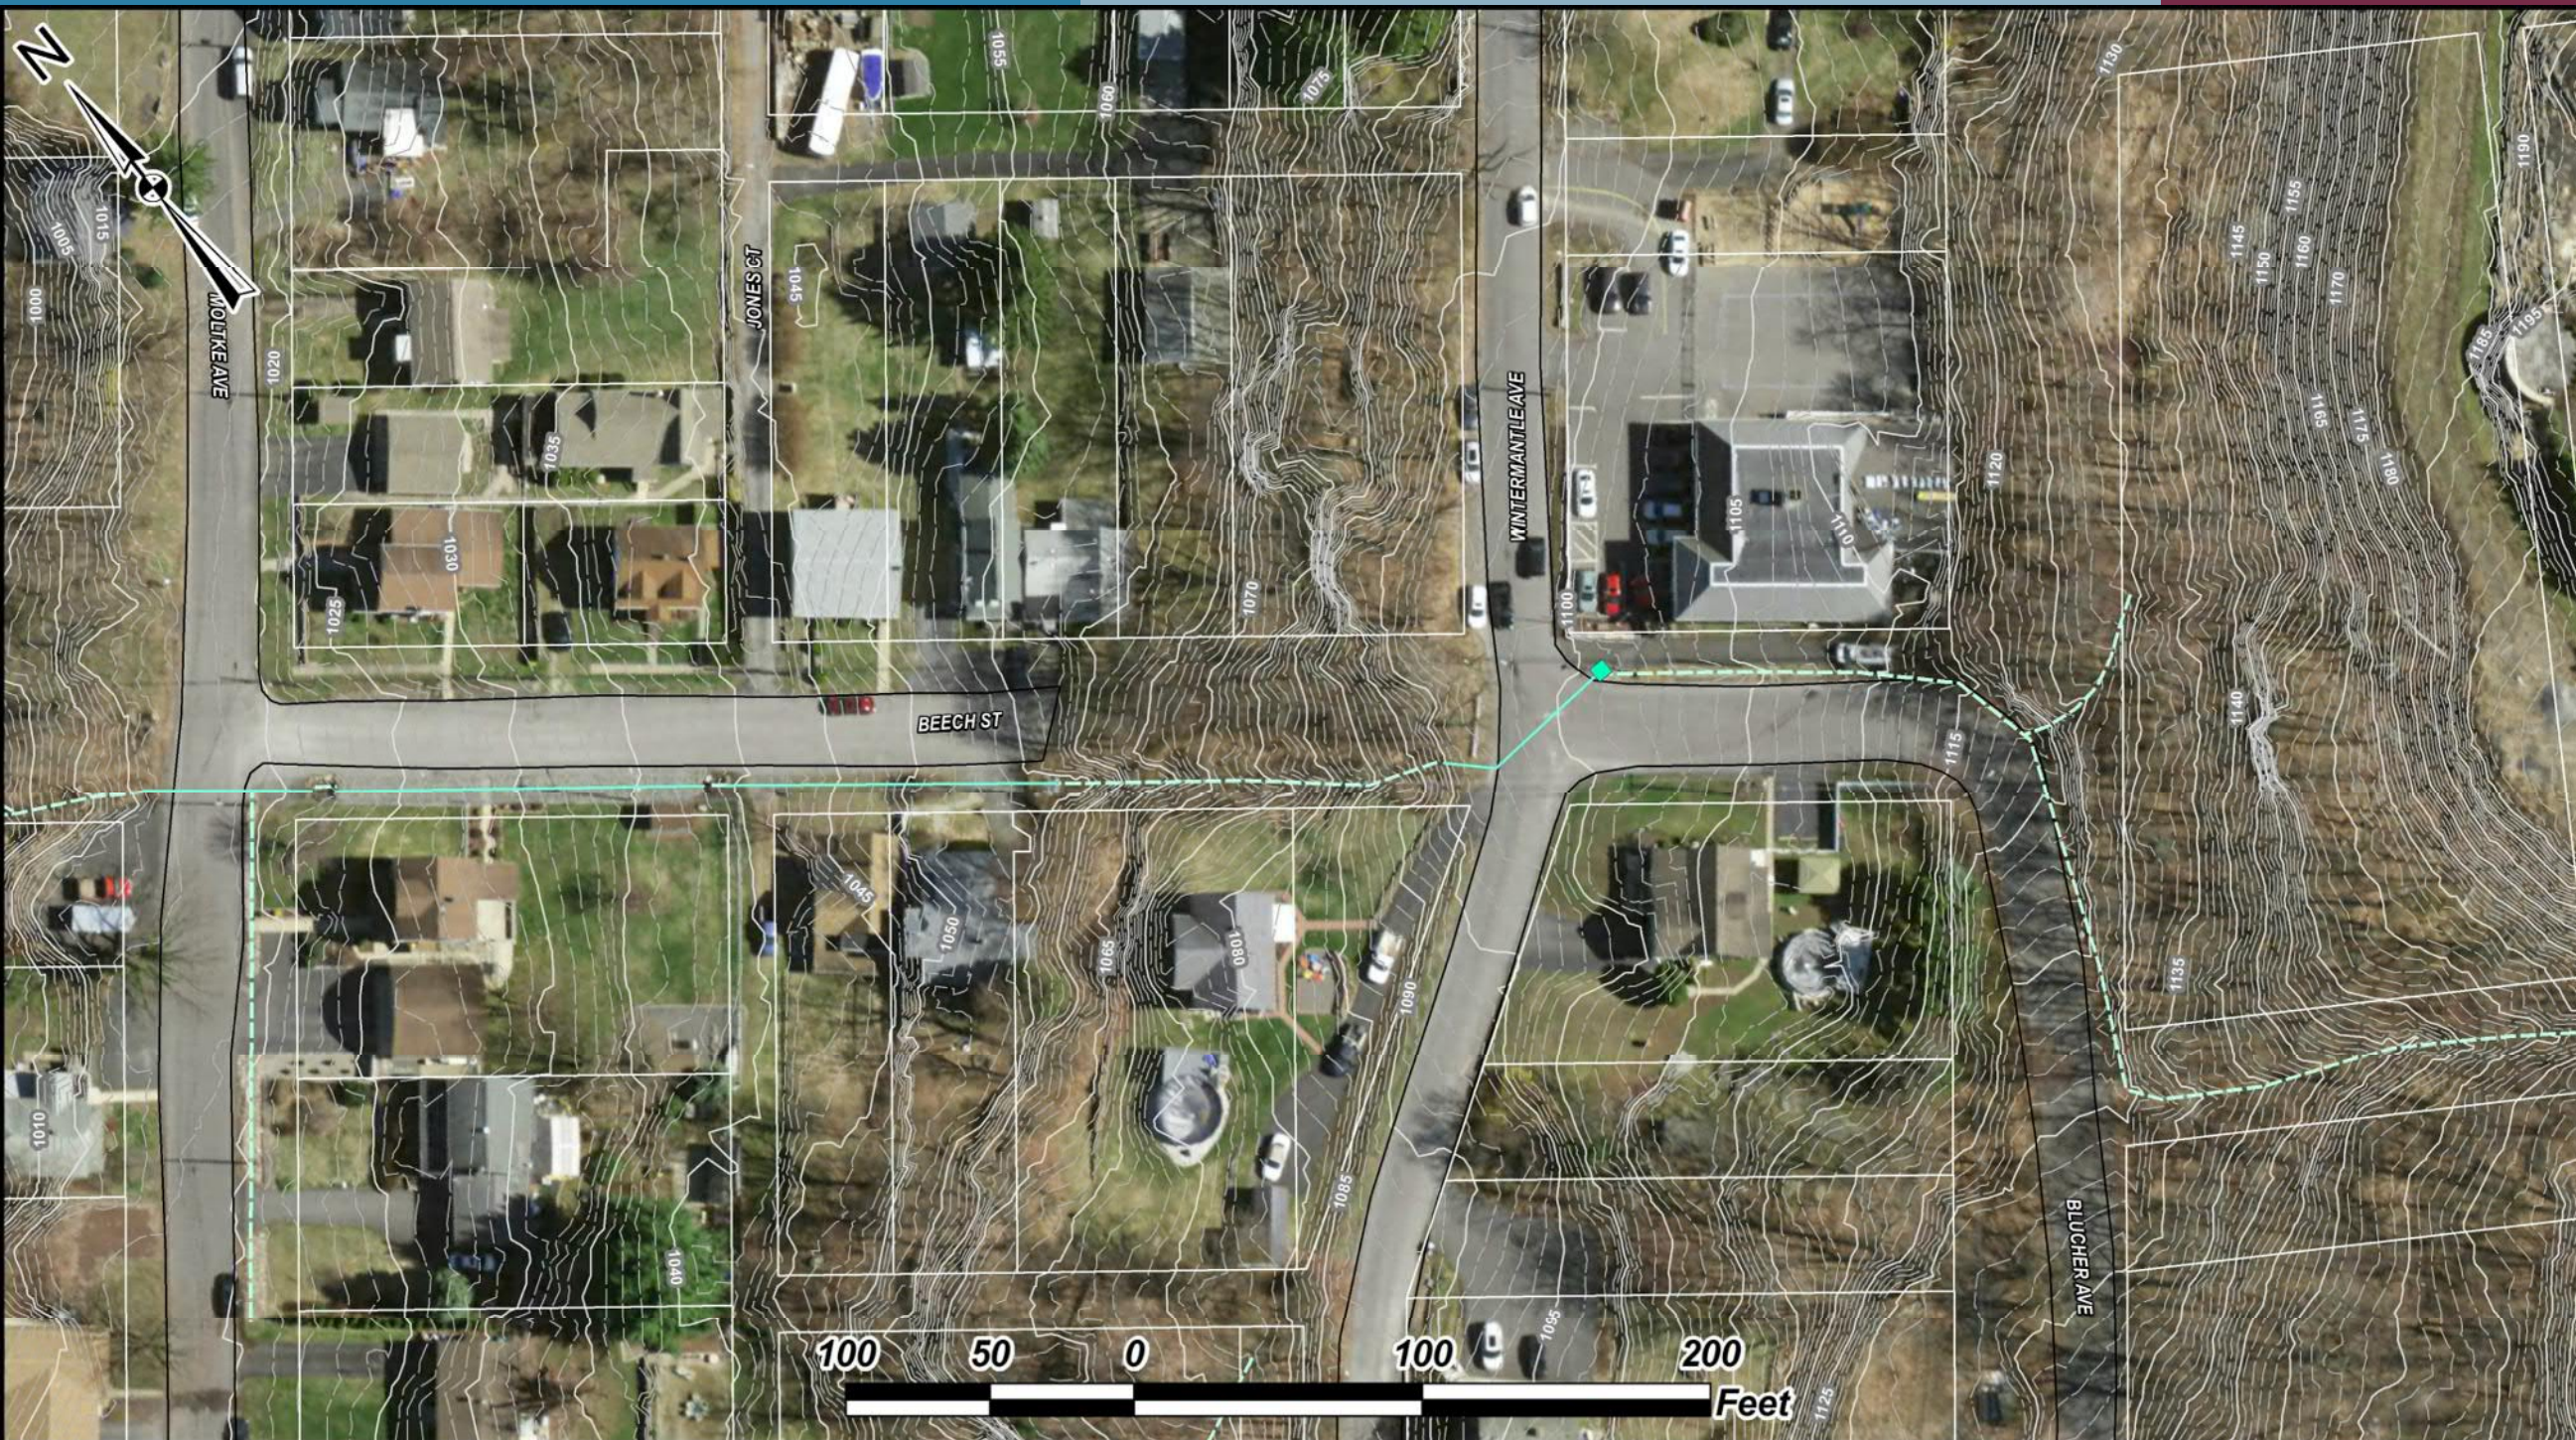
# BEECH STREET & WINTERMANTLE AVENUE

Along the northern side of Beech Street, just north of Wintermantle Avenue is an open drainage swale which is located immediately adjacent to the edge of pavement for the cartway (See Photos in Section 3.5.5). Stormwater runoff from Blucher Avenue and the woodlands to the southeast drain into this swale. Flooding and icing conditions from this drainage system pose a danger to vehicles traveling down the hill from Blucher Avenue. This hazard is of even a greater concern because the building on this corner houses the Discovery Montessori School. (See Figure 3.5.1)

- *Roadway Hazard (Ice & Flooding)*
- *Residential Flooding*
- *School Safety*

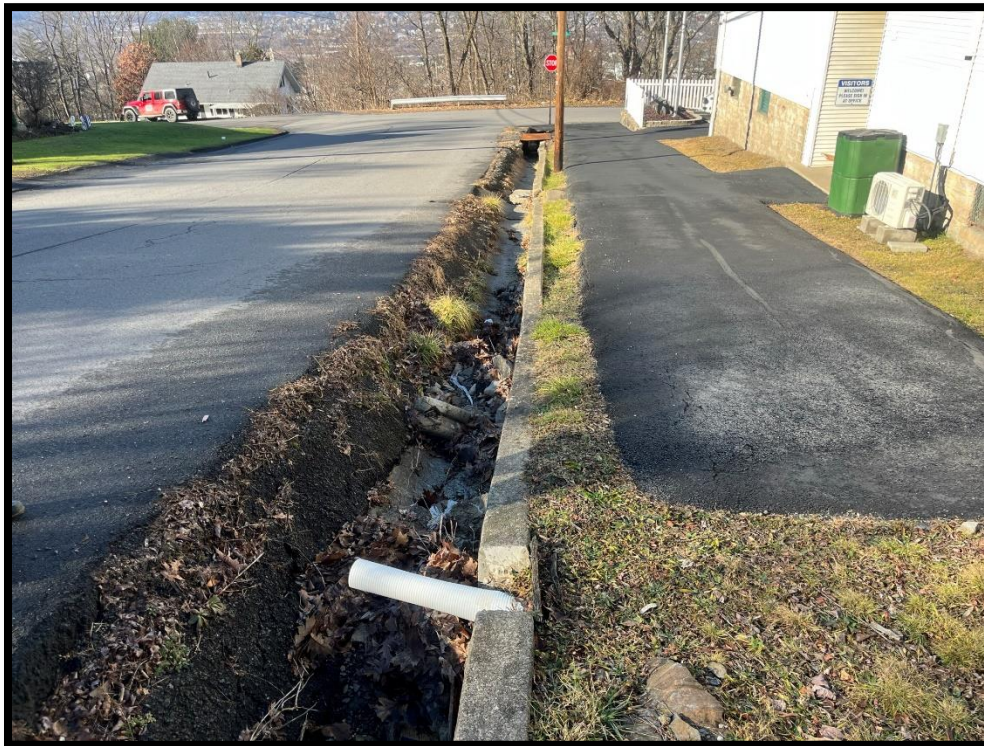
**Photo 3.5.2** View looking down Beech Street from Blucher Avenue. Flooding and icing conditions pose a hazard to vehicles coming down the hill.

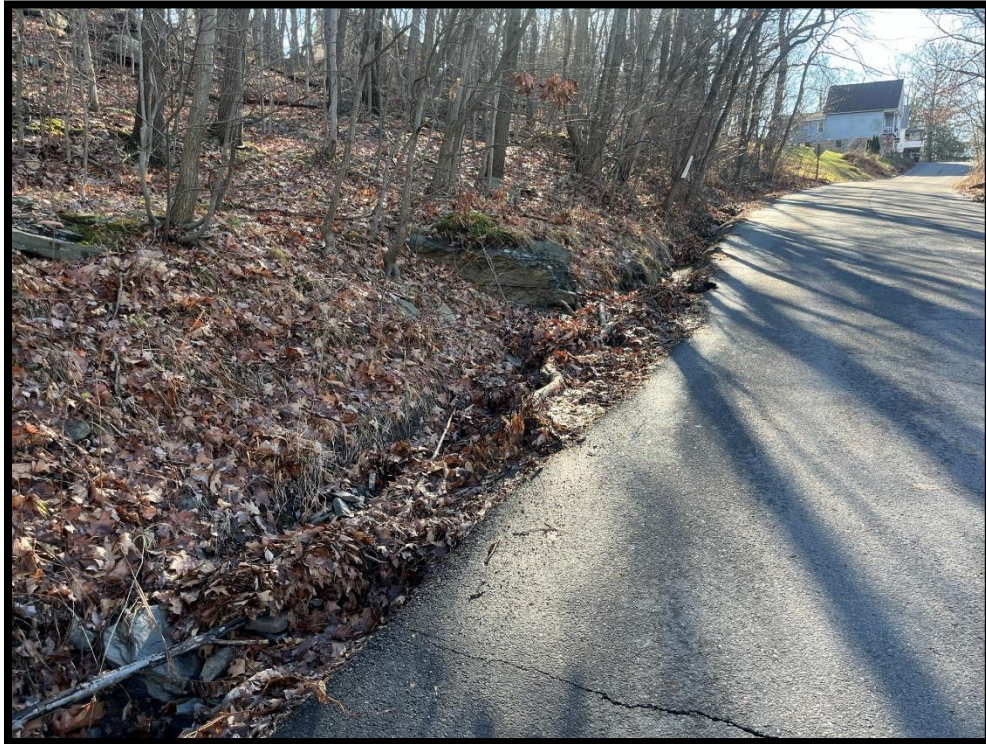
**Photo 3.5.3** This drainage swale along Blucher Avenue should be excavated and stabilized to better handle stormwater runoff.

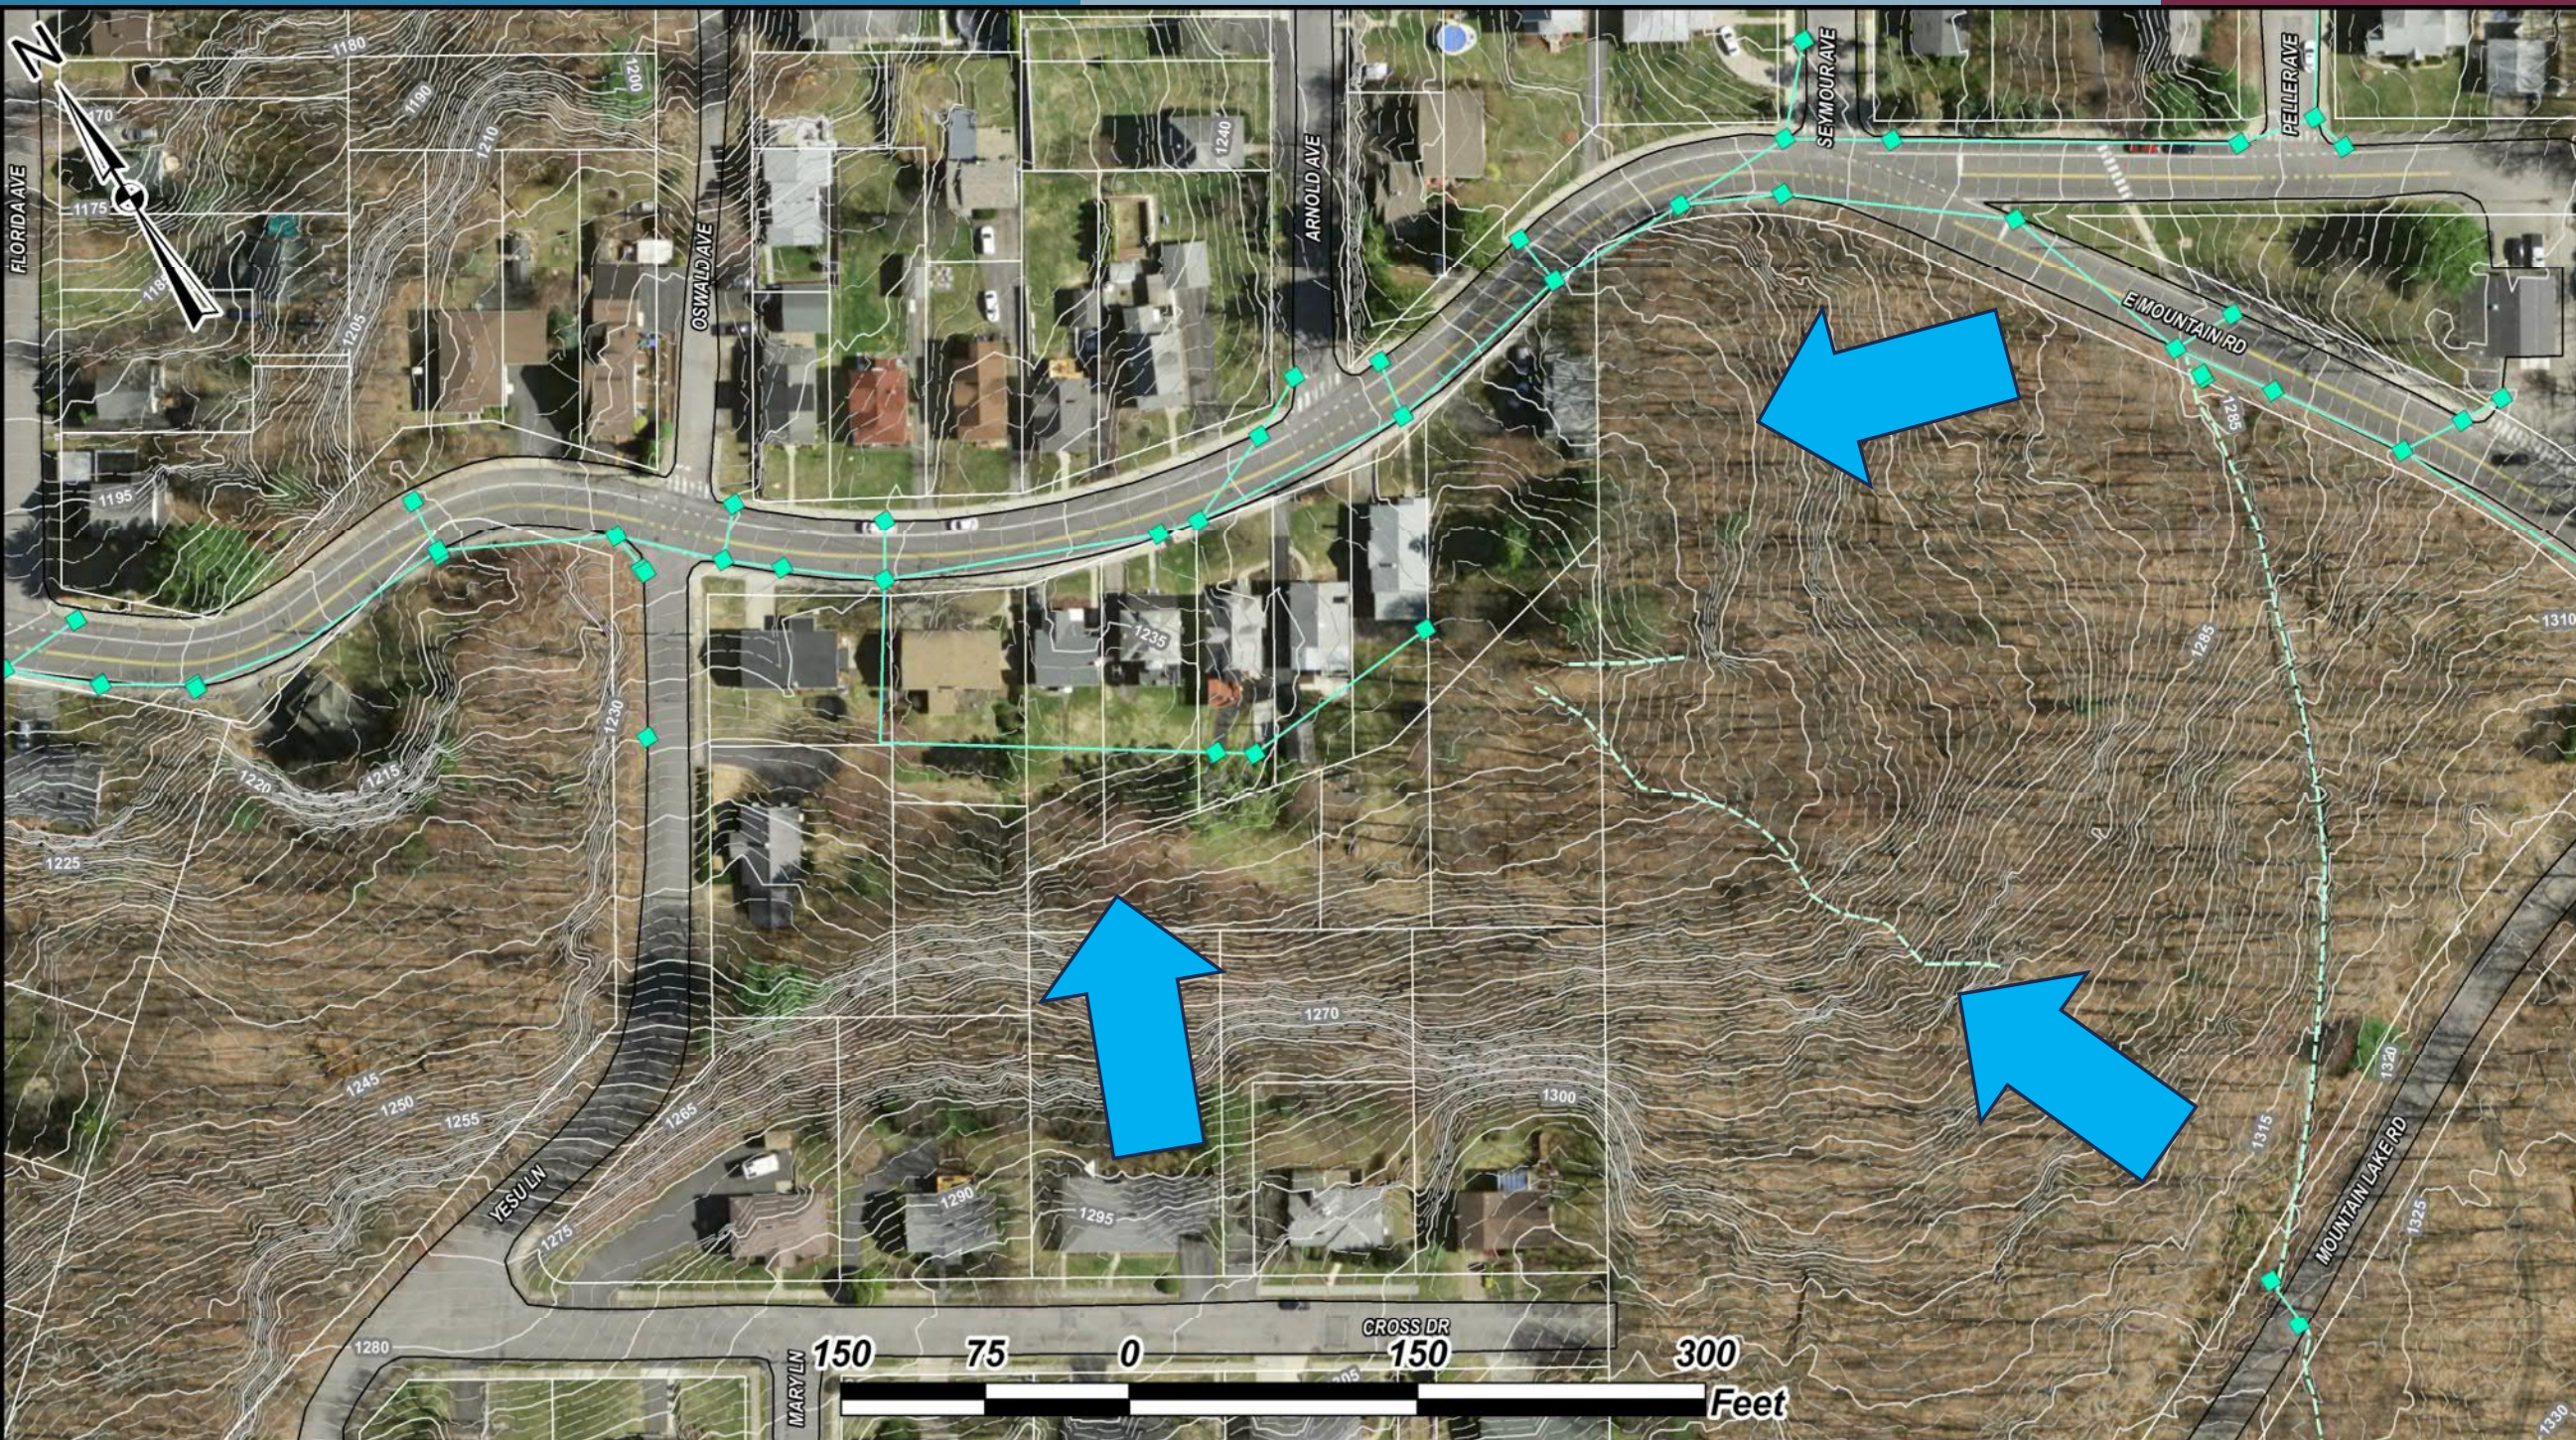
# EAST MOUNTAIN ROAD

Previously, drainage flowing into the back yards of these homes was collected in a storm drain and discharged into the existing drainage system along East Mountain Road (See Photos in Section 3.6.5). However, based upon flooding photos and videos provided by the homeowners, it appears that this backyard system has failed. Photos of water discharging from a yard grate in the middle of the drainage system indicates that a pipe in the lower portion of the system has collapsed, causing residential flooding.

- Residential Flooding
- Runoff from new Mountain Lake Road Culvert?
- Submitted photos of pipe discharge in rear yard.
- Ties into Mountain Lake Road drainage system

Based upon our evaluation of this drainage problem, HRG feels that the entire drainage system should be replaced behind these homes. Since a majority of the water flowing onto these properties is from a City-owned property, it is appropriate for the City to replace the storm sewer. A new 24" HDPE pipe with lawn grate inlets has been proposed along the same general route that the current system follows. A new headwall will be built to assure that upstream water flows into the system, and the discharge into the East Mountain Road system will be rebuilt. (See Figure 3.6.2).

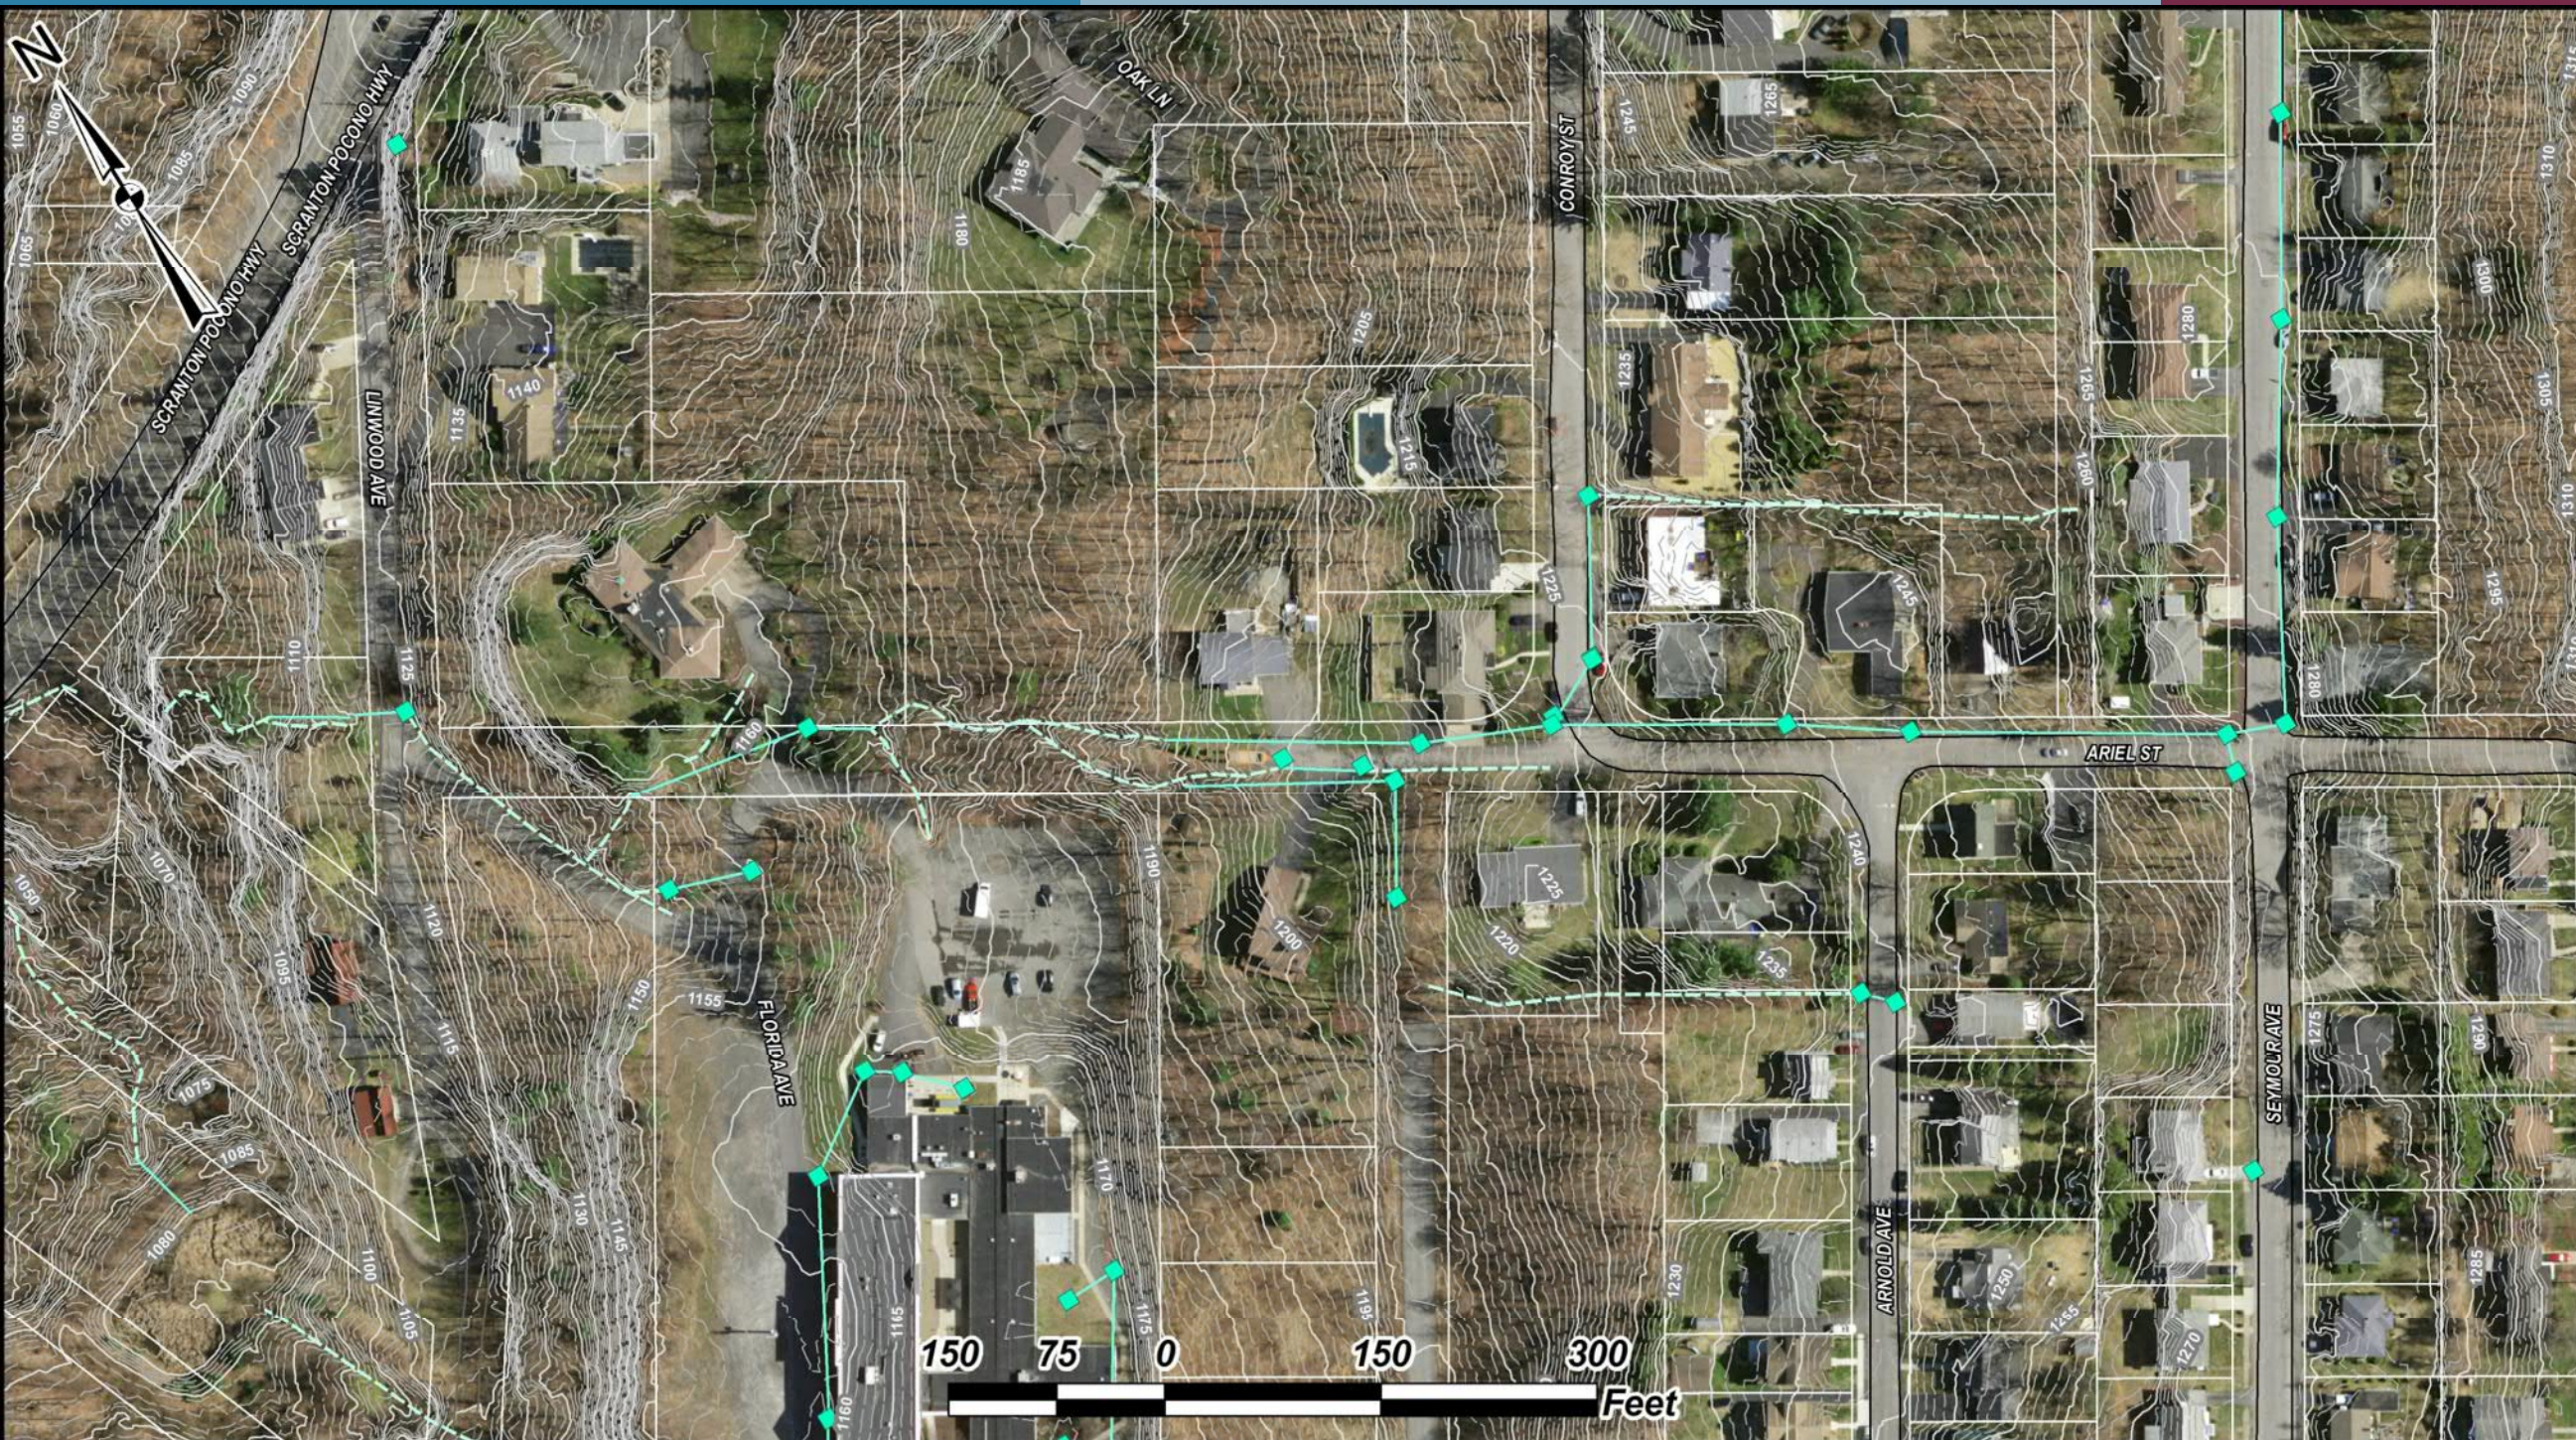
# LINWOOD AVENUE

- *Washouts on Linwood & Florida Avenues*
- *Residential Flooding*
- *Existing drainage system on Ariel Street*

Based upon our evaluation of this drainage problem, HRG has concluded that the entire drainage system from the end of Ariel Street to the culvert under State Route 307 should be rebuilt (See Figure 3.7.2). Beginning at the discharge of the two stormwater pipes at the end of Aerial Street, a stable swale should be constructed to convey the runoff downhill. The existing driveway culvert should be replaced by a new collection system along the Nursing Home driveway down to Linwood Avenue. At the discharge from Linwood Avenue, another drainage swale is needed to direct the runoff to the Route 307 culvert.

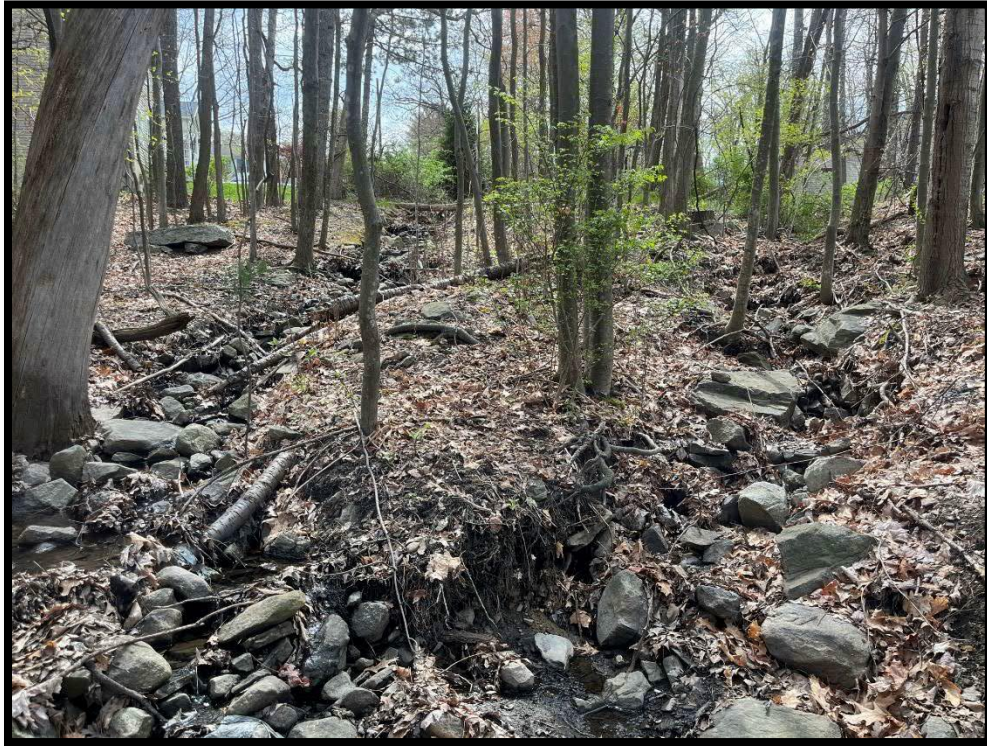
**Photo 3.7.5** View of the unstable conditions that have developed within the drainageway of the Ariel Street stormwater runoff.

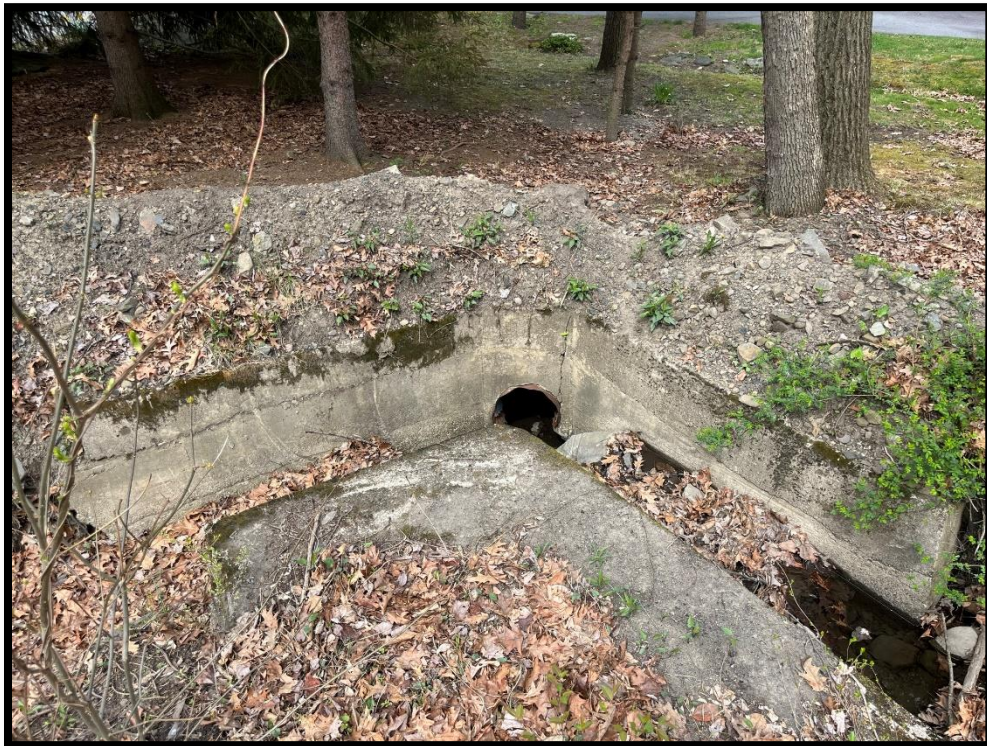
**Photo 3.7.6** This is the existing driveway culvert below Ariel Street. It is both undersized and in disrepair.

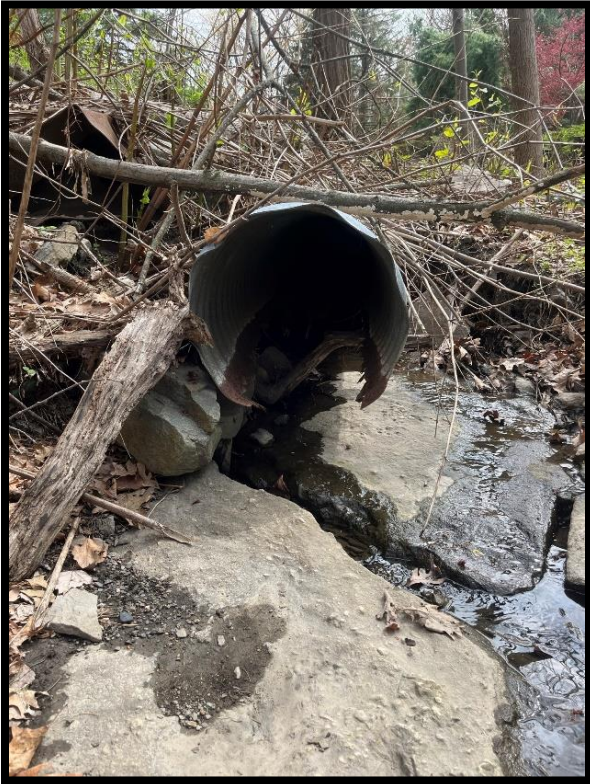
**Photo 3.7.5** The downstream end of the driveway culvert shows the structural failure of the corrugated metal pipe.

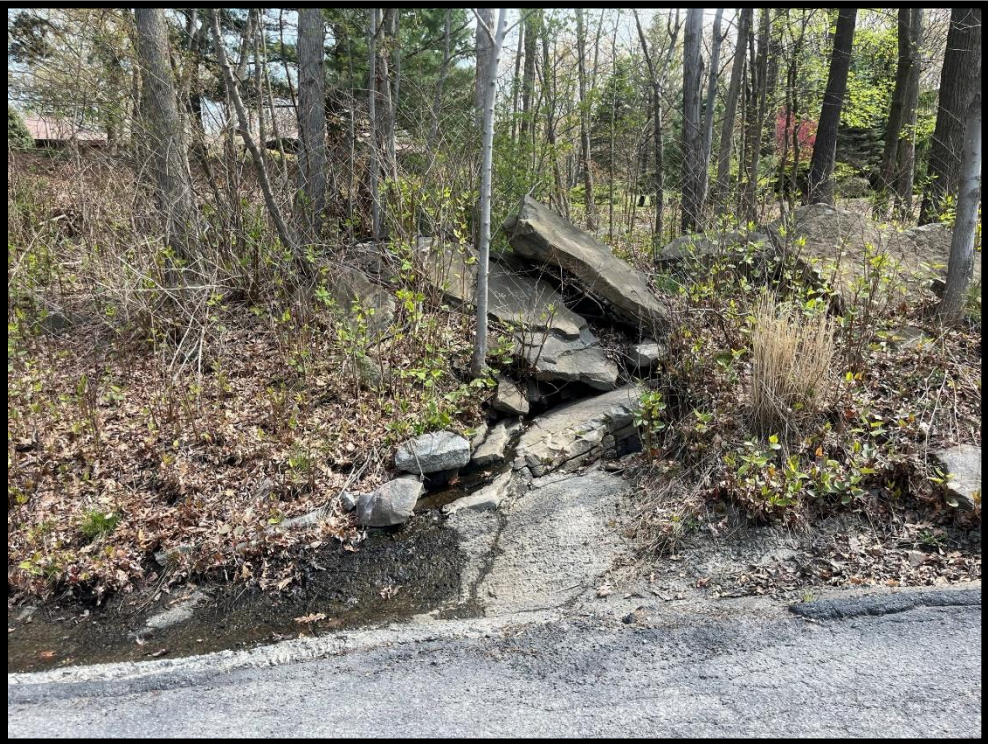
**Photo 3.7.6** The swale downstream of the driveway culvert has been blocked by these large boulders.

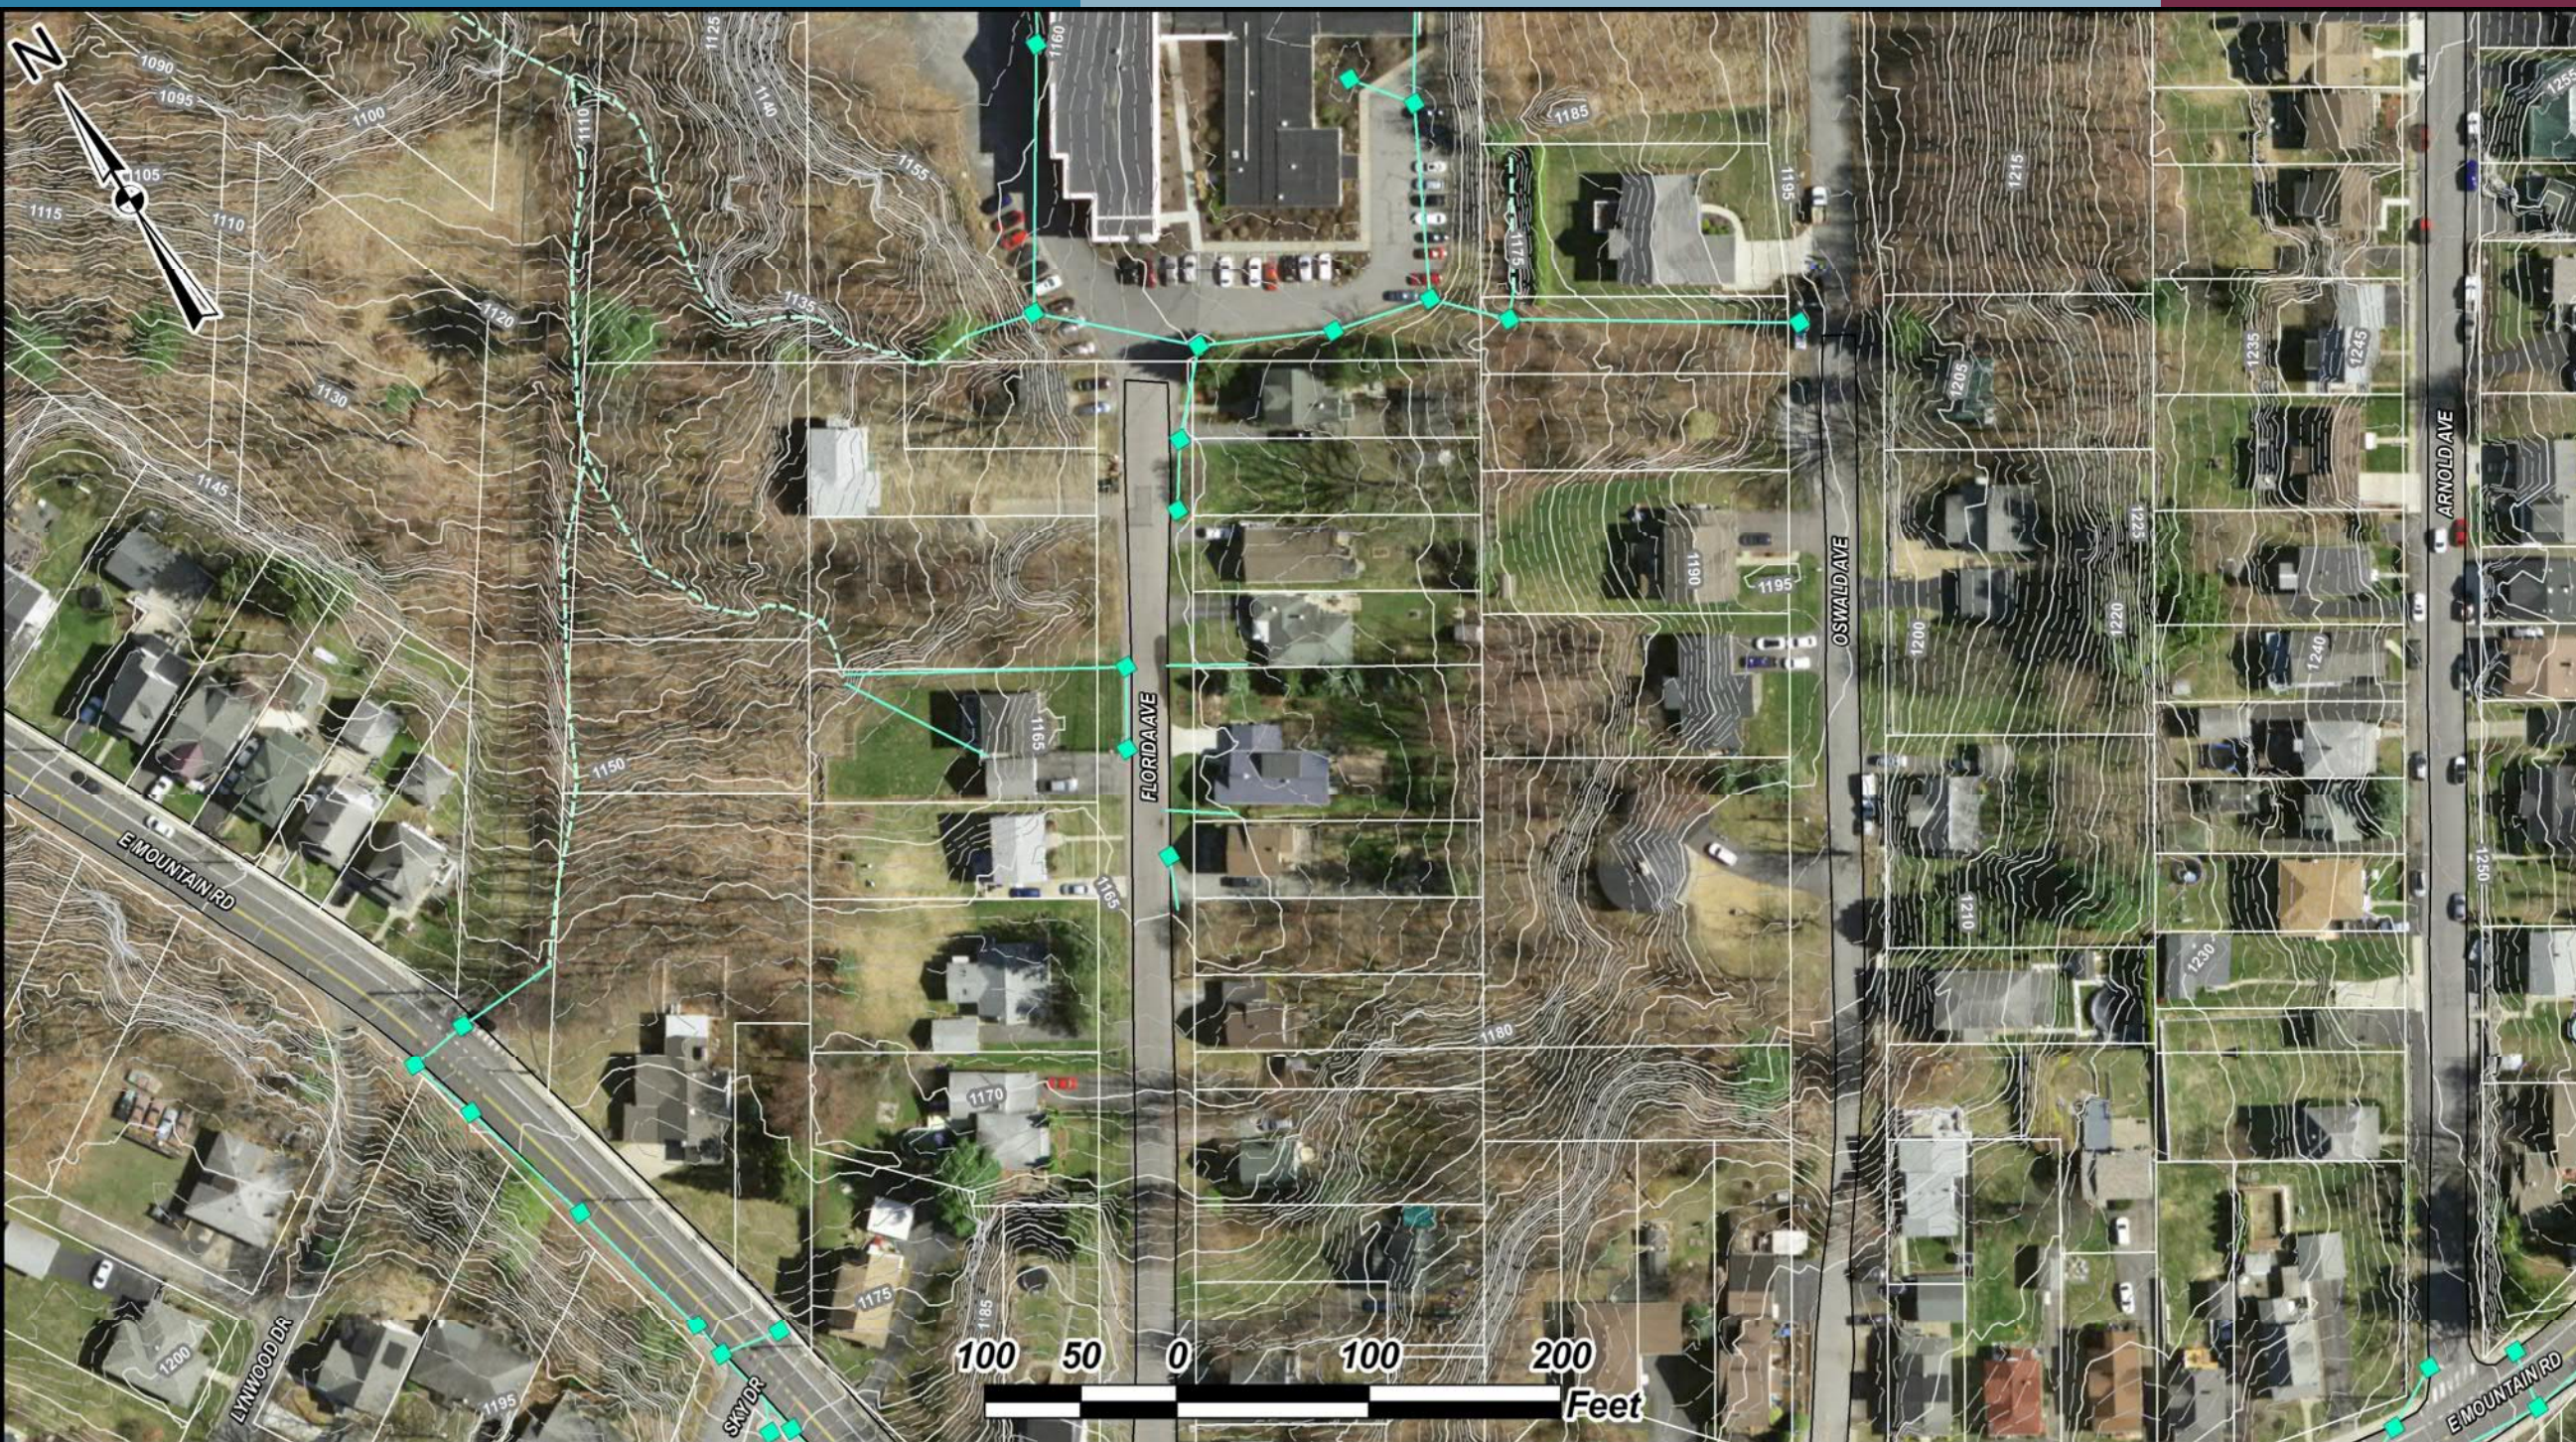
# FLORIDA AVENUE

Ponded water has been a longtime problem along a low-lying section of Florida Avenue. Although three roadway drainage inlets were observed during a field evaluation, it was noted that the southern catch basin, adjacent to 125 Florida Avenue, is not connected to the drainage system (See Figure 3.8.1). Roadside discharge from several small lawn drains was also observed (See Photos in Section 3.8.5).

In addition, there was a report by the residents of 101 Florida Avenue about flood water flowing down the hill behind their home. Our field evaluation found that this was most likely caused by drainage from Oswald Avenue. Although there is a catch basin on that street which flows into the drainage system for the Linwood Nursing and Rehabilitation Center, a section of missing curb along Oswald allows stormwater runoff to bypass the inlet. Therefore, much of the runoff from the low spot on Oswald Avenue drains down the hillside towards 125 Florida Avenue.

- *Ponding water on Florida Avenue*
- *Runoff from Oswald Avenue*

To prevent ponding on Florida Avenue, HRG recommends the installation of two new stormwater catch basins on the eastern side of Florida Avenue (See Figure 3.8.2). These new inlets are to be tied into the existing drainage system which discharges into the woodland behind 120 Florida Avenue. New curbing along the western shoulder of Oswald Avenue is recommended to keep runoff from bypassing the existing inlet.

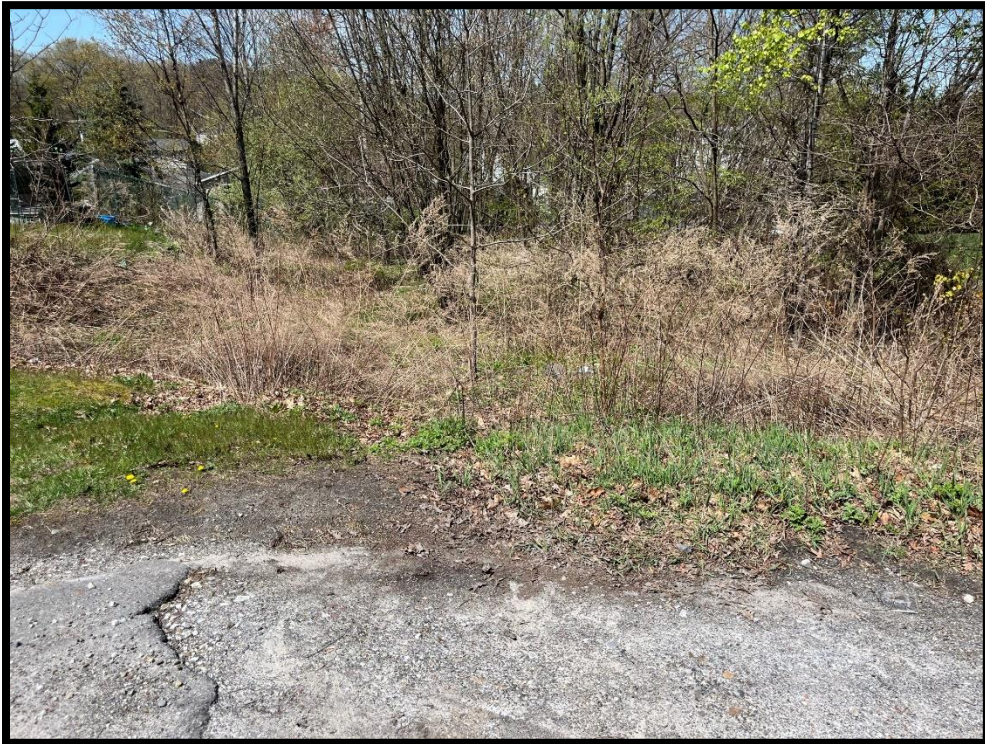
**Photo 3.8.4** Missing curb along a low section on Oswald Avenue has allow stormwater runoff to bypass a catch basin on that road, and has resulted in flooding at 101 Florida Avenue.
