# FINAL REPORT

## EAST MOUNTAIN STORMWATER AND DRAINAGE STUDY

Submitted to: City of Scranton  
Lackawanna Co., PA

January 9, 2024

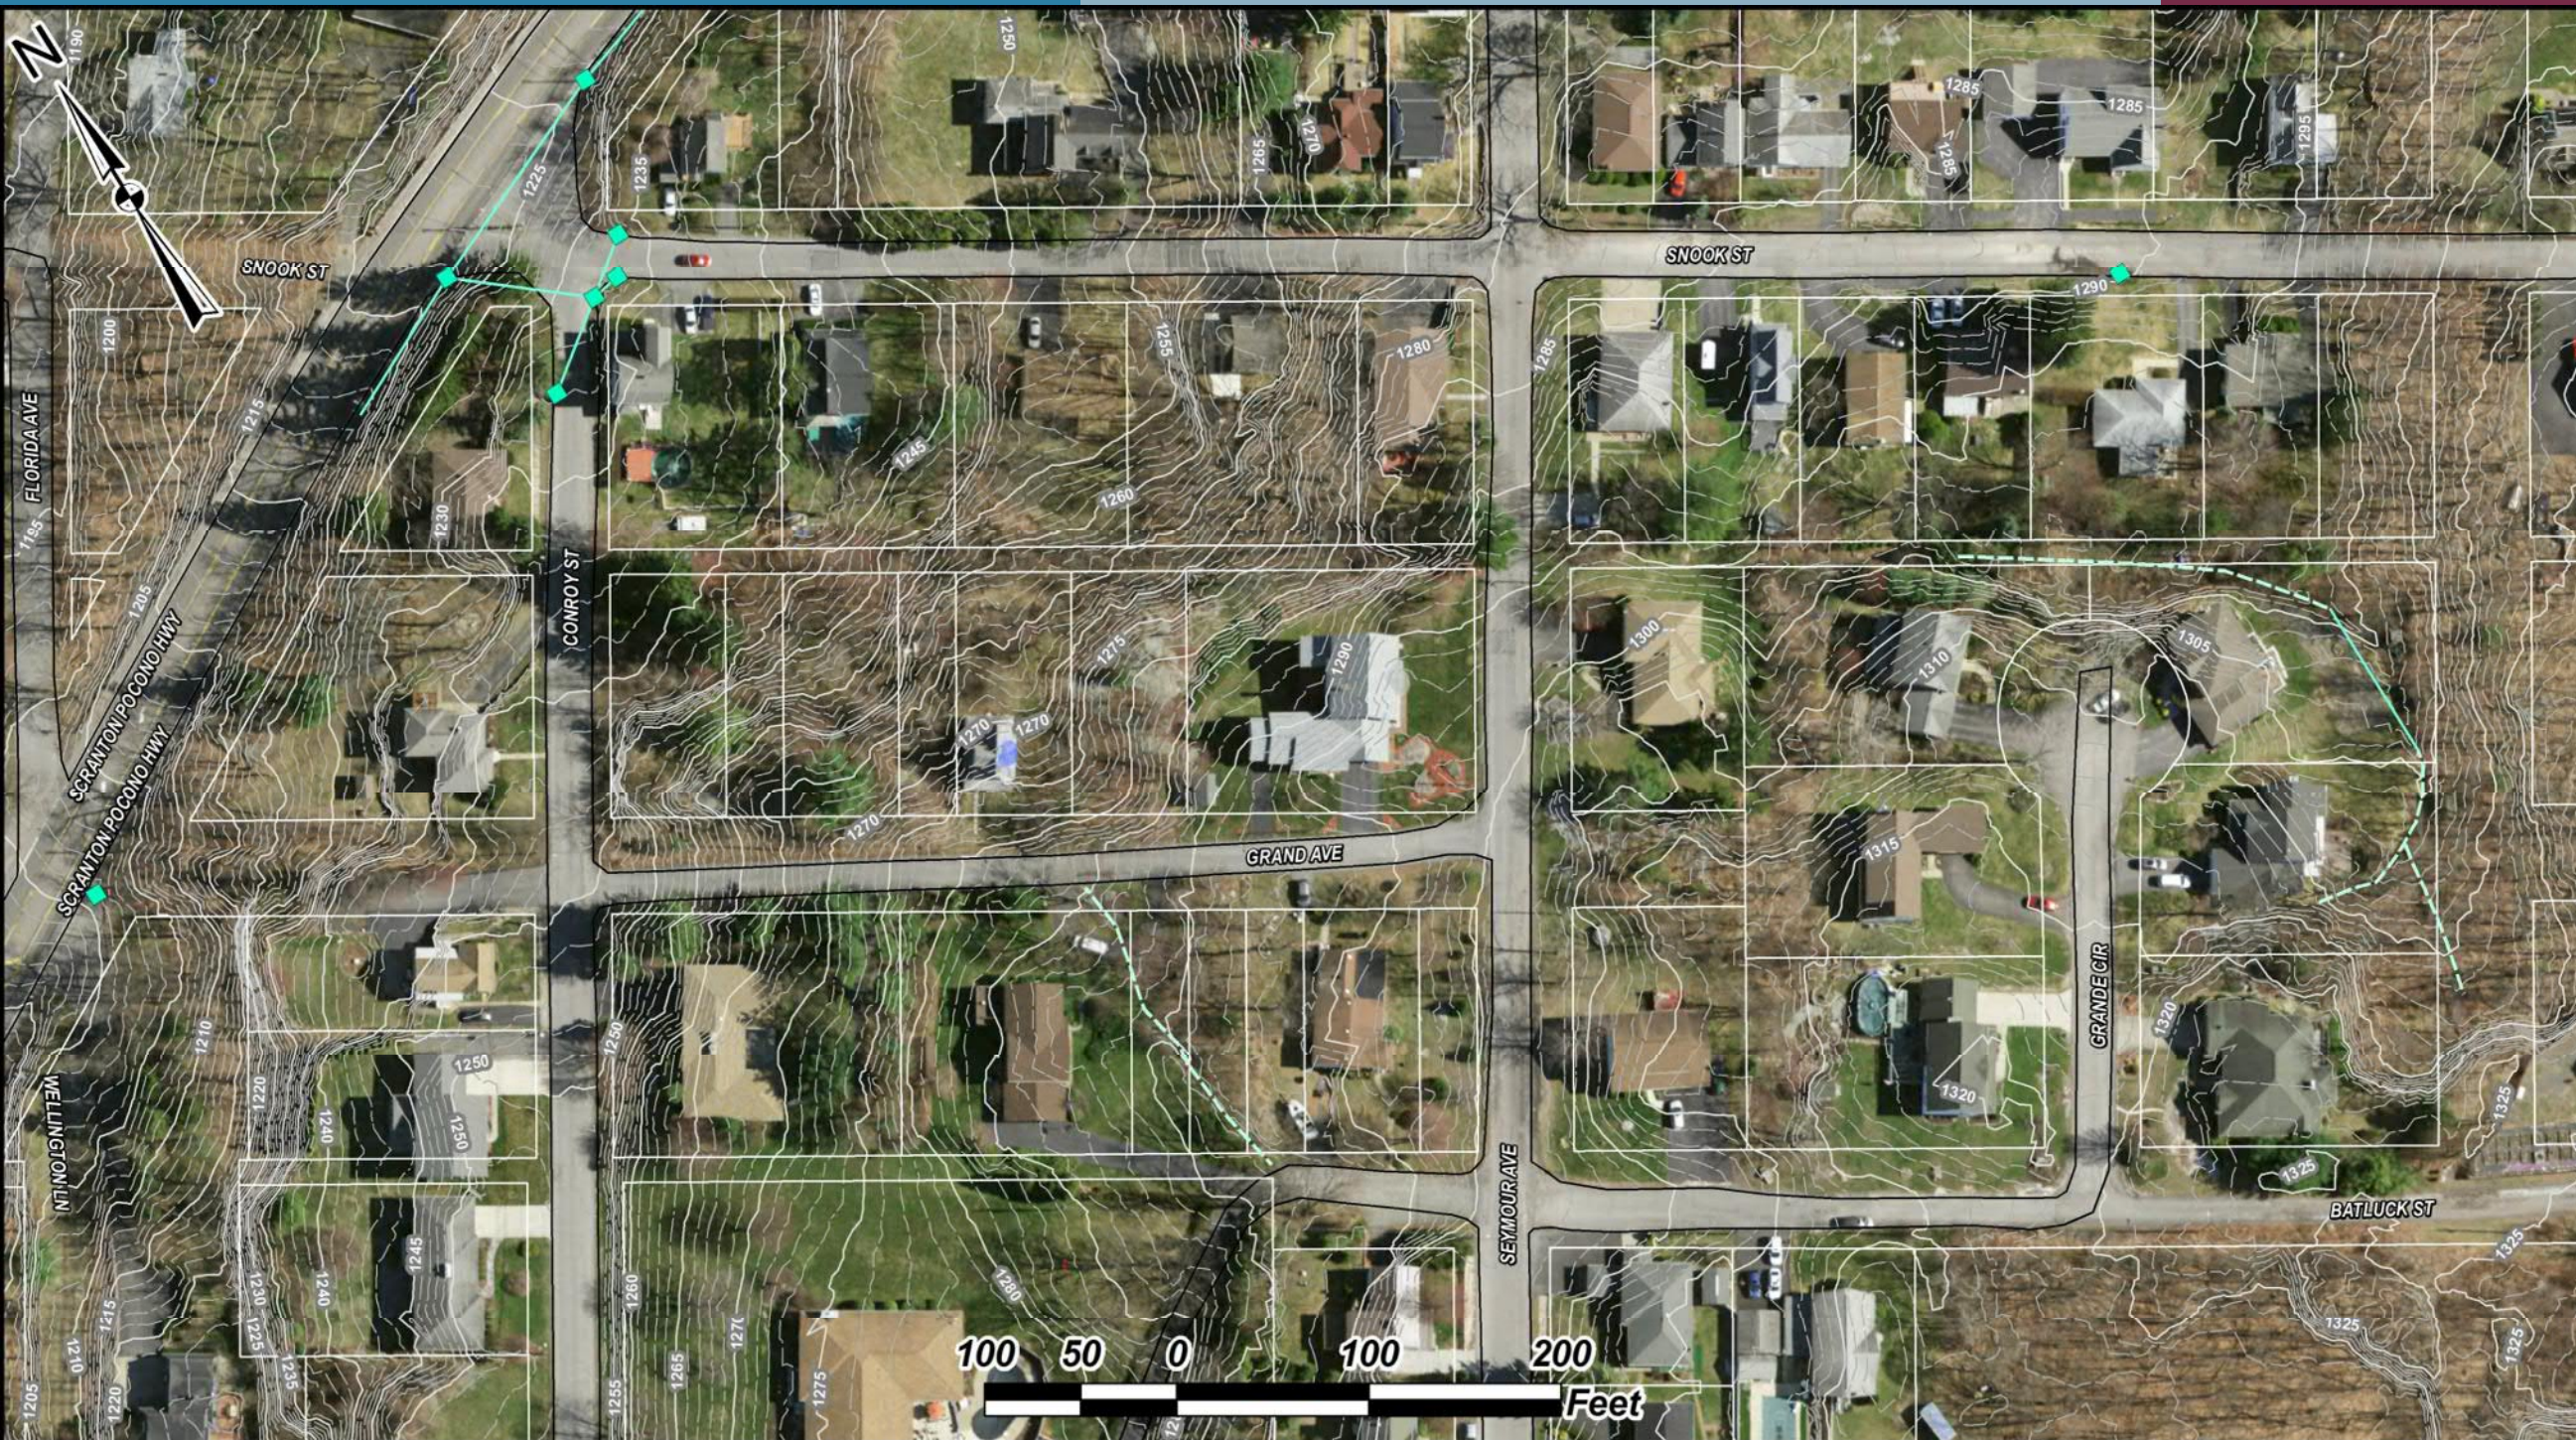
# SNOOK STREET

Recent development on Grande Circle has made the situation worst. It appears that grading for the new homes increased groundwater seepage, which flows behind the homes on Snook Street. The water ponds in a low-lying area but is not able to infiltrate into the ground due to shallow bedrock (See Photos in Section 3.9.5).

- Residential Flooding on Snook St. & Grand Ave.
- High Groundwater Table
- Street Ponding on Seymour Avenue
- Runoff crossing Moosic Street

Based upon our evaluation of this drainage problem, HRG has concluded that a new roadway drainage system is needed for the area from Batluck Street down to Snook Street (See Figure 3.9.2). Undulating topography makes it impossible to drain water away from this area without a storm sewer system. Therefore, a series of catch basins and drainpipes are proposed within the public right of way. Roadway paving and curbing is also recommended to convey the runoff into the inlets and away from private property. The new drainage system will discharge into the existing Route 307 stormwater management system. The proposed system will not change the current drainage area which feeds into the Route 307 storm sewer. Rather than overland flow, the water will be conveyed via the proposed pipe system. Although this may result in a minor change in the time of concentration, no significant impact is expected in the volume of runoff conveyed by the Route 307 storm sewer.

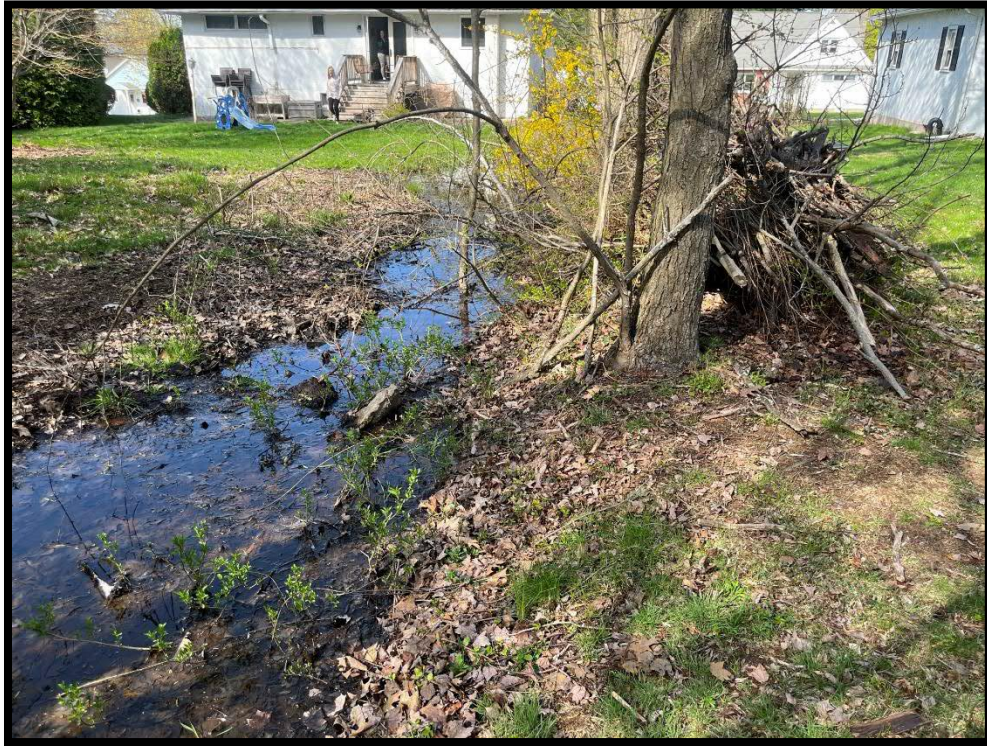
**Photo 3.9.3** Runoff from Grande Circle ponds in the rear yard of homes along Snook Street where it is unable to infiltrate into the ground due to shallow bedrock.

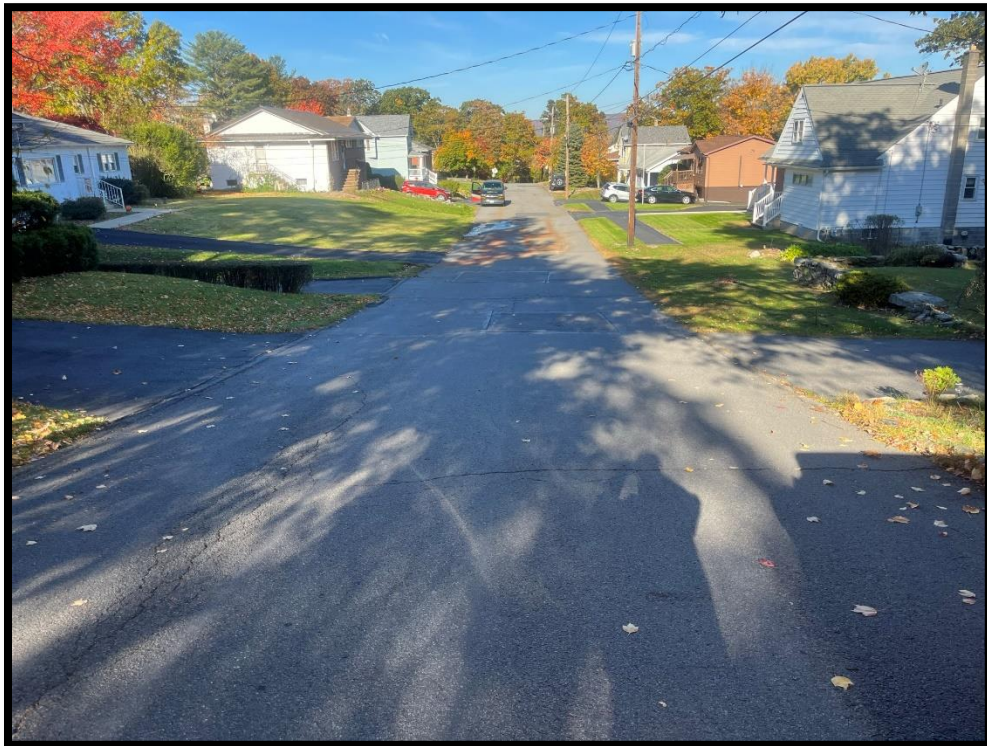
**Photo 3.9.4** View looking down Snooks Street at an area which is often flooded by stormwater runoff. Undulating topography makes it impossible to drain water away from this area without a storm sewer system.
