# FINAL REPORT

## EAST MOUNTAIN STORMWATER AND DRAINAGE STUDY

Submitted to: City of Scranton  
Lackawanna Co., PA

January 9, 2024

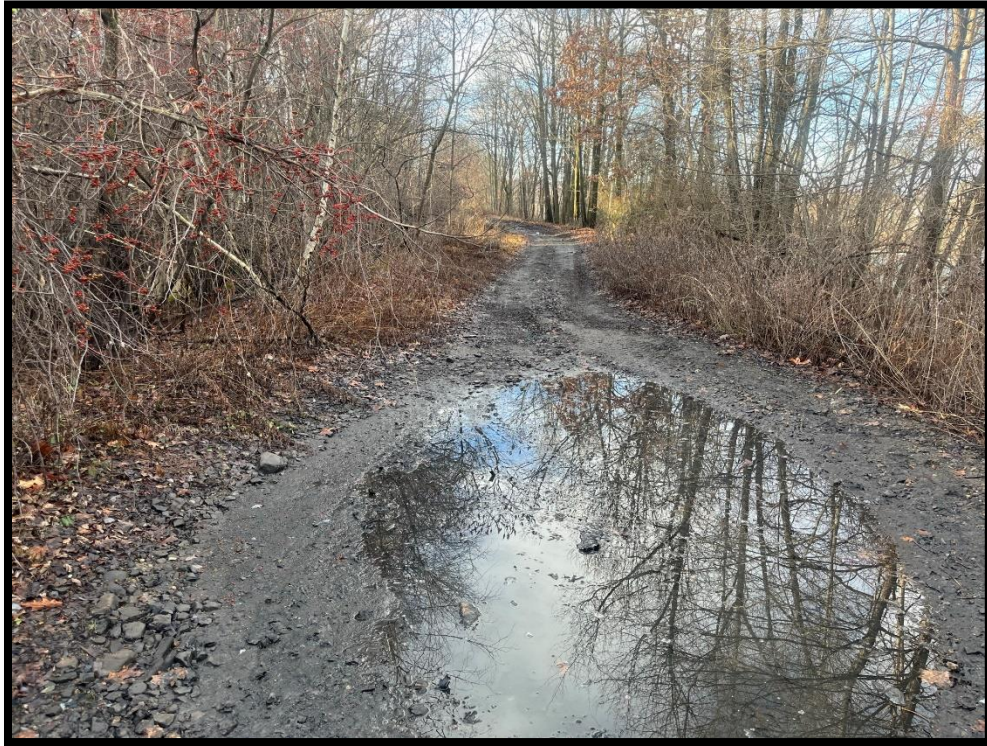
**Photo 3.1.3** This abandoned railroad grade dates back to pre-1891 when it was the route of the Erie and Wyoming Valley Railroad.

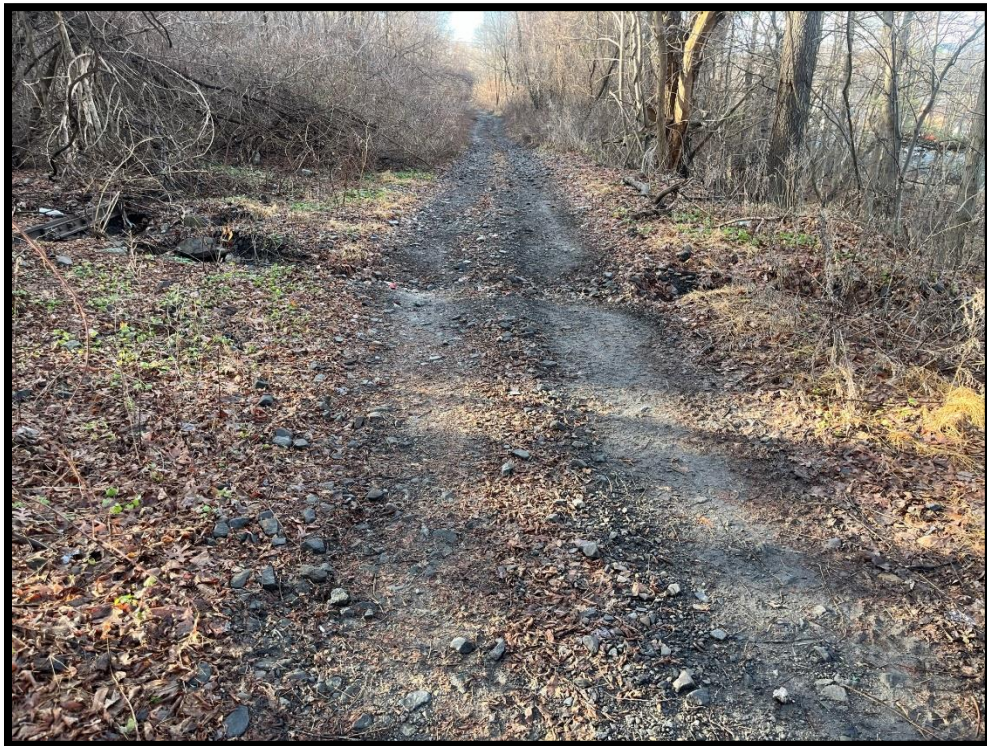
**Photo 3.1.4** Concentrated flow of stormwater runoff from East Mountain has eroded ditches across the railroad grade.

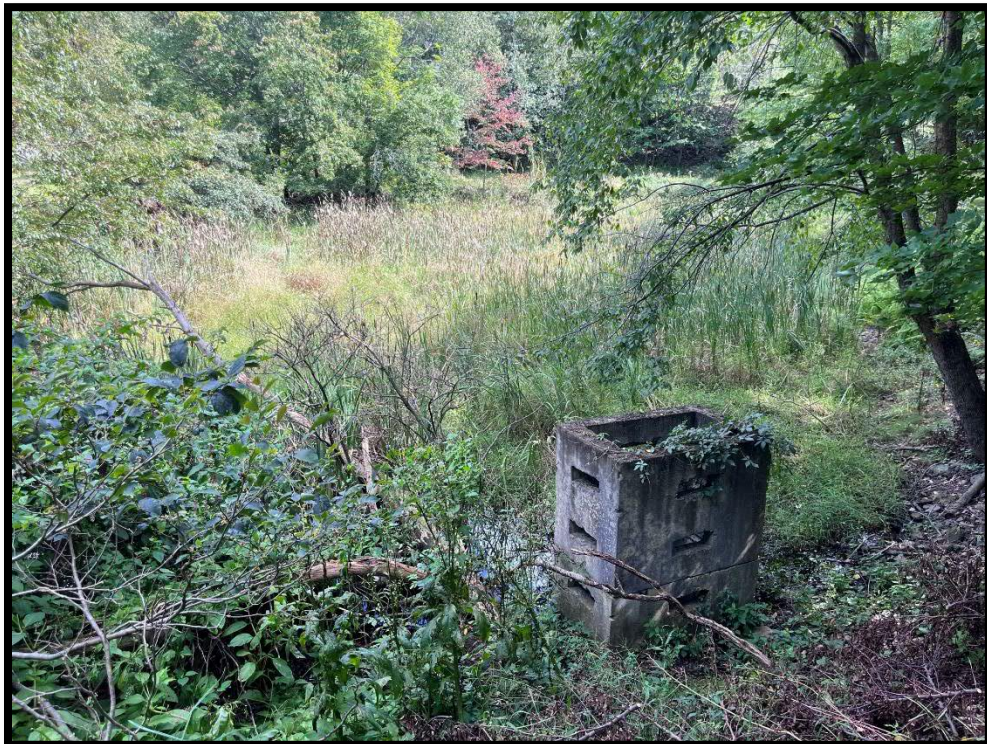
**Photo 3.2.2** View of the existing stormwater detention basin which was built as part of the Mountain Laurel Estates Subdivision.

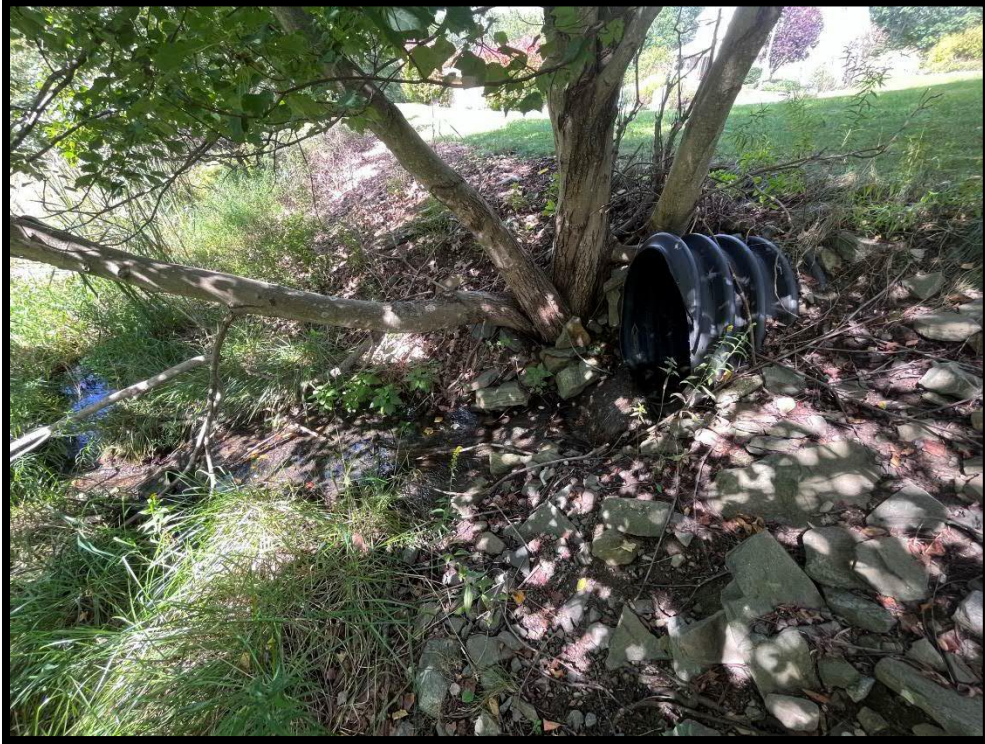
**Photo 3.2.3** Existing discharge pipe from the drainage system along Cherry Street into the detention basin. It appears that only a fraction of the runoff from this street makes it into this basin.

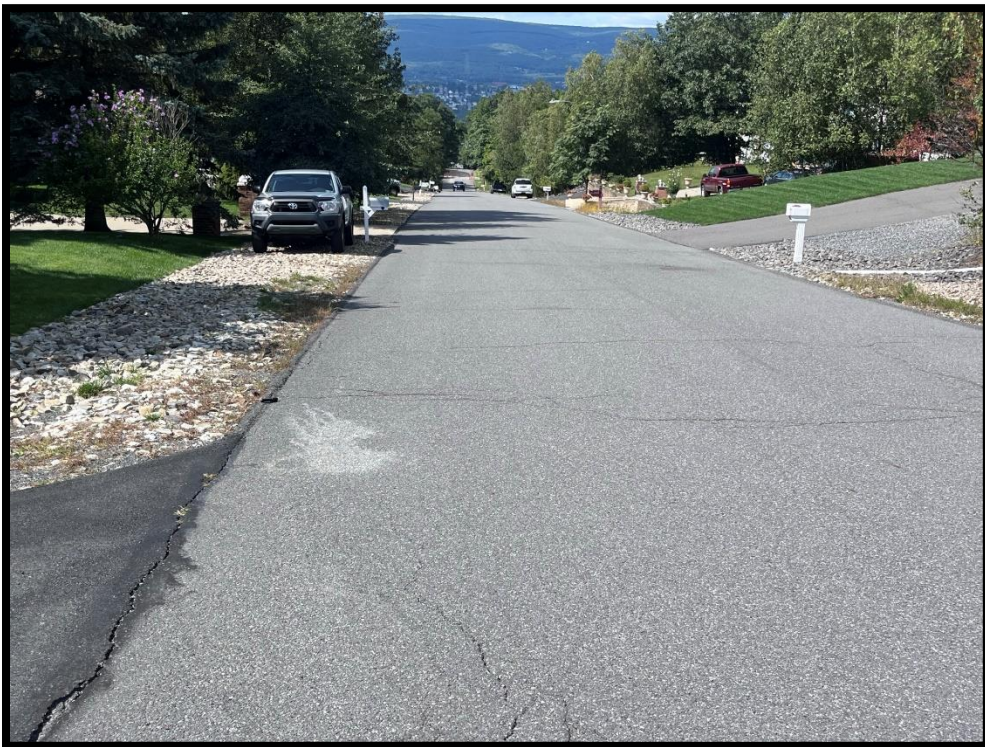
**Photo 3.2.4** Existing stone shoulders on both sides of Cherry Street have created a drainage problem along the roadway by keeping runoff from entering the inlets.

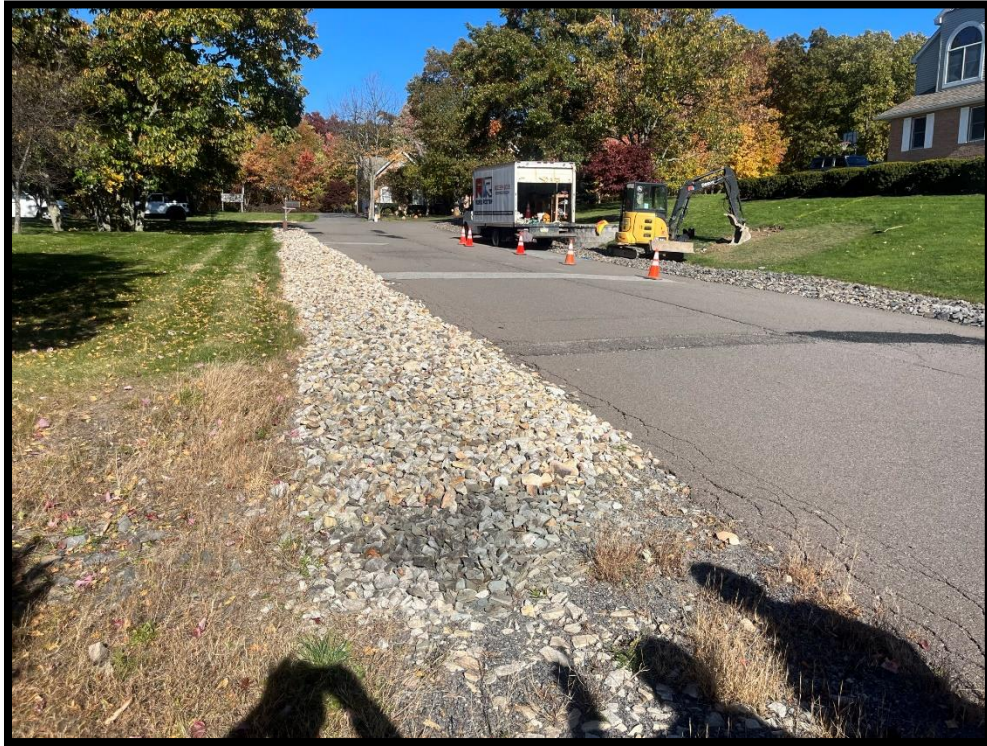
**Photo 3.2.5** It appears that roadway runoff drains into the stones along the roadway shoulder and is then unable to drain into the inlets.

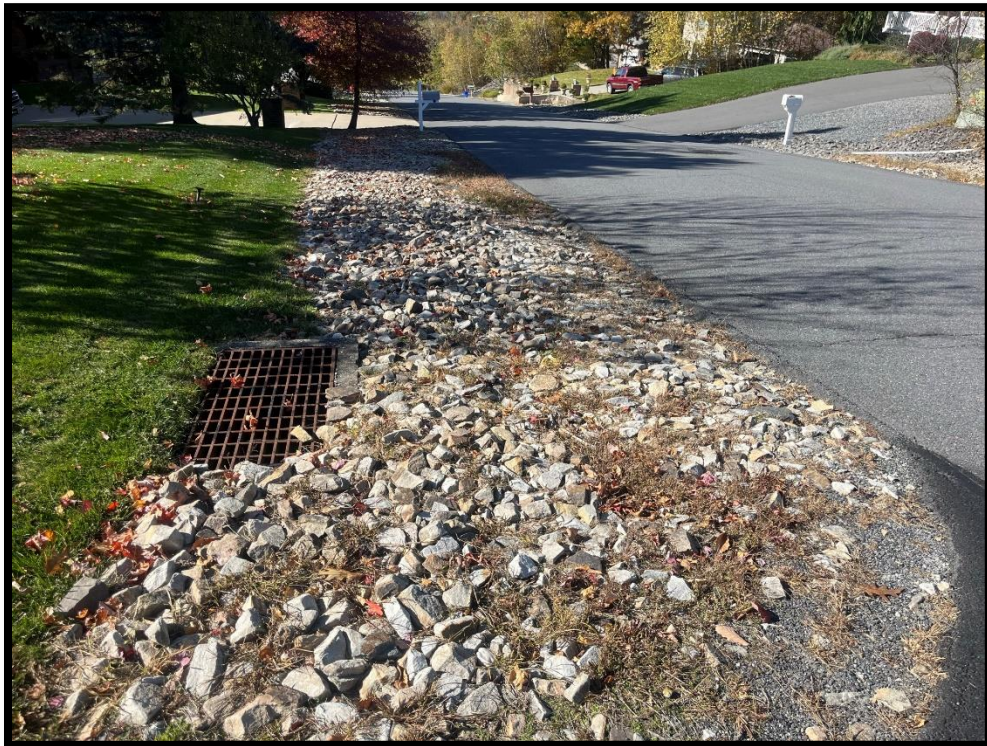
**Photo 3.2.6** Stormwater inlets were placed on the back side of the stone shoulder rather than along the paved cartway

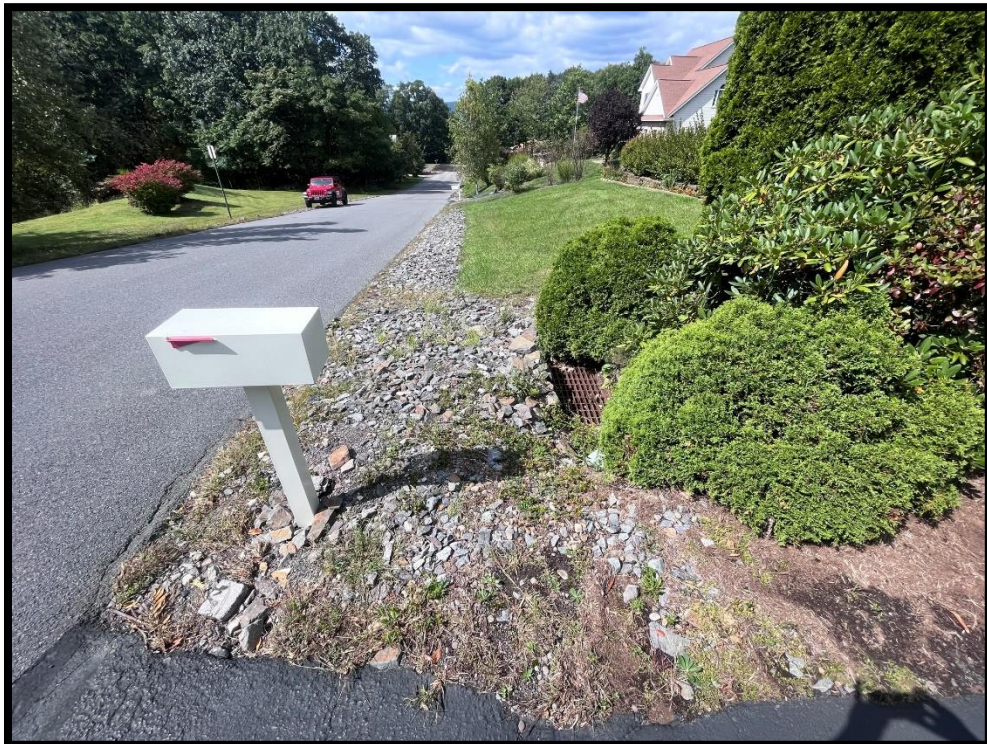
**Photo 3.2.8** Additional Civil Survey of the project area is needed to identify existing features which may be impacted by the improvements.

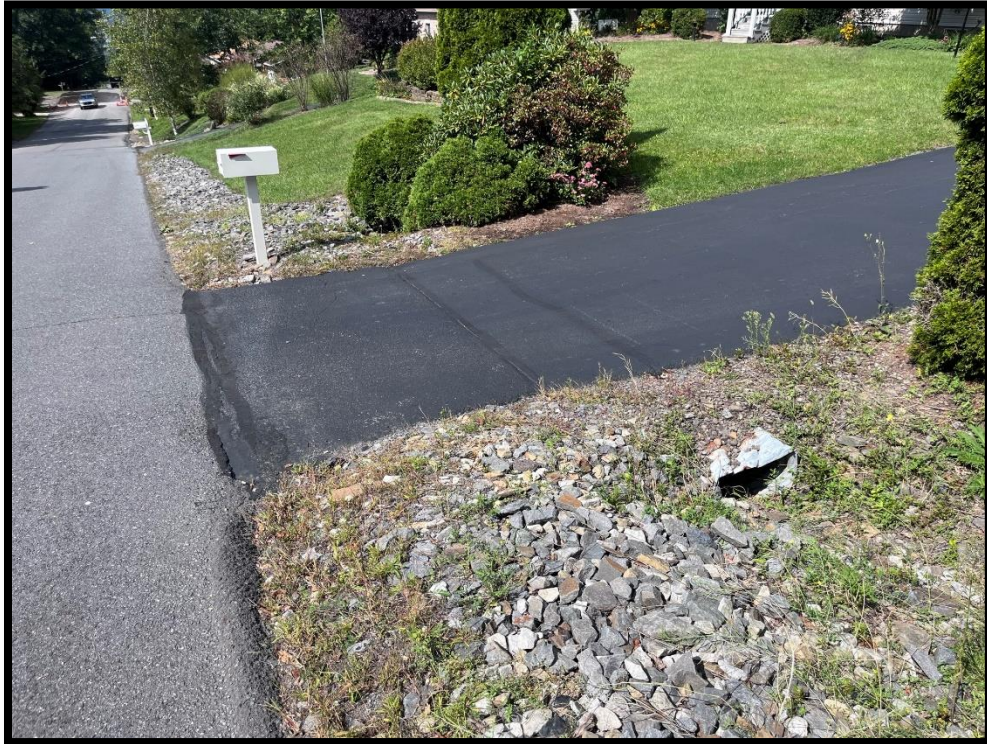
**Photo 3.2.9** The water then flows through the stone shoulder until it hits an obstruction, such as a driveway crossing, which deflects the water back into the roadway.

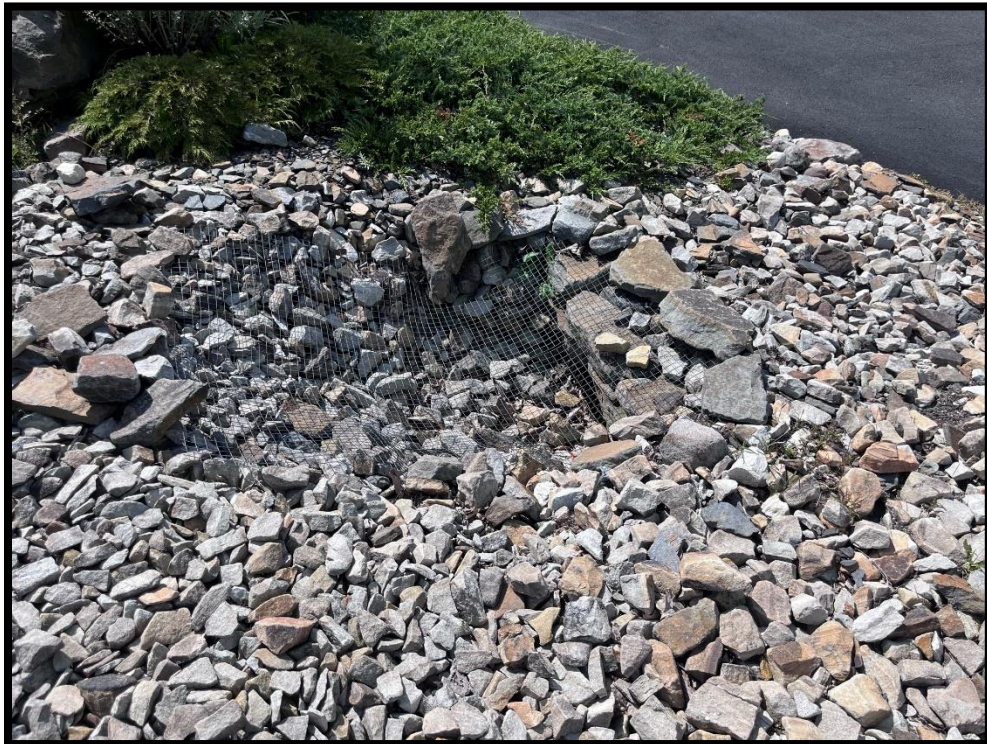
**Photo 3.2.10** Each inlet should be opened up and existing debris and silt should be removed.

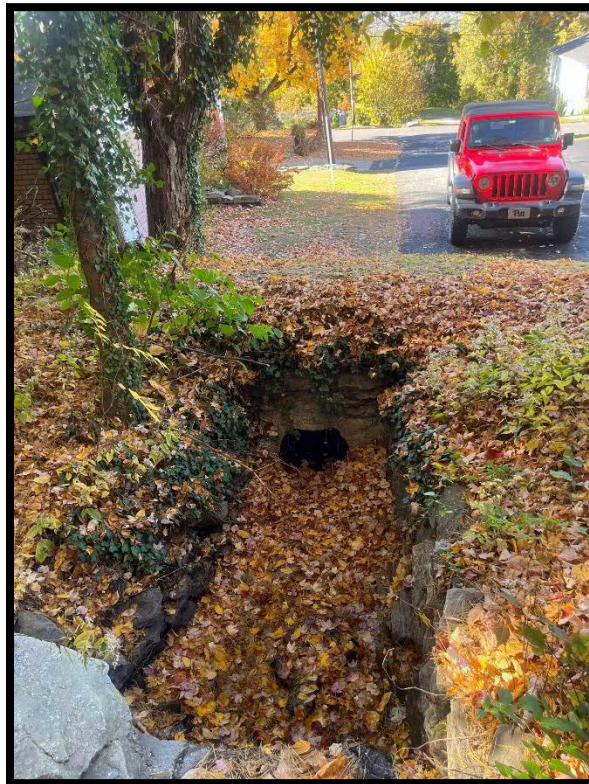
**Photo 3.3.6** This stone inlet at the top of the lower section of East Elm Street requires a track rack for safety and protection from debris.

The existing stone inlet at the top of lower East Elm Street should be retrofitted with a trash rack for both safety and debris protection. Below Moltke Avenue, the East Elm Street drainage swale should be cleared and stabilized all the way down to the proposed culvert under the abandoned railroad grade. The existing storm drain on the northern side of East Elm Street should also be replaced since the current corrugated metal pipe has failed.

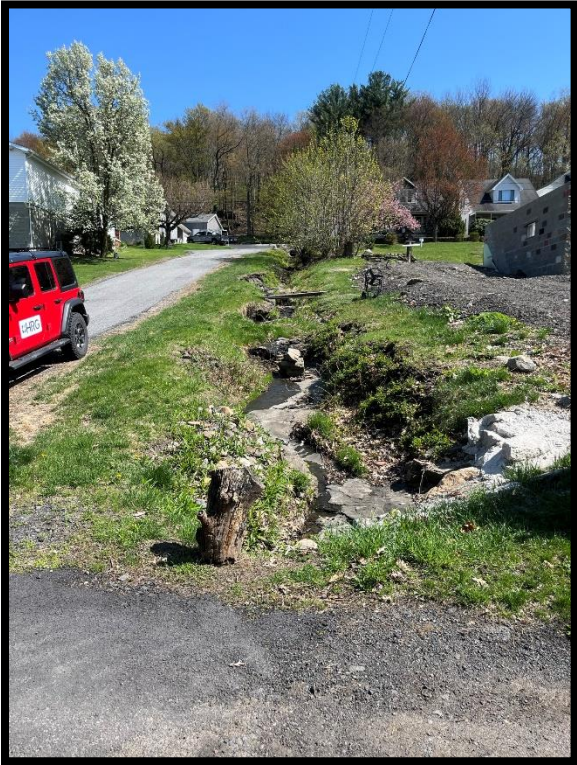
**Photo 3.3.7** The drainage swale along East Elm Street, below Moltke Avenue is overgrown and clogged with debris.

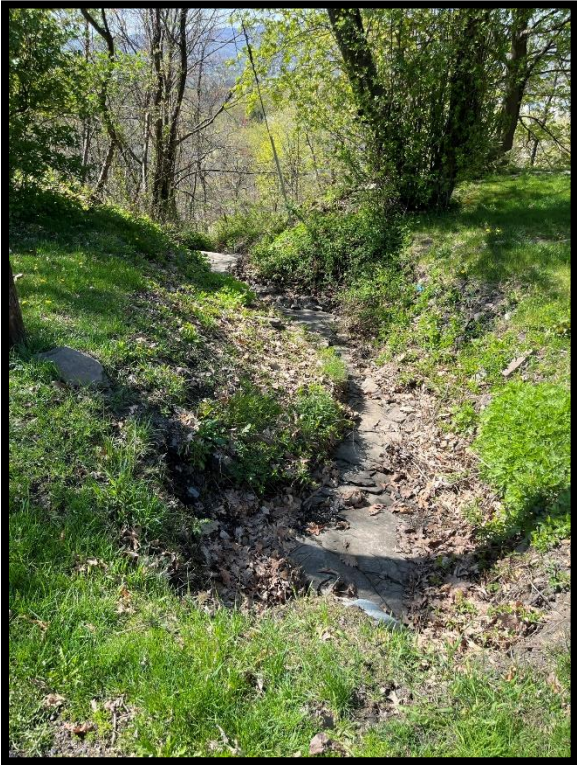
**Photo 3.3.8** Stabilization is also needed in the channel flowing downhill from the end of East Elm Street.

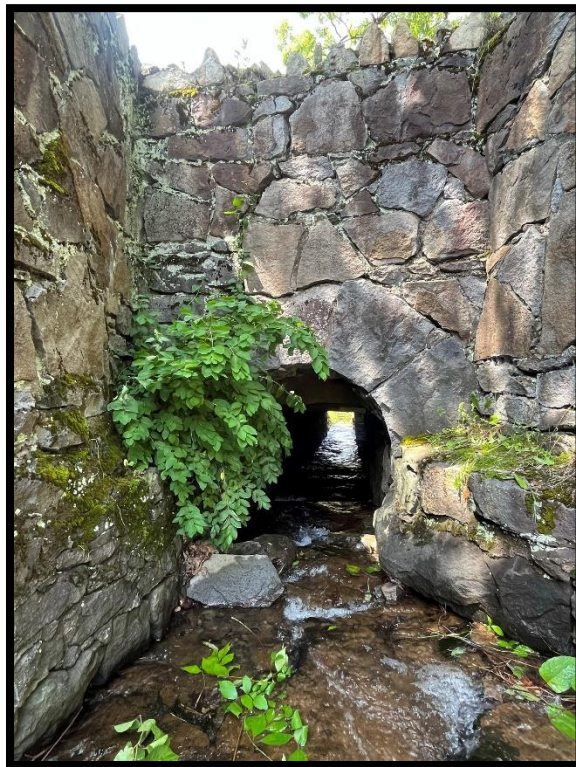
**Photo 3.4.2** Stone culvert at the Marine Corps League Museum which was built in 1936 by the Works Progress Administration.

Due to the historical significance of the stonework at the Marine Corps League Museum, HRG recommends working to limit the maximum flow rates entering the culverts, rather than removing or replacing them with larger culvert pipes. This could be accomplished by creating a stormwater detention basin where excess stormwater flow could be stored and released at a controlled rate. It is believed that there may be sufficient room along the edge of the existing gravel parking lot to build a basin, but final drainage calculations will be required to determine the size and discharge rates of this basin. Maintenance and clearing of the existing culverts are also recommended to increase their capacity.

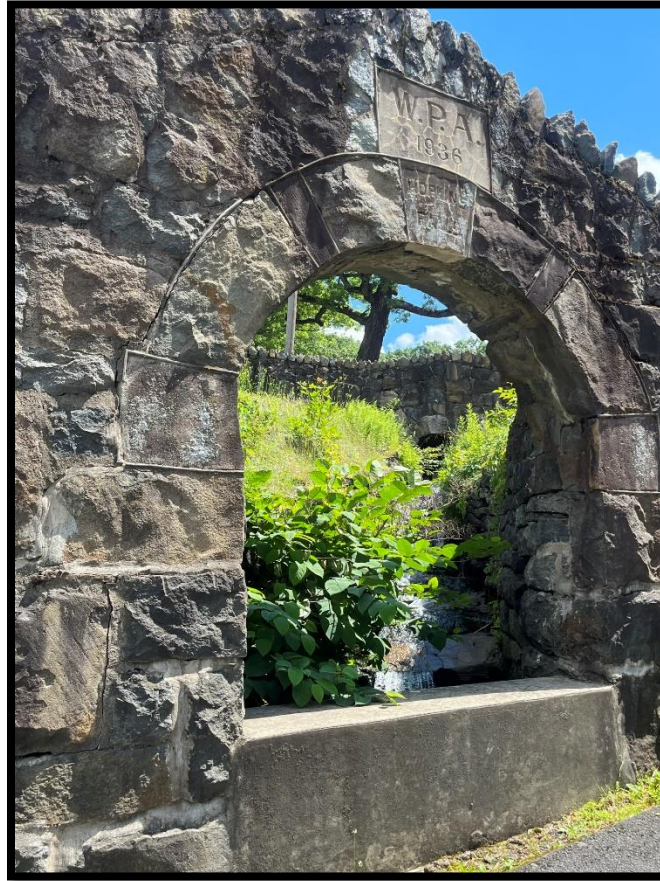
**Photo 3.4.3** Stonework at the Marine Corps League Museum which was built in 1936 by the Works Progress Administration.

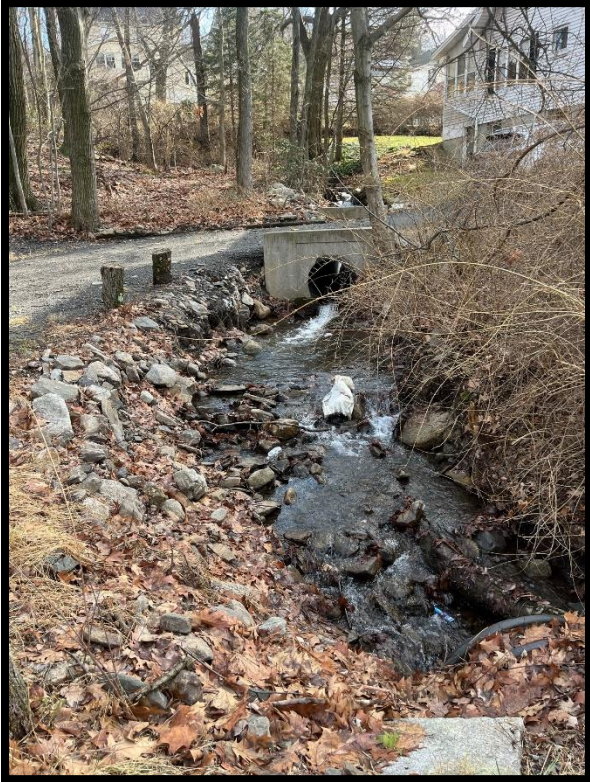
**Photo 3.4.6** Further downstream, Mountain Lake Creek passes through this driveway culvert.

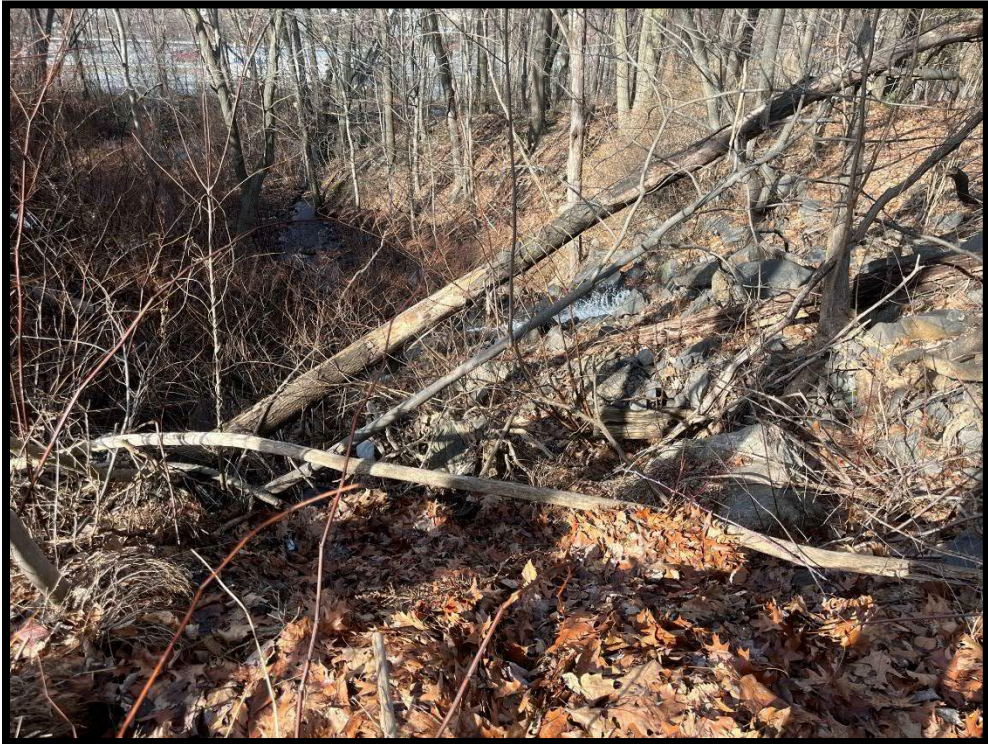
**Photo 3.4.7** The channel below Moltke Avenue should be cleared of debris to improve flow.

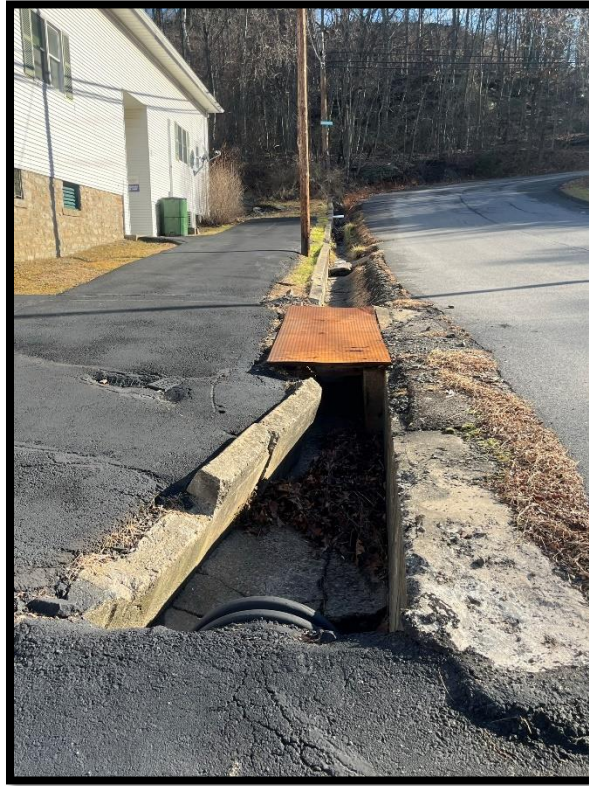
**Photo 3.5.1** View looking up Beech Street from Wintermantle Avenue at the existing drainage ditch adjacent to the Discovery Montessori School.

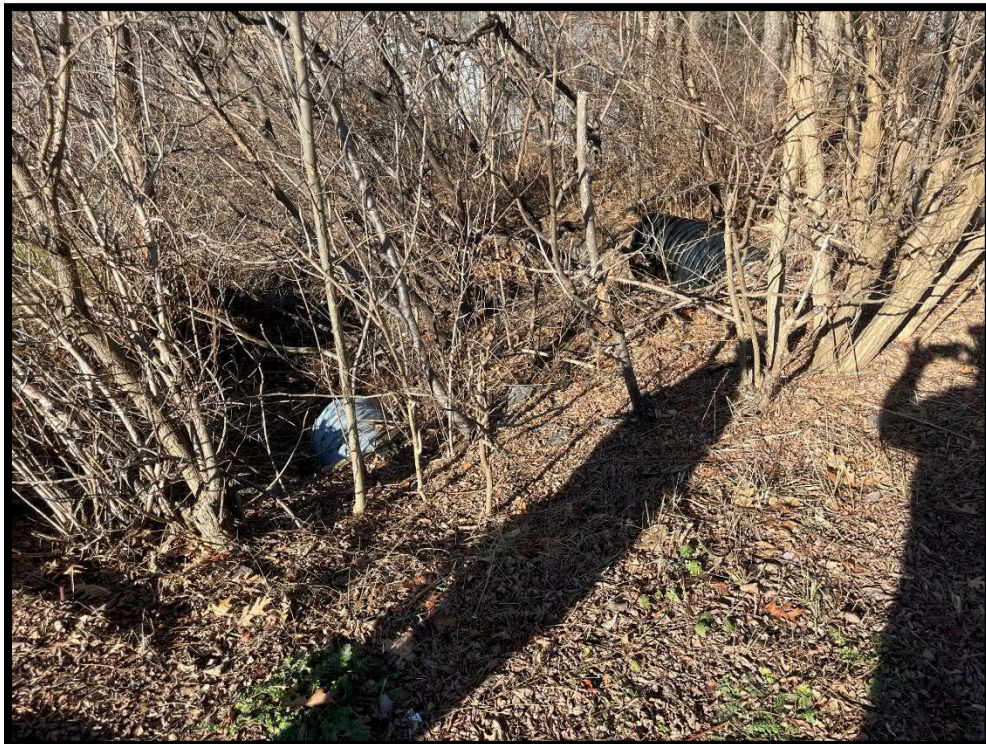
**Photo 3.5.4** The existing discharge below Wintermantle Avenue should also be stabilized.

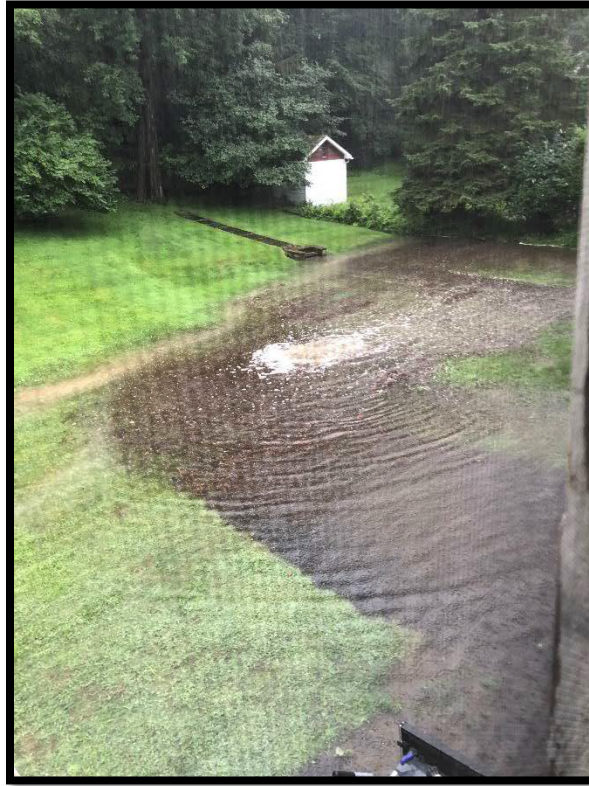
**Photo 3.6.1** Homeowner's photo shows water discharging from a lawn grade during a flooding event. This indicates that the pipes in the lower portion of the drainage system must be blocked or collapsed.

Based upon our evaluation of this drainage problem, HRG feels that the entire drainage system should be replaced behind these homes. Since a majority of the water flowing onto these properties is from a City-owned property, it is appropriate for the City to replace the storm sewer. A new 24" HDPE pipe with lawn grate inlets has been proposed along the same general route that the current system follows. A new headwall will be built to assure that upstream water flows into the system, and the discharge into the East Mountain Road system will be rebuilt. (See Figure 3.6.2).

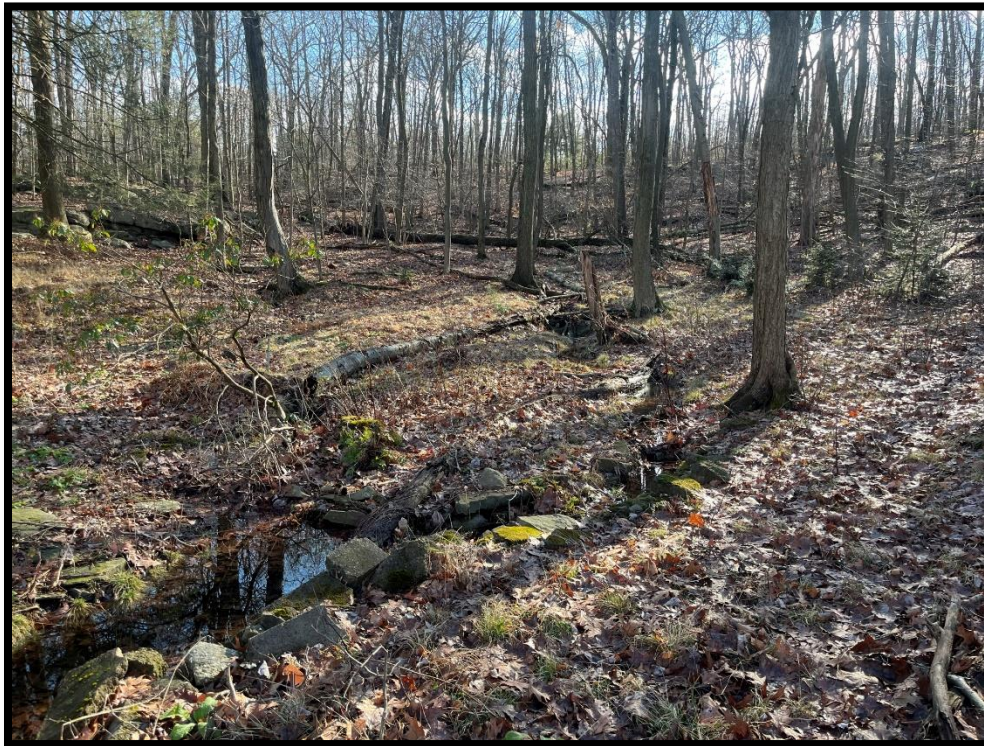
**Photo 3.6.2** View looking east towards the City-owned property which drains onto these properties.

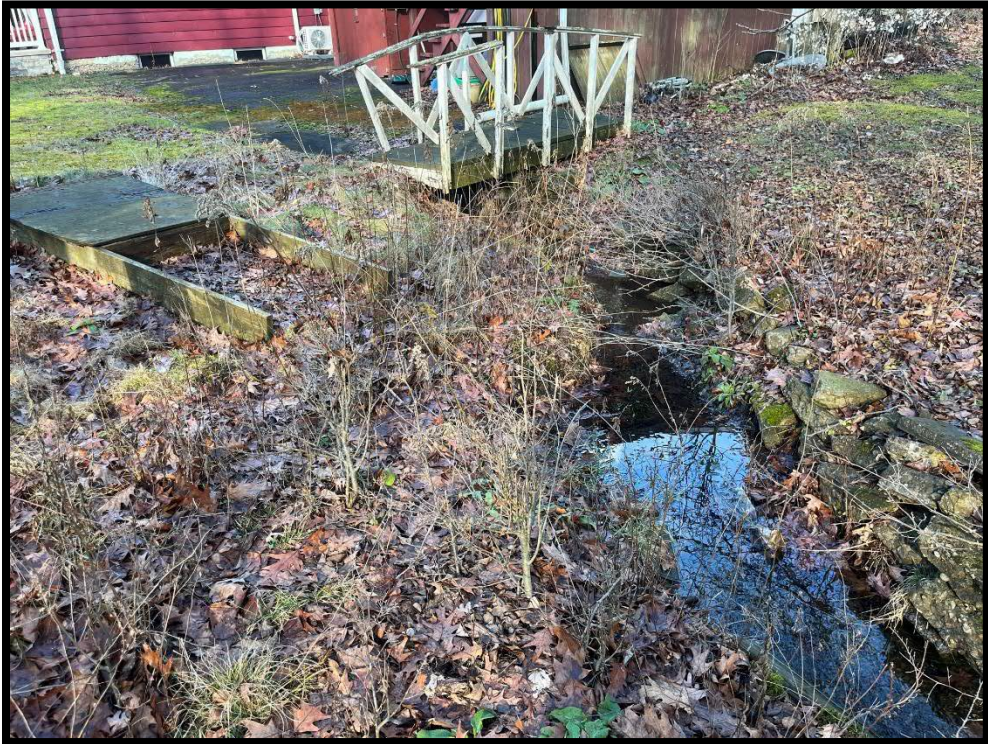
**Photo 3.6.3** The existing stormwater inlet for this drainage system is located under this small bridge.

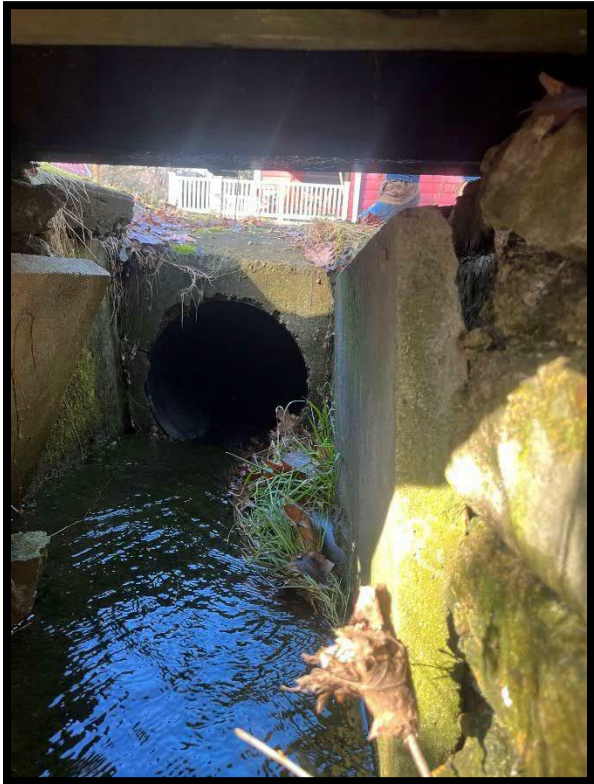
**Photo 3.6.4** Existing headwall draining stormwater runoff into the drainage system behind the homes on East Mountain Road.

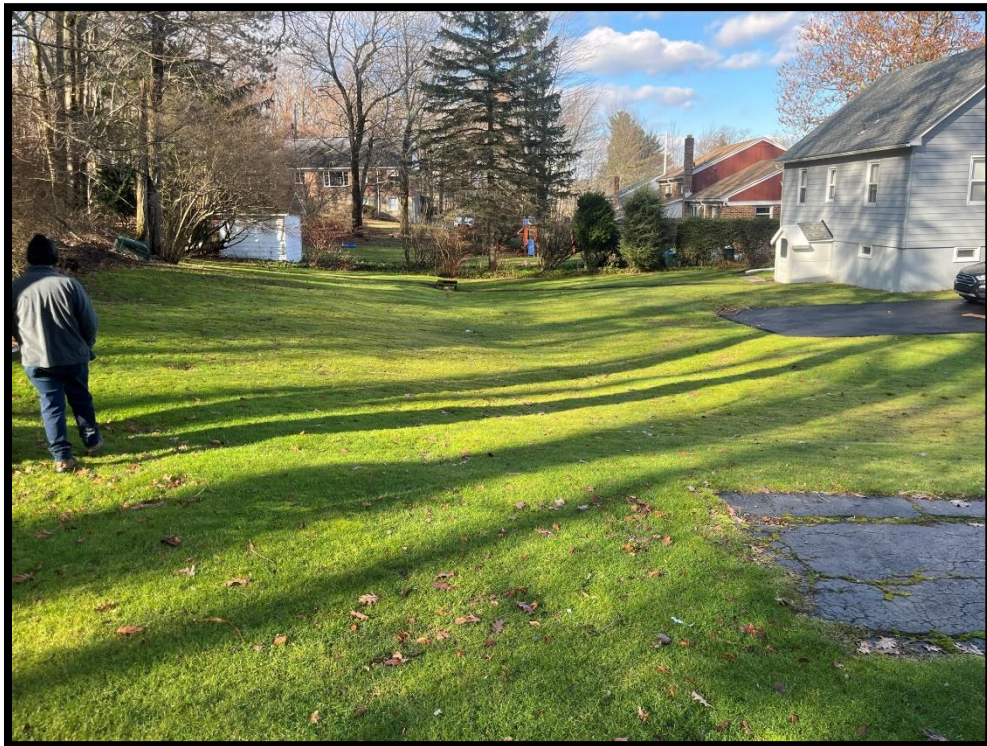
**Photo 3.6.6** Low spot which runs through the backyards where the new drainage system is proposed.

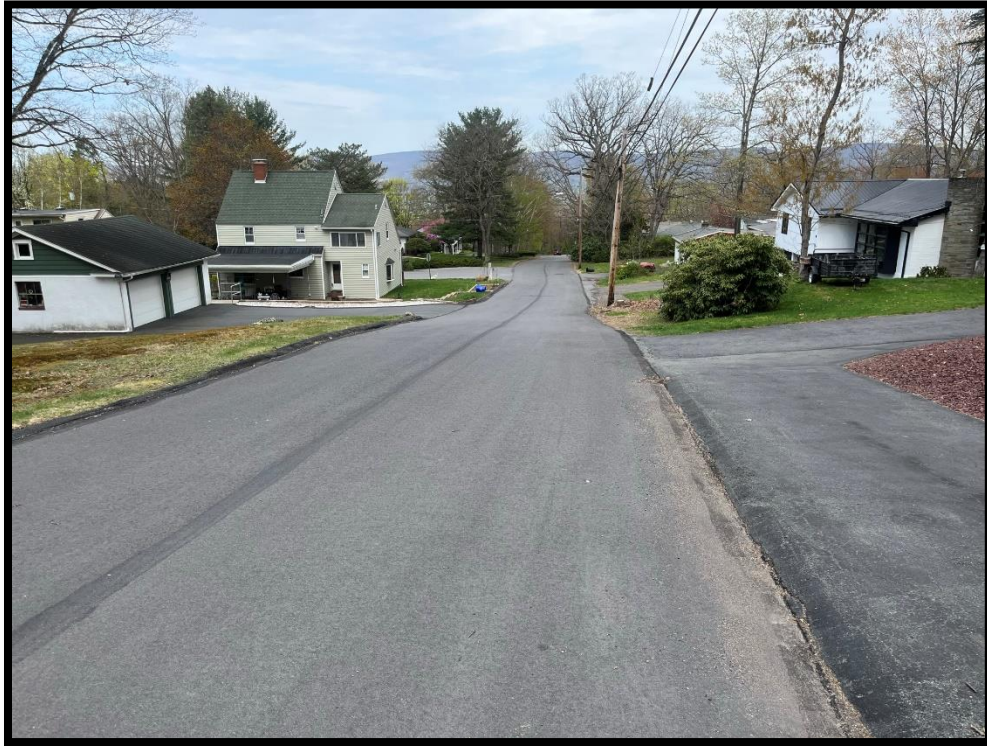
**Photo 3.7.1** View looking down Ariel Street towards the dead end where the stormwater drainage system discharges.

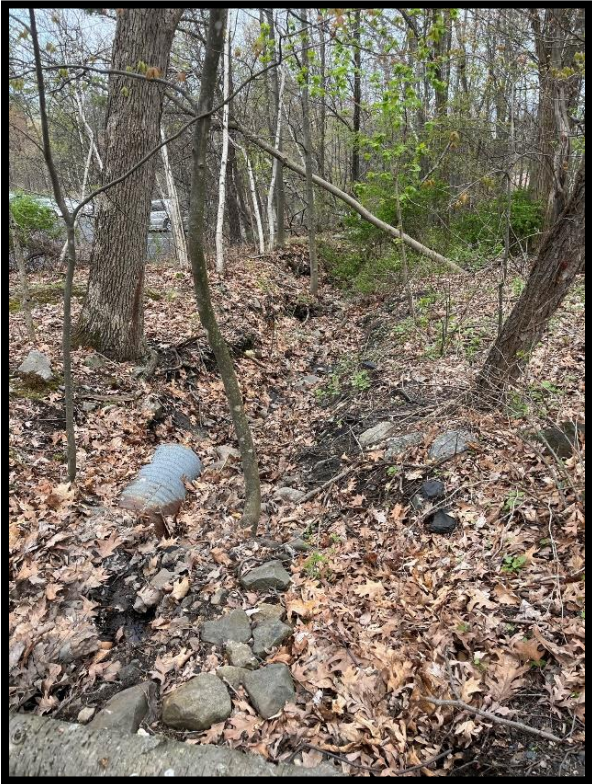
**Photo 3.7.3** One of two stormwater discharges at the end of Ariel Street

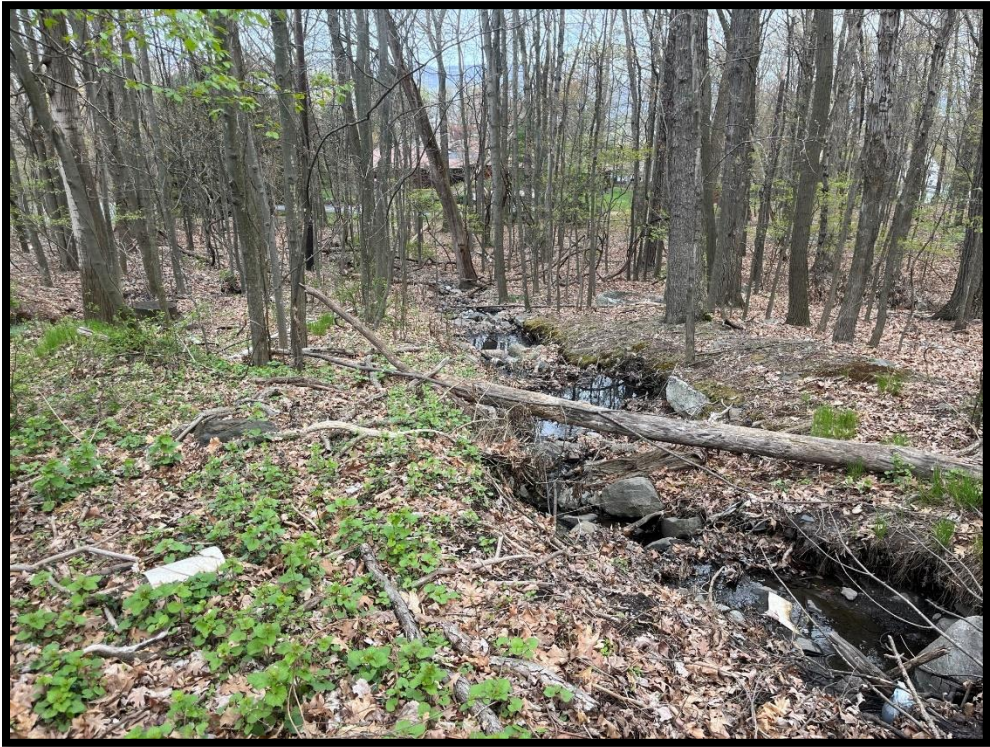
**Photo 3.7.4** Stormwater discharges into this unmaintained drainage swale which had eroded and is filled with debris.

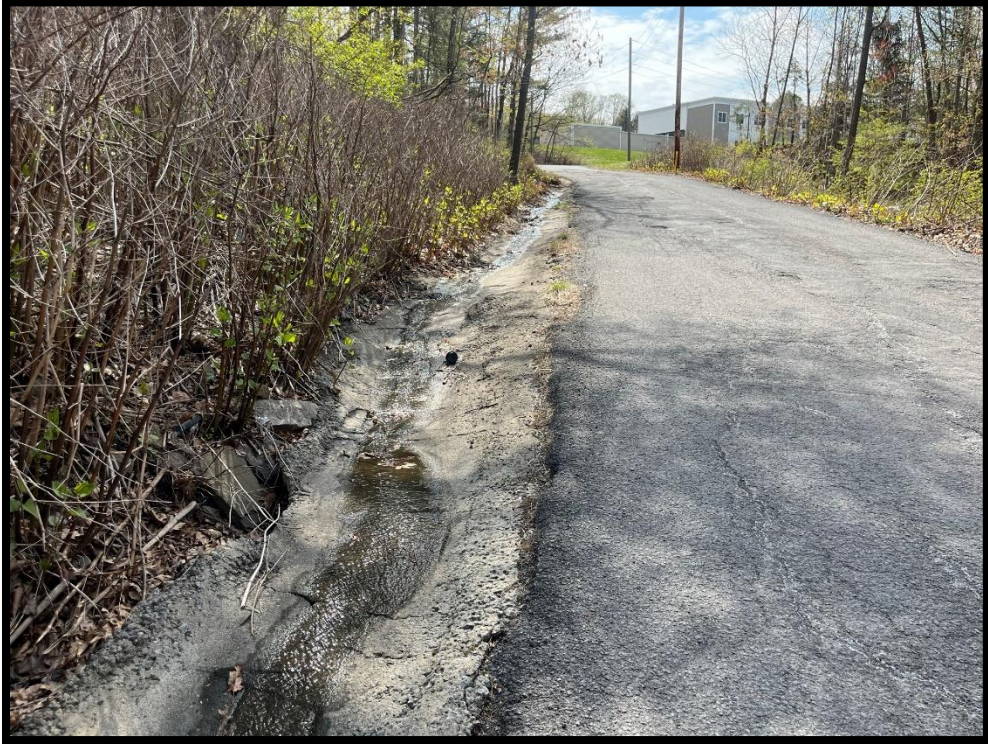
**Photo 3.7.7** The concrete gutter along the Nursing Home driveway is insufficient to convey flow from larger storm which results in flooding of the cartway.

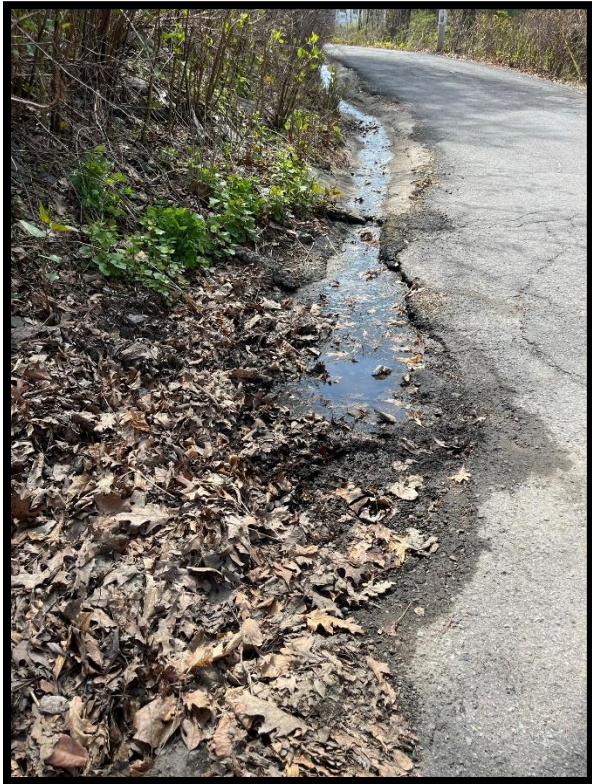
**Photo 3.7.8** Inlet for the cross drain under Linwood Avenue is filled with silt and debris, and not functioning.

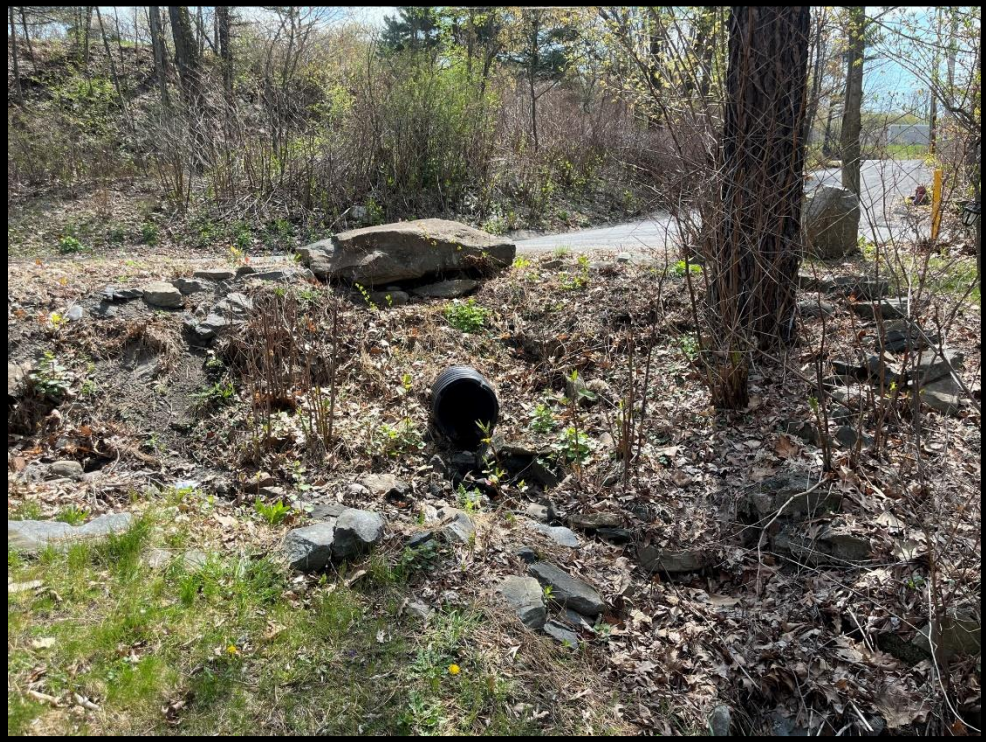
**Photo 3.7.9** Discharge from the Linwood Avenue culvert has no outlet protection or downstream drainage swale .

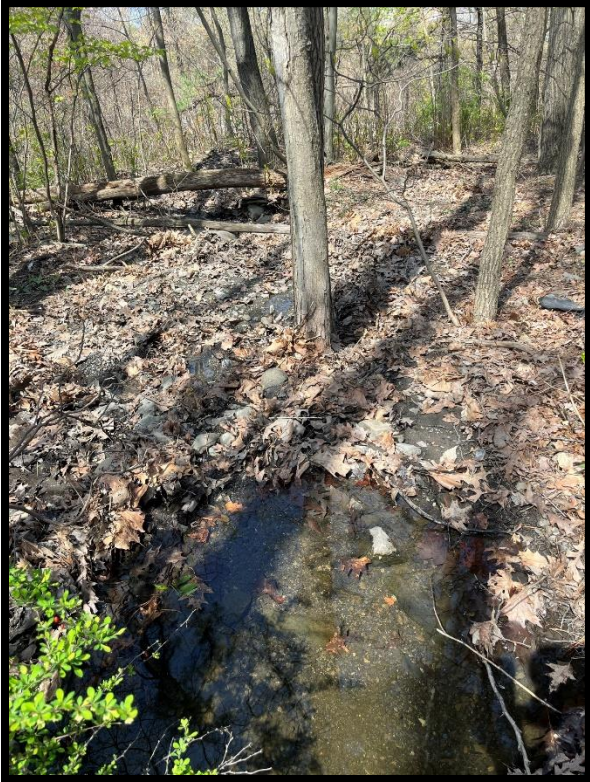
**Photo 3.7.10** Drainage from the Linwood Avenue culvert is allowed to free-flow downhill towards the Route 307 culvert.

Based upon our evaluation of this drainage problem, HRG has concluded that the entire drainage system from the end of Ariel Street to the culvert under State Route 307 should be rebuilt (See Figure 3.7.2). Beginning at the discharge of the two stormwater pipes at the end of Aerial Street, a stable swale should be constructed to convey the runoff downhill. The existing driveway culvert should be replaced by a new collection system along the Nursing Home driveway down to Linwood Avenue. At the discharge from Linwood Avenue, another drainage swale is needed to direct the runoff to the Route 307 culvert.

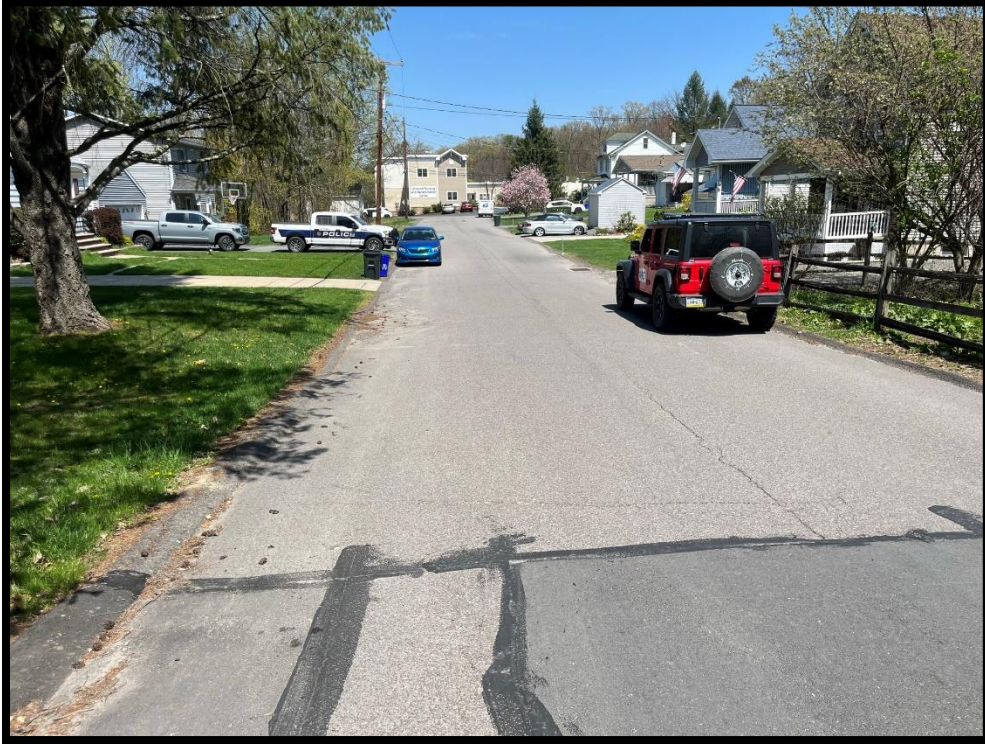
**Photo 3.8.1** View looking north on Florida Avenue towards the Linwood Nursing and Rehabilitation Center.

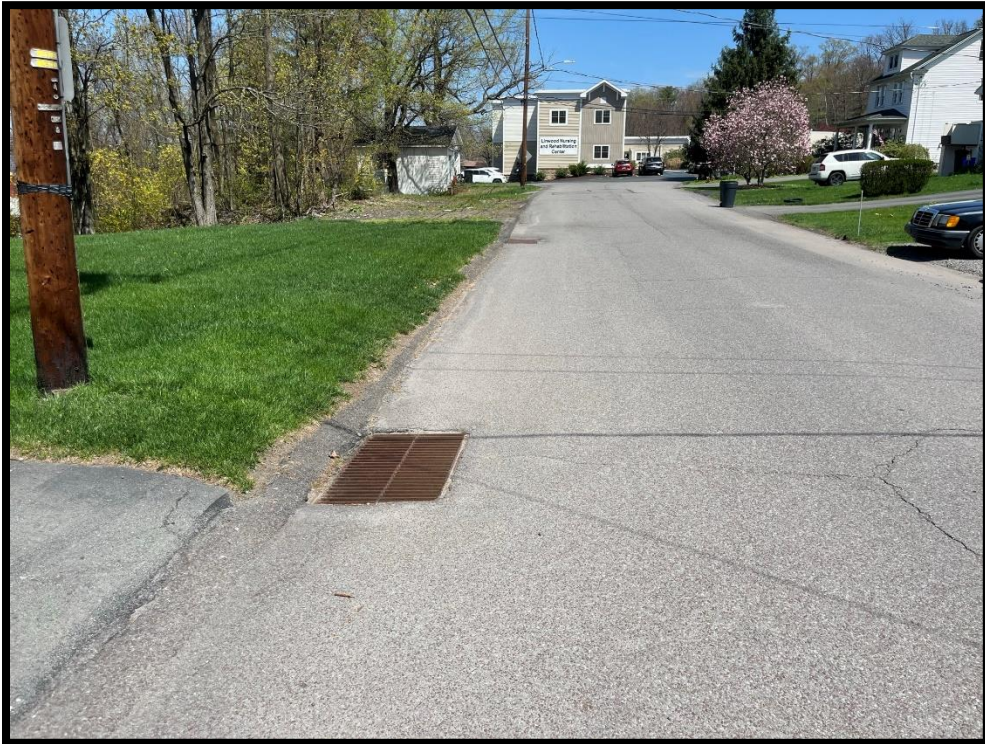
Ponded water has been a longtime problem along a low-lying section of Florida Avenue. Although three roadway drainage inlets were observed during a field evaluation, it was noted that the southern catch basin, adjacent to 125 Florida Avenue, is not connected to the drainage system (See Figure 3.8.1). Roadside discharge from several small lawn drains was also observed (See Photos in Section 3.8.5).

**Photo 3.8.2** These two stormwater inlets have been insufficient to eliminate the ponding of stormwater in a low-lying section of Florida Avenue.

To prevent ponding on Florida Avenue, HRG recommends the installation of two new stormwater catch basins on the eastern side of Florida Avenue (See Figure 3.8.2). These new inlets are to be tied into the existing drainage system which discharges into the woodland behind 120 Florida Avenue. New curbing along the western shoulder of Oswald Avenue is recommended to keep runoff from bypassing the existing inlet.
