# FINAL REPORT

## EAST MOUNTAIN STORMWATER AND DRAINAGE STUDY

Submitted to: City of Scranton  
Lackawanna Co., PA

January 9, 2024

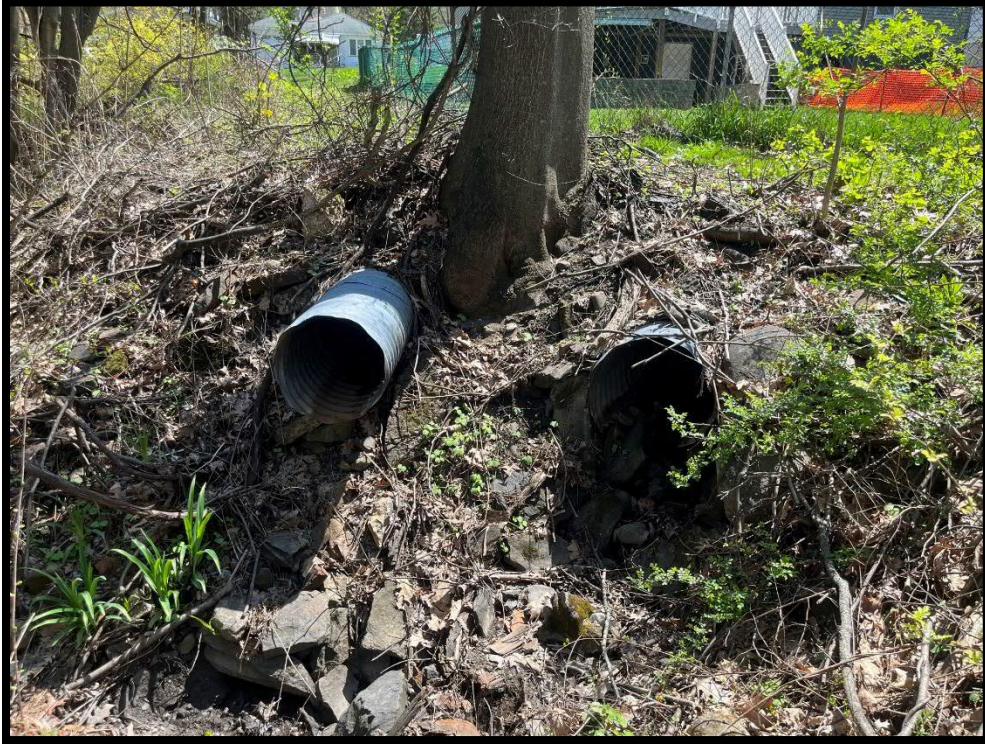
**Photo 3.8.3** The existing Florida Avenue drainage system discharges into the woodland behind 120 Florida Avenue.

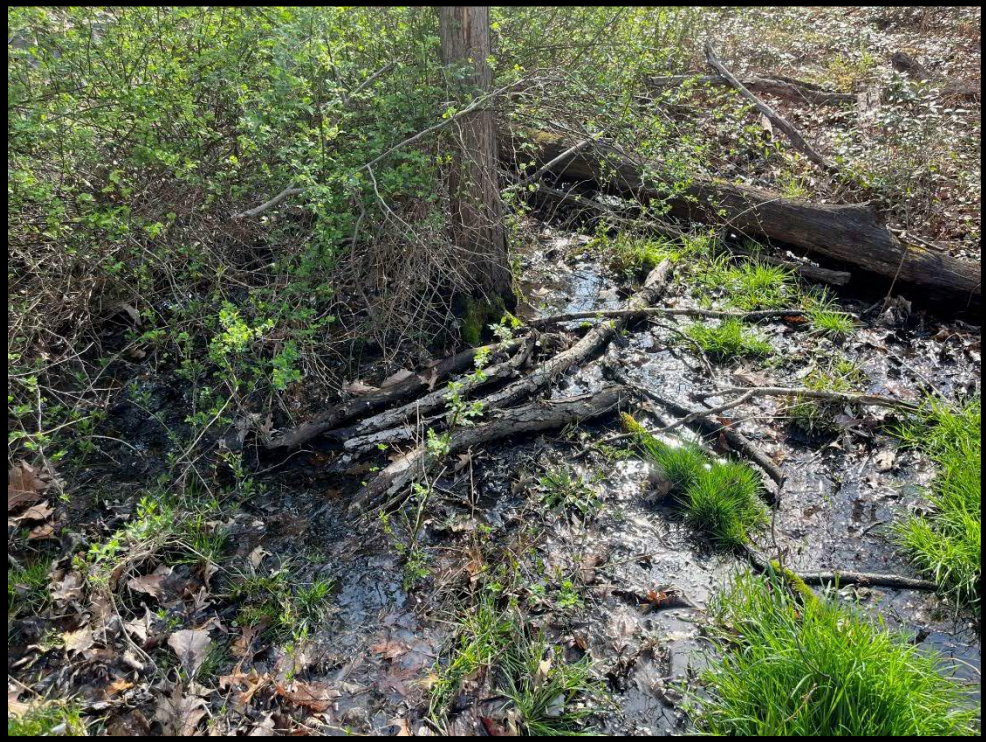
Recent development on Grande Circle has made the situation worst. It appears that grading for the new homes increased groundwater seepage, which flows behind the homes on Snook Street. The water ponds in a low-lying area but is not able to infiltrate into the ground due to shallow bedrock (See Photos in Section 3.9.5).

**Photo 3.9.1** Groundwater seepage near the new development on Grande Circle has led to increased residential flooding on Snook Street.

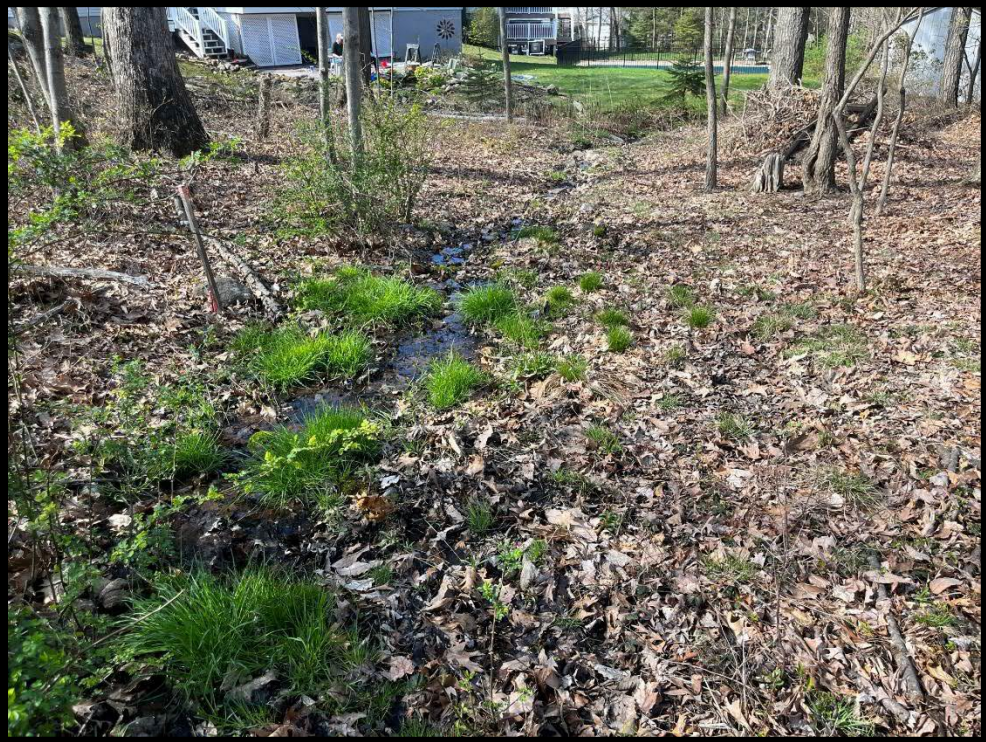
**Photo 3.9.2** Groundwater seepage flows around areas filled for construction of the new homes on Grande Circle.

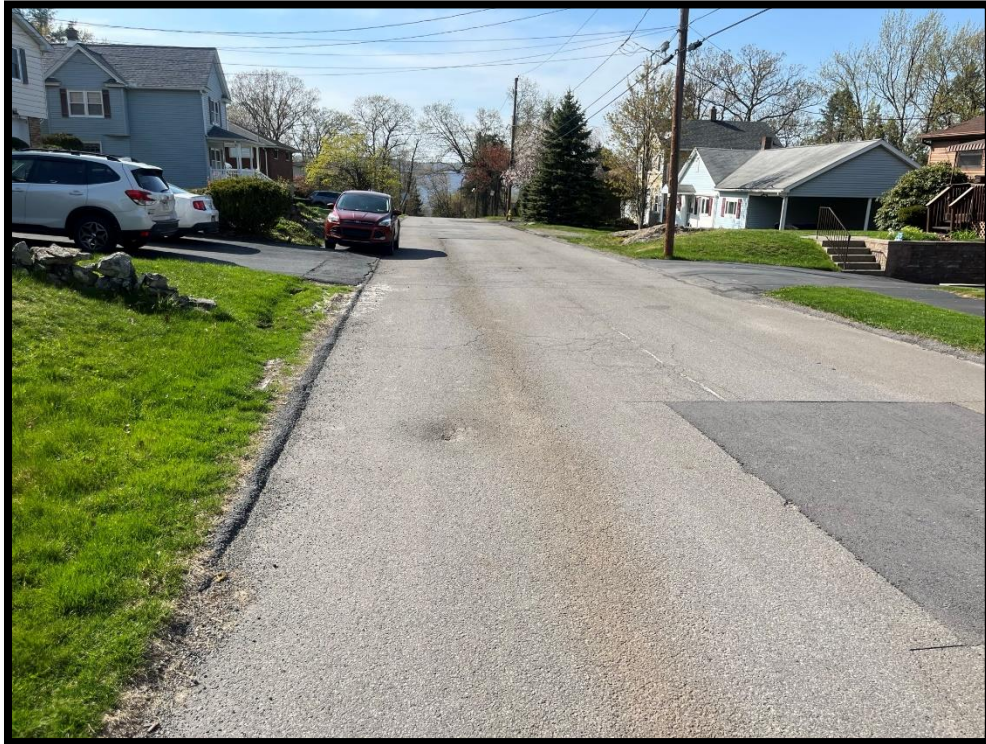
**Photo 3.9.5** The proposed stormwater drainage system will drain water off of Snook Street and discharge the runoff into the existing Route 307 drainage system.

Based upon our evaluation of this drainage problem, HRG has concluded that a new roadway drainage system is needed for the area from Batluck Street down to Snook Street (See Figure 3.9.2). Undulating topography makes it impossible to drain water away from this area without a storm sewer system. Therefore, a series of catch basins and drainpipes are proposed within the public right of way. Roadway paving and curbing is also recommended to convey the runoff into the inlets and away from private property. The new drainage system will discharge into the existing Route 307 stormwater management system. The proposed system will not change the current drainage area which feeds into the Route 307 storm sewer. Rather than overland flow, the water will be conveyed via the proposed pipe system. Although this may result in a minor change in the time of concentration, no significant impact is expected in the volume of runoff conveyed by the Route 307 storm sewer.

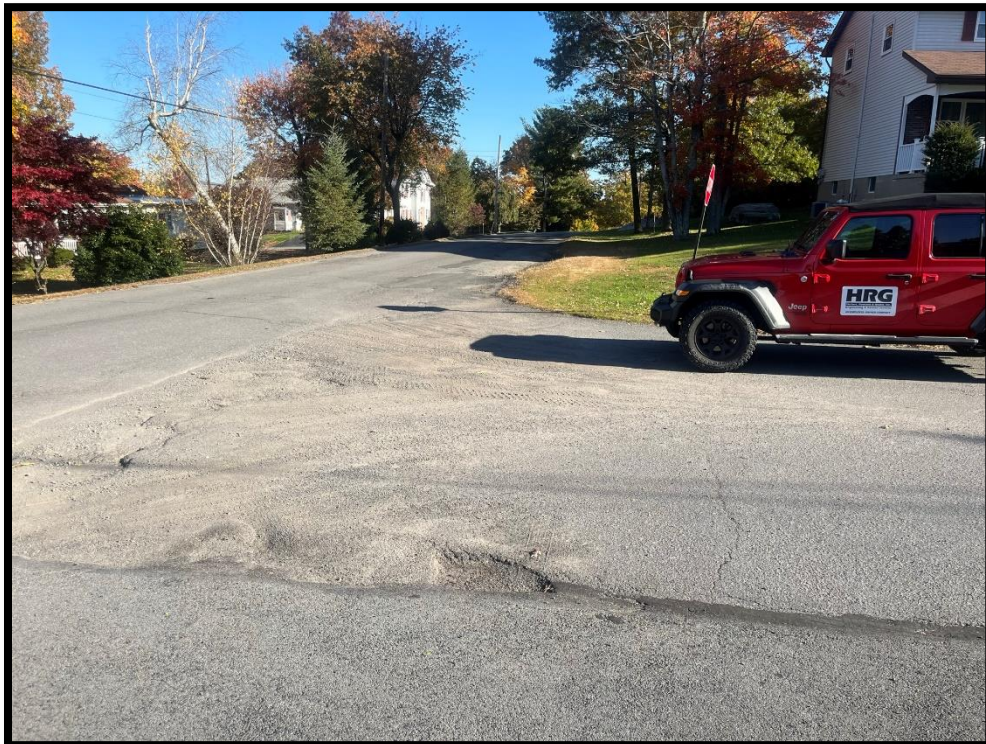
**Photo 3.9.6** The new drainage system will also alleviate flooding at the intersection of Batluck Street and Seymour Avenue.

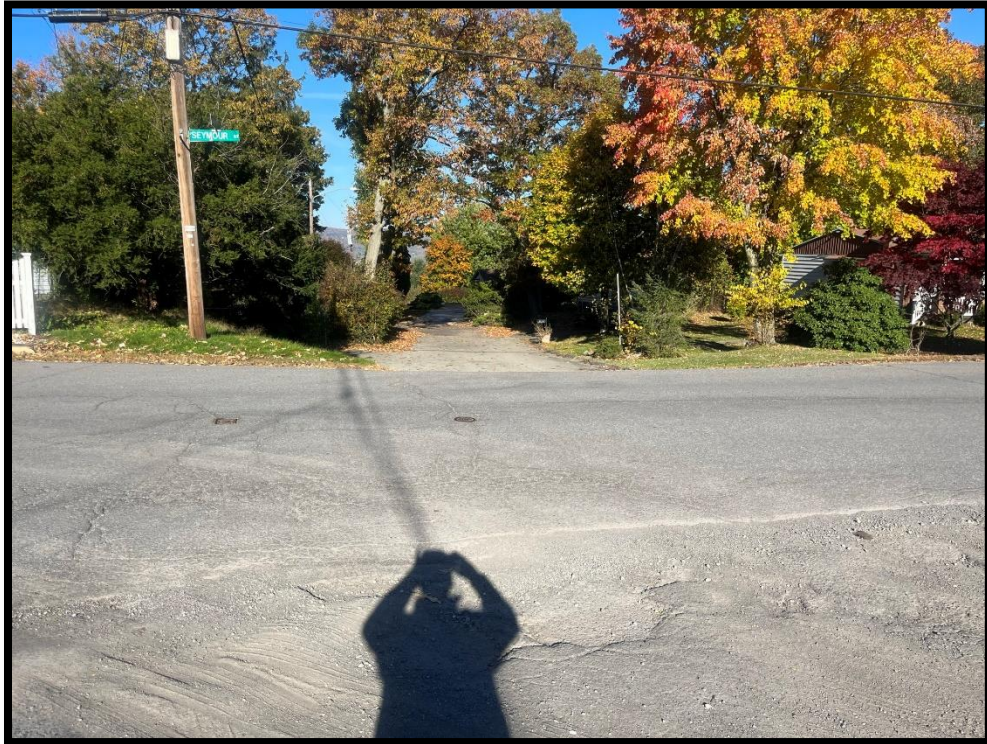
**Photo 3.9.5** New roadway curbing will convey the runoff into the inlets and away from private property.

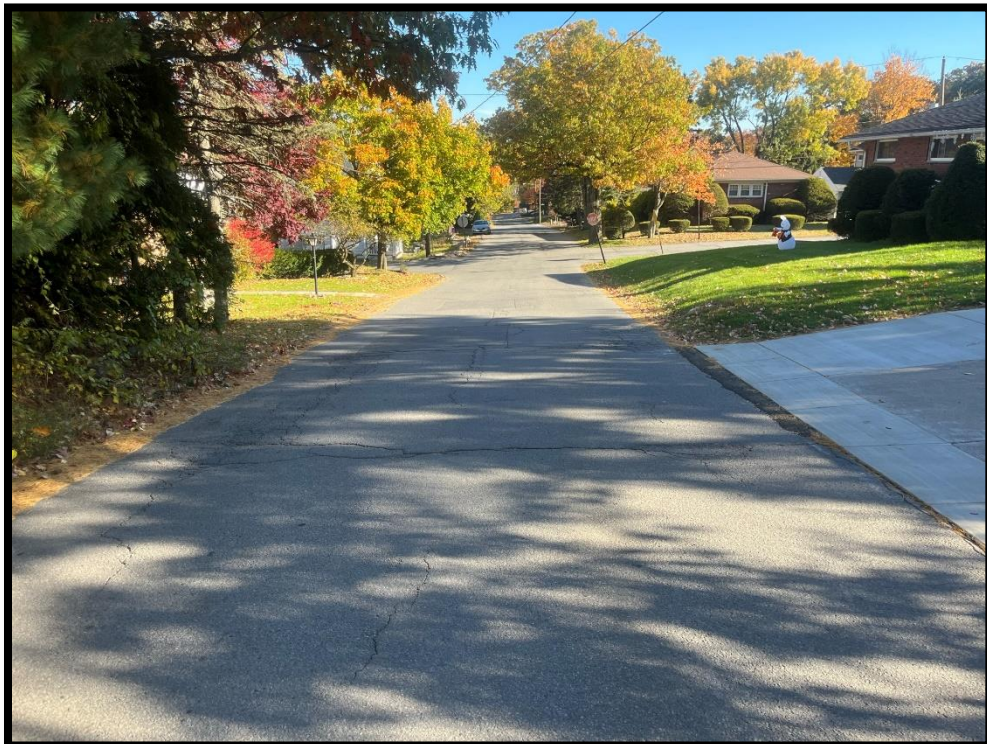
**Photo 3.9.6** View looking down Seymour Avenue towards the intersection with Snook Street.

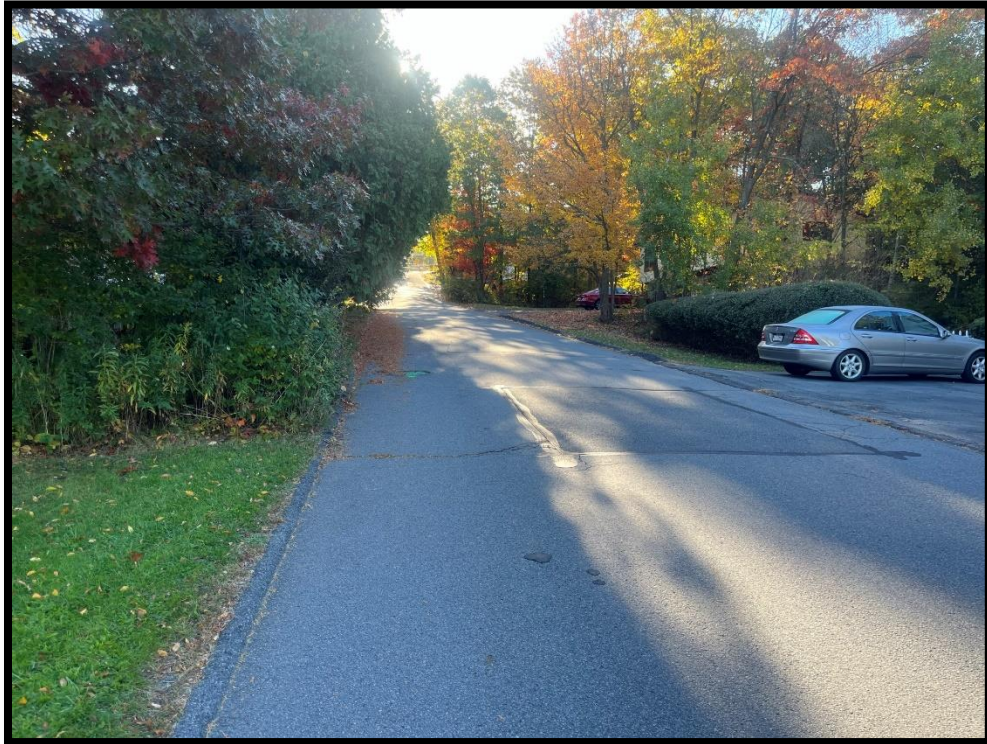
**Photo 3.9.7** View looking northwest on Snook Street towards Route 307. In the past, stormwater runoff has flooded this area.

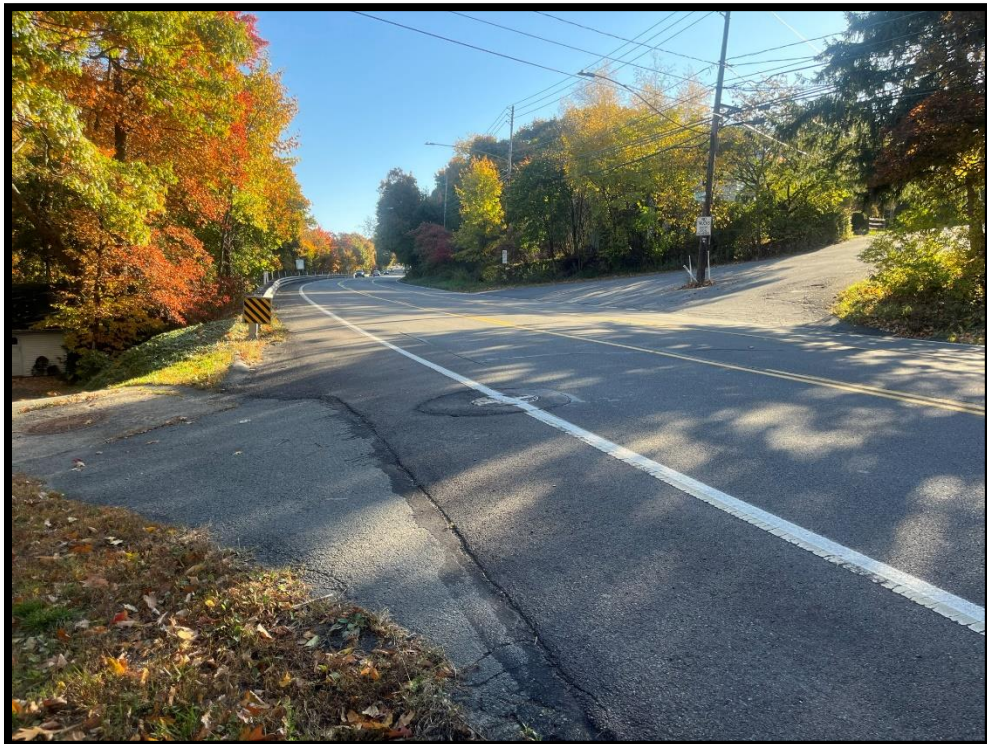
**Photo 3.9.8** View of the intersection of Snook Street and Route 307. Better management of stormwater runoff on Snook Street will reduce the amount of water which runs onto the highway.

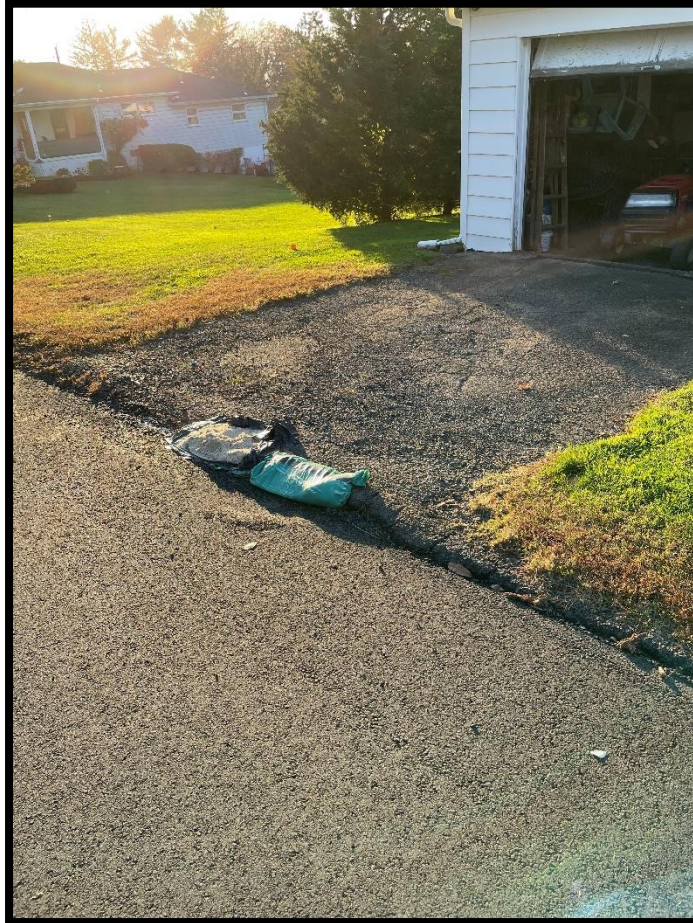
**Describe flooding issue in detail:** After paving project this past summer water from the street runs into my driveway and garage because the curb was damaged and never replaced.

**IS THIS ISSUE ADDRESSED BY THE DRAINAGE STUDY?**  
PARTIALLY – New culverts at Derby Ave will help, repair of curb required

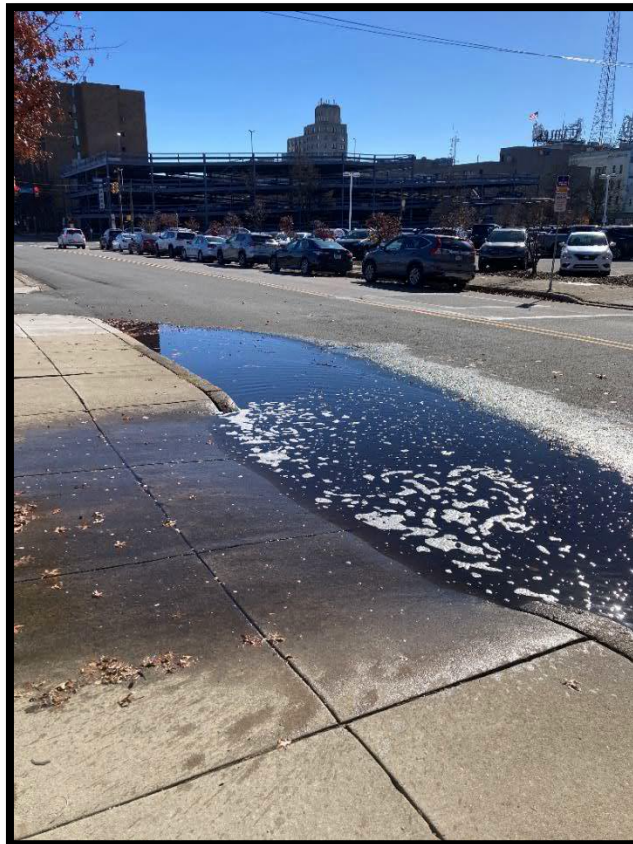
## **PUBLIC COMMENT: FLD-02**

**Describe flooding issue in detail:** There is large ponding at Hallstead and Linden, near St. Mary's. There is no storm drain or catch basin nearby, and water pools into the road.

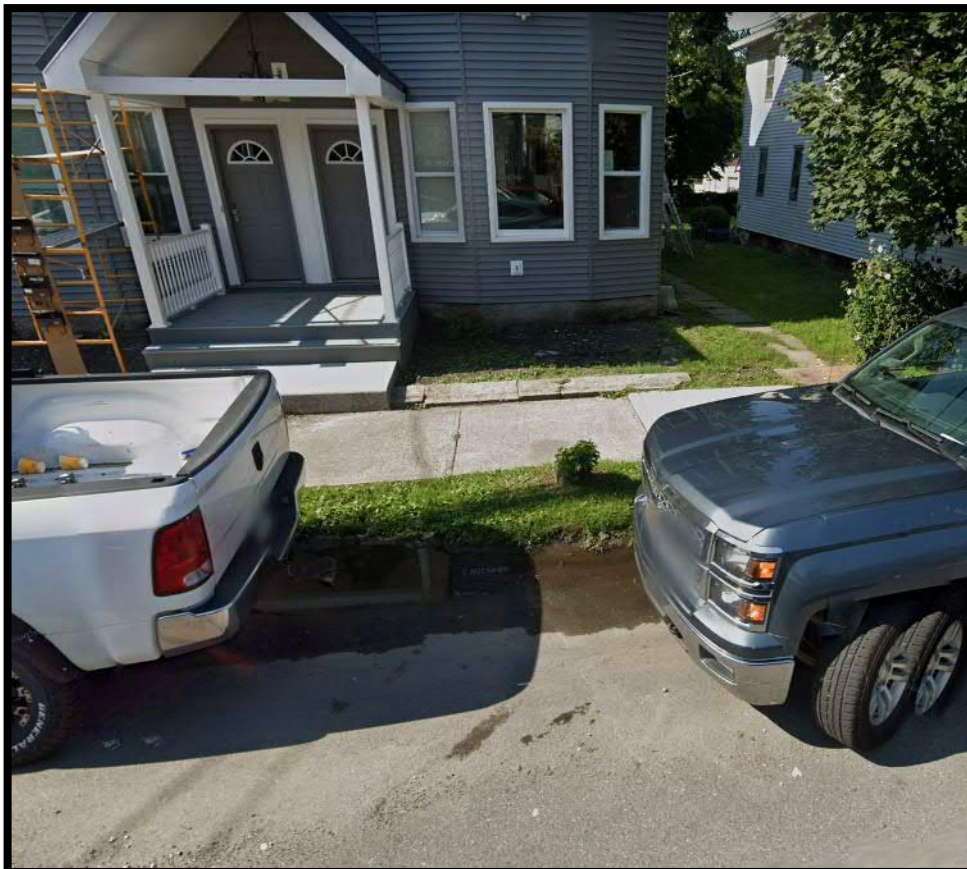
**Describe flooding issue in detail:** no curb, street floods property. Concerned about upcoming storms!

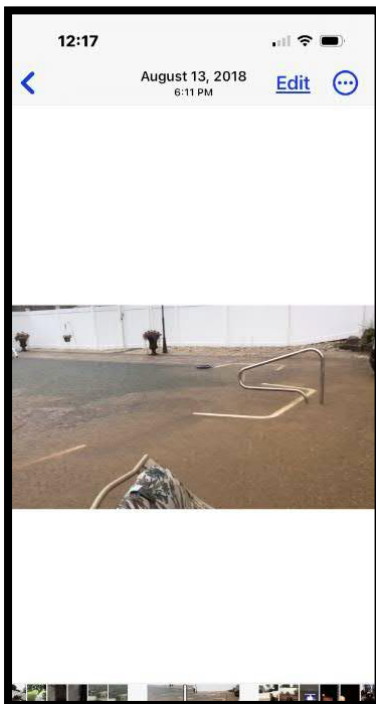
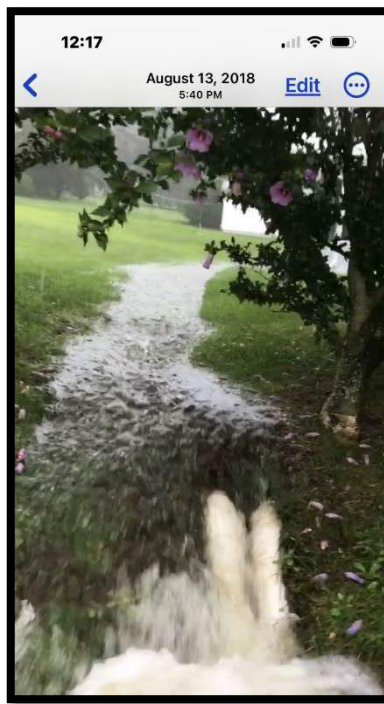
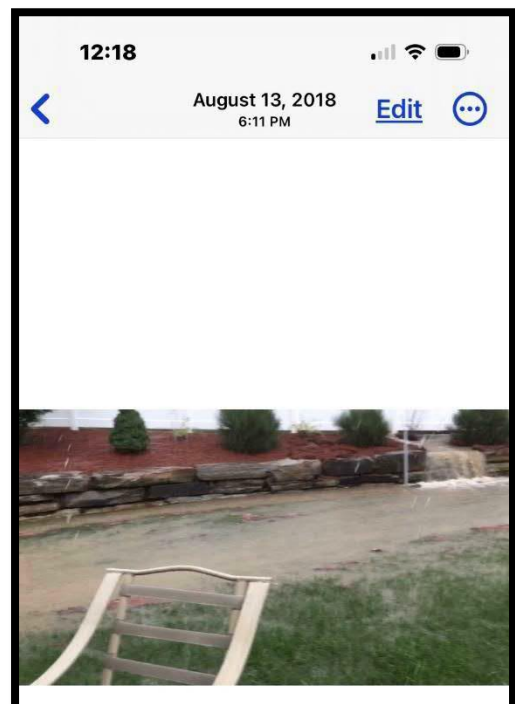
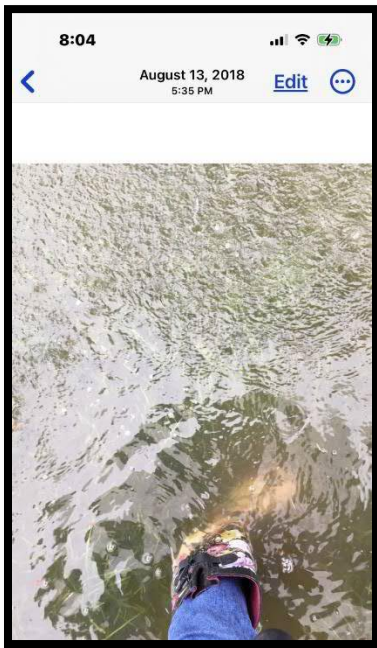
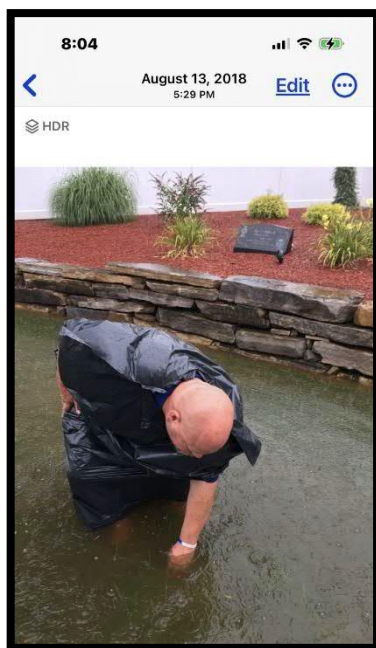
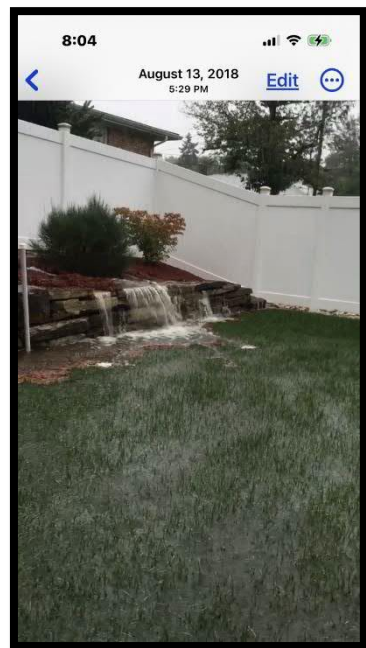
## PUBLIC COMMENT: FLD-05

**Describe flooding issue in detail:** When the ground water table is saturated, and we get downpours. The water runoff from the neighbors above us, and the neighbors on East Elm Street come into our yard like a running creek. Including the runoff from Howard Gardner School, and above. Make its way to our side and back yard. Which has flooded our basement, inground pool, and sunk some of our pool side pavers. The city has a 15 foot right of way on both sides of our property, and behind our property.

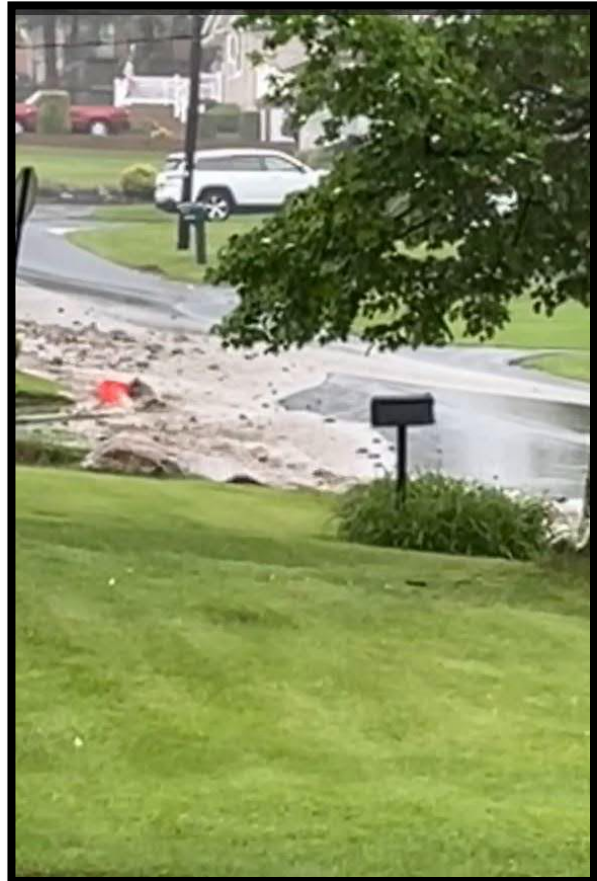
## **PUBLIC COMMENT: FLD-06**

**Describe flooding issue in detail:** The storm drains clog/covered as soon as the rain becomes strong and is unable to flow down into the drains. My neighbors and I have needed to go and shovel out the drains to allow the water to flow down.

**IS THIS ISSUE ADDRESSED BY THE DRAINAGE STUDY?**  
PARTIALLY – New culverts at Derby Ave will help, clean-out of existing sewer may be required

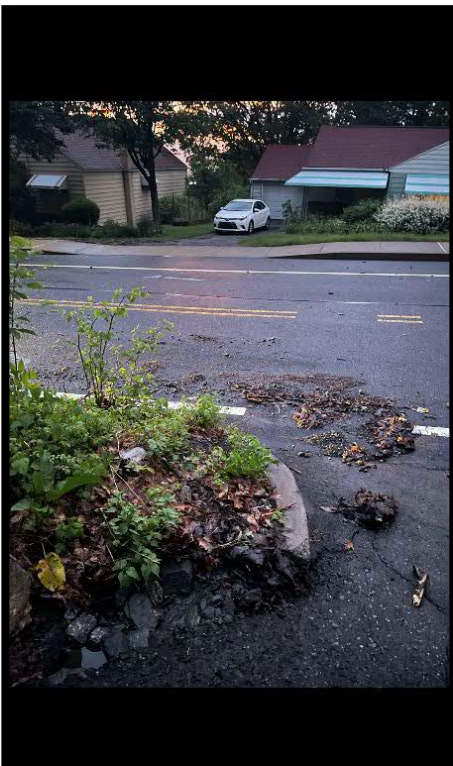
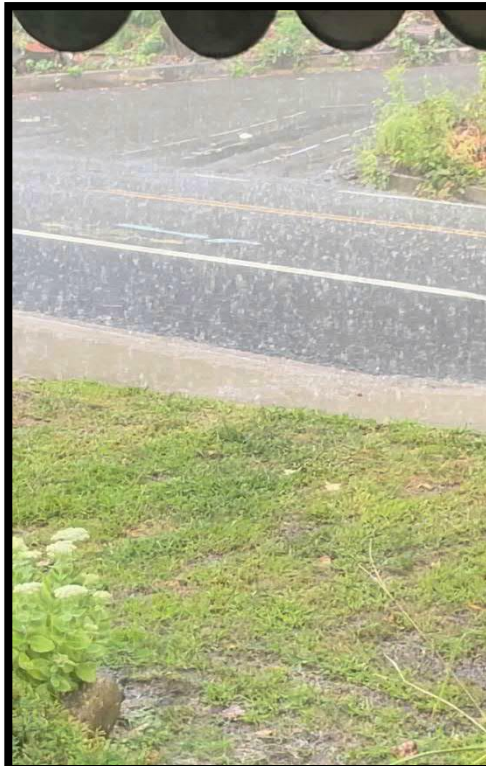
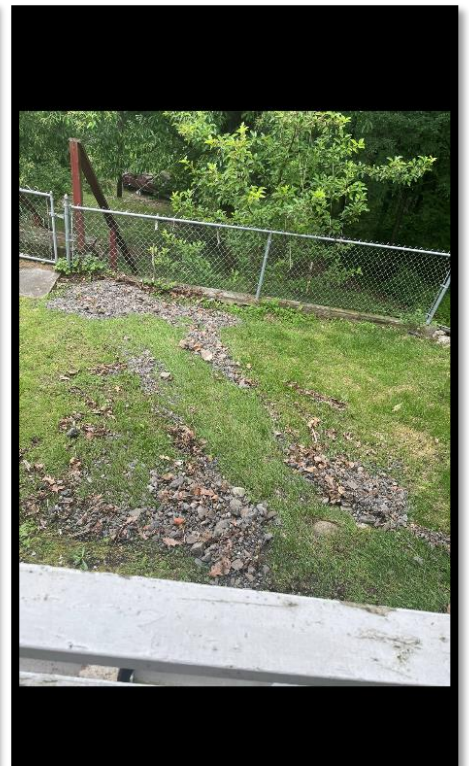
## PUBLIC COMMENT: FLD-07

**Describe flooding issue in detail:** Storm drain needed at my house do to run off of Waldorf lane . When it storms the Woldorf Ln Å turns into a water shoot . There are no drain at bottom of road . Water shoots across East Mountain Rd & into my yard , carrying dibree & staring to wash away my foundation.

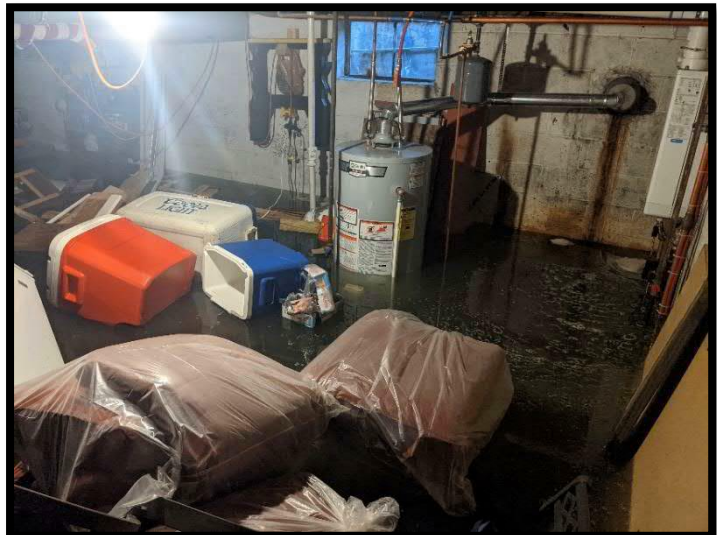
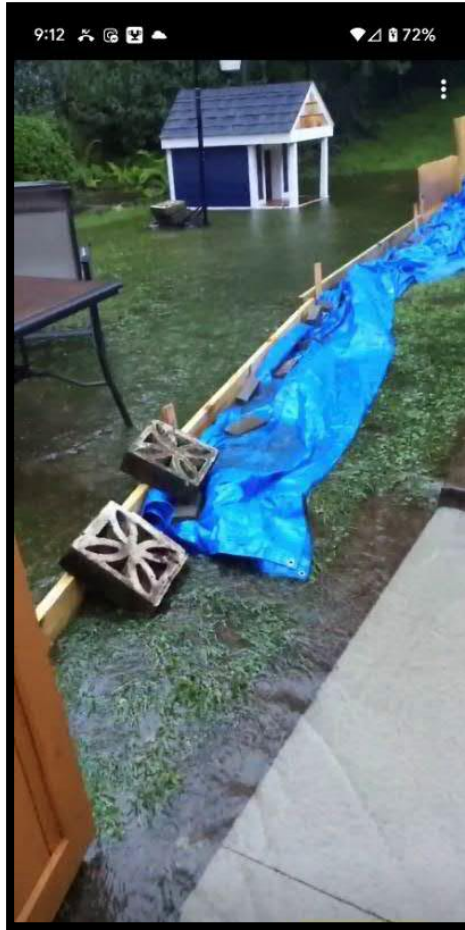
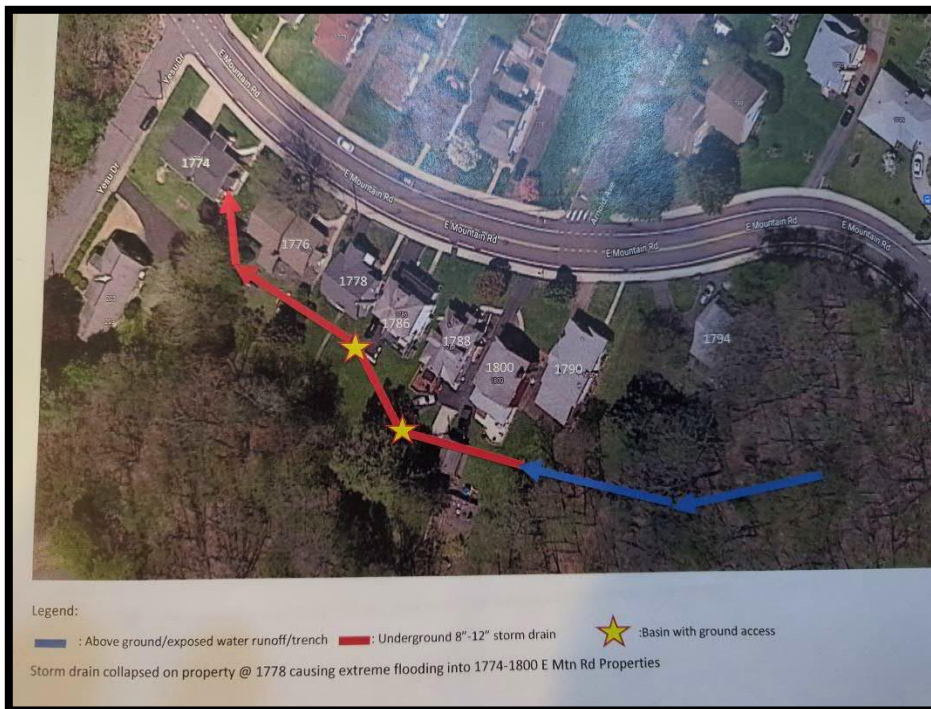
## PUBLIC COMMENT: FLD-08

**Type of Issue:** Other Lack of proper storm water management causes flooding in our basement and yard. Only needs to be a moderate rain. Well over \$15,000 in damage over 9 years

**Describe flooding issue in detail:** Water runoff from city owned Robinson Park travels downhill through a drain pipe in the backyards of the homes on the even numbered side of the 1700 block of East Mountain Road. The drain pipe is blocked/collapsed/inadequate and causes flooding to the inside of the homes on this block as well as the backyards. This flooding occurs in only moderate rain conditions. Heavy rain is devastating. We have incurred, at minimum, \$15000+ in damages/losses from this flooding over 9 years. In September 2021 the flood conditions were so bad that we had nearly 3 feet of water in our basement. We had seven pumps running simultaneously, nonstop for hours (with a total discharge capacity of around 30,000 gallons of water per hour/500 gallons per minute) and even with seven pumps the water continued to rise in our basement until Scranton DPW arrived with an industrial pump.

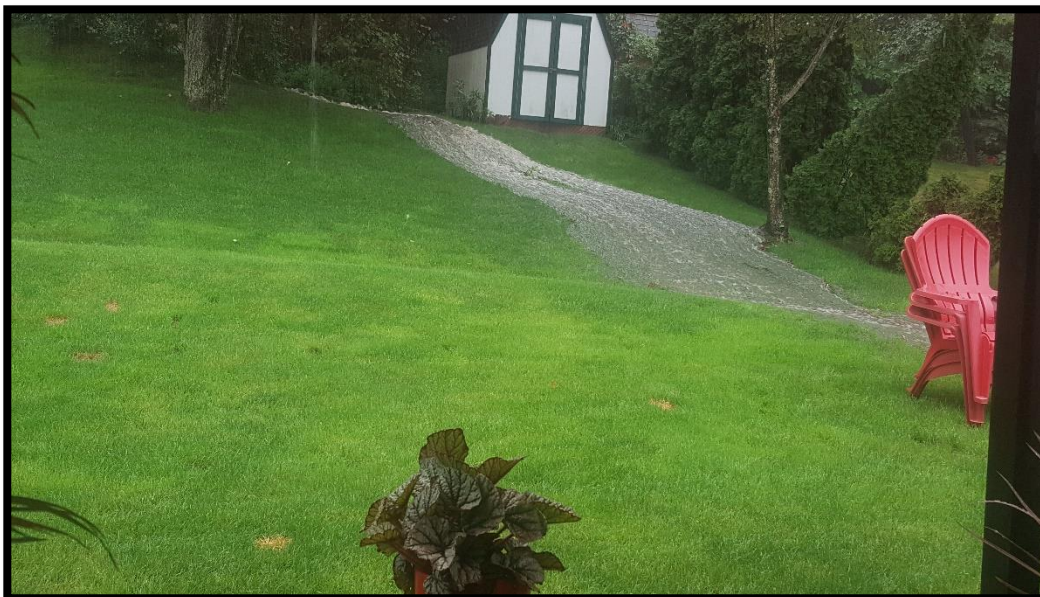
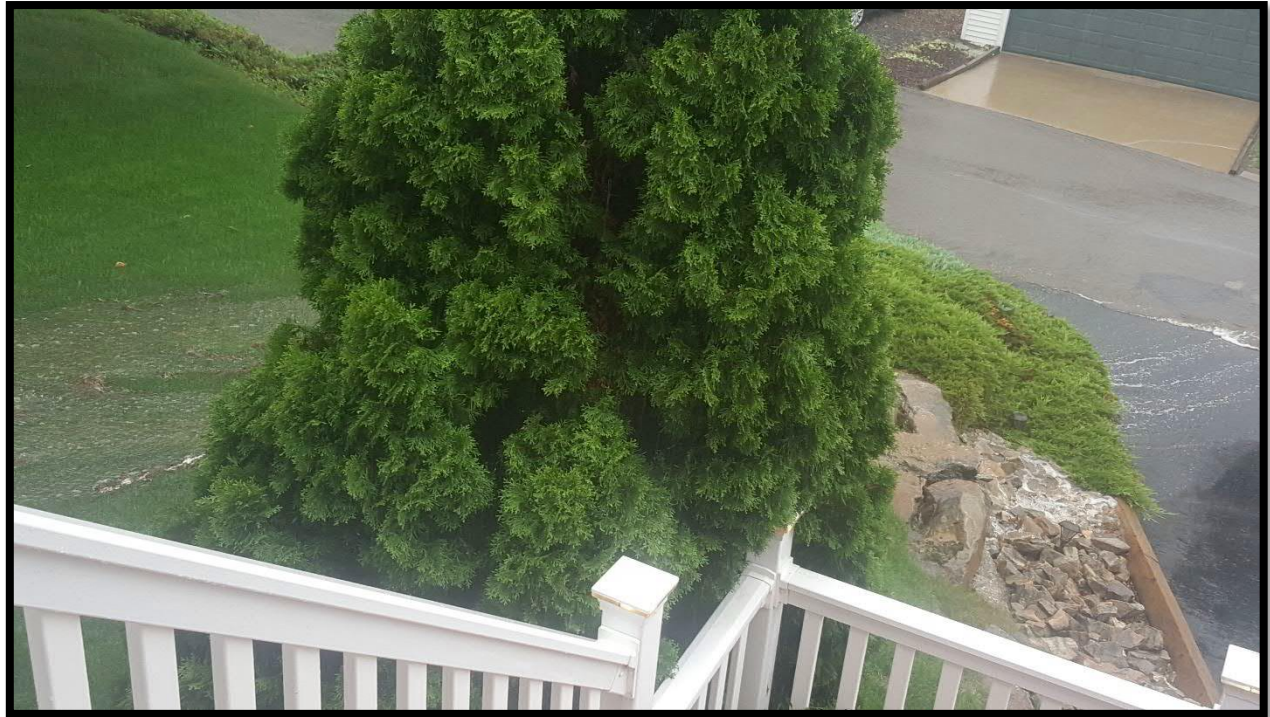
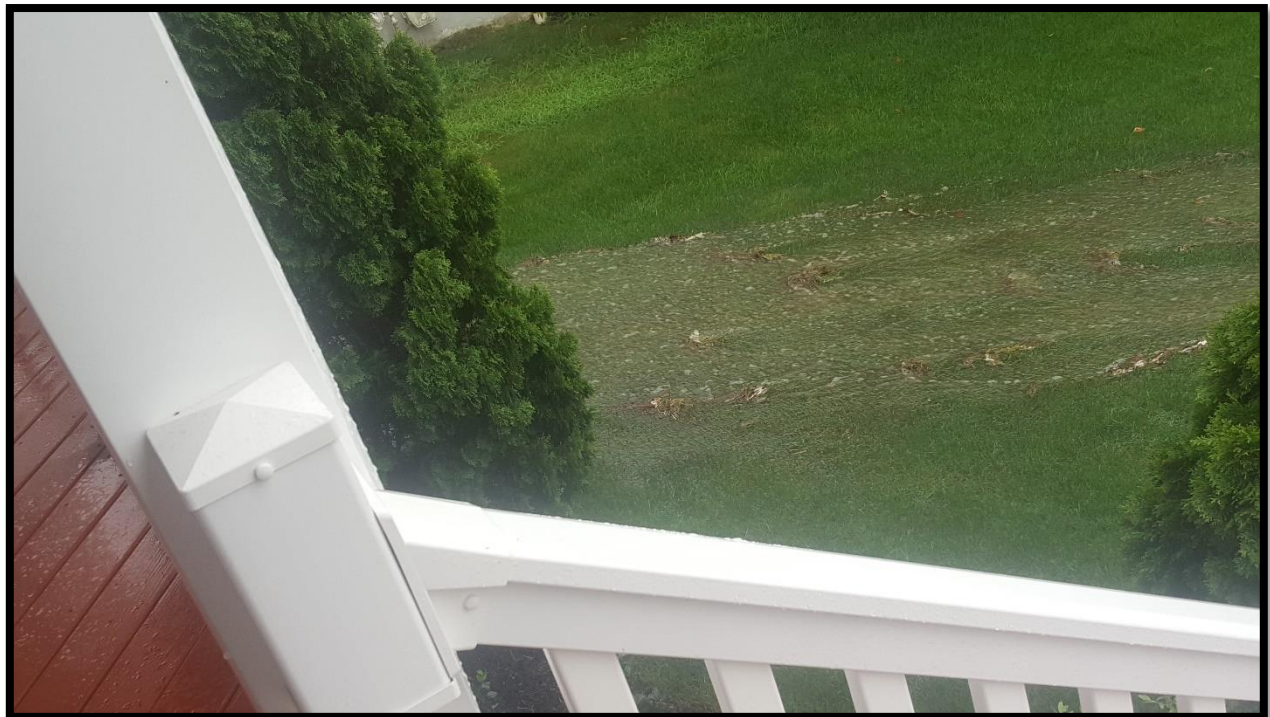
## PUBLIC COMMENT: FLD-09

**Describe flooding issue in detail:** Every heavy or long term rain, stormwater runs through the backyard up against the deck and house. On 08/13/2018 NEPA received 7 inches of rain in a 24 hour period. I had a rock ditch installed when the home was first purchased to pipe the water away from the yard/home. During this storm the ditch couldn't handle it and the water jumped the ditch, hit the back of the house for a extended period until it came through patio doors at each end of the house flooding the first floor and basement/garage. Since then I have to use a pump against the rear of the home to try and pump the water in between the houses. A Insurance did not cover any of the damages. I do have pictures and video's of the incident.

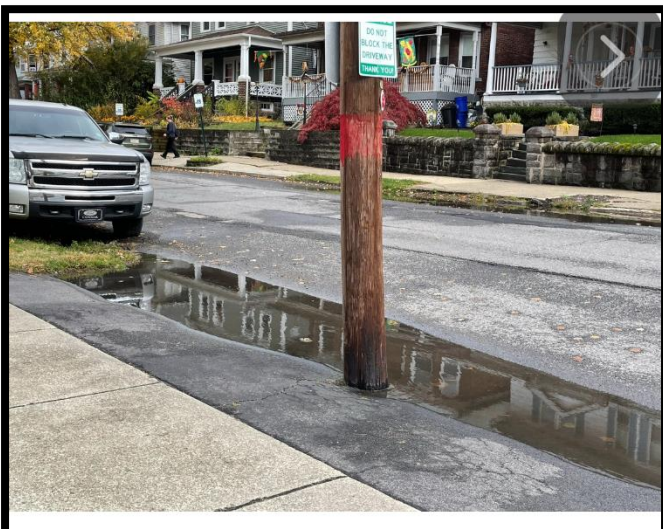
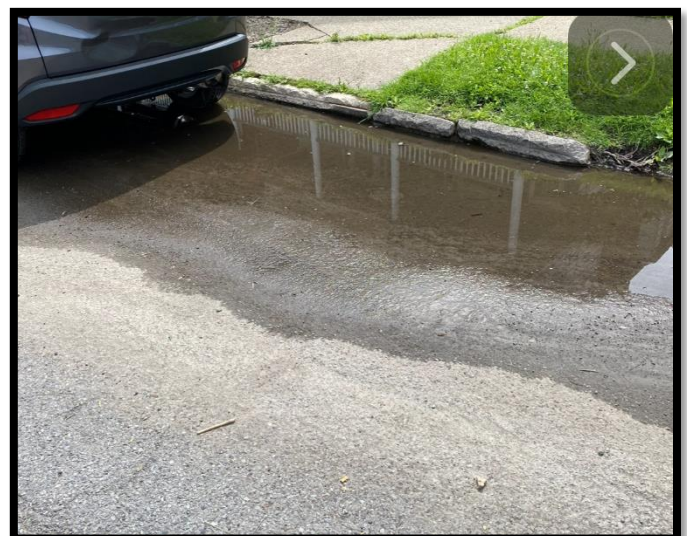
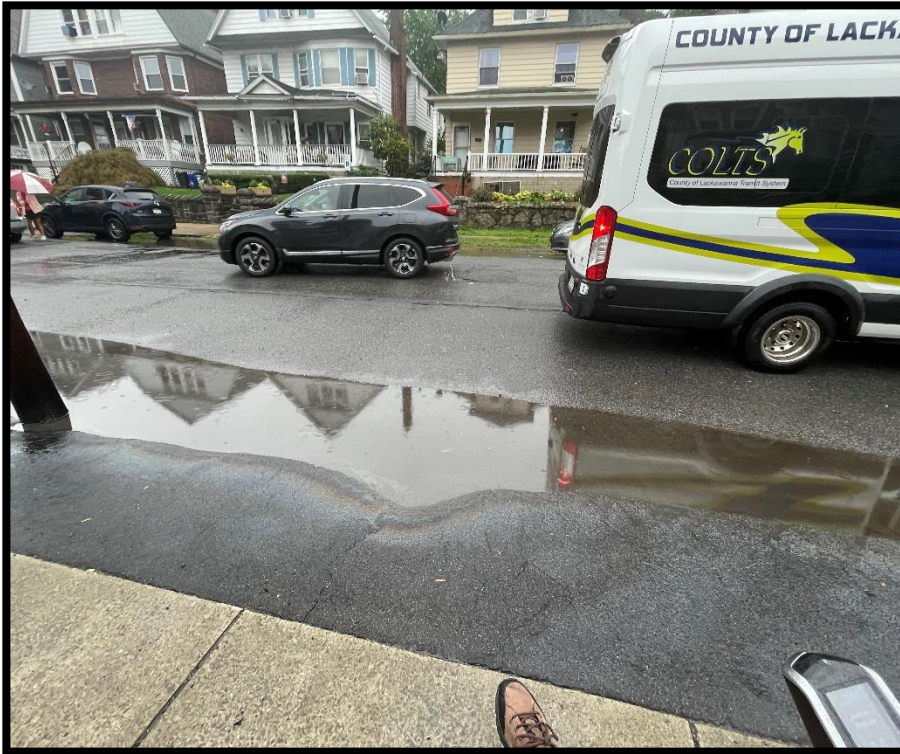
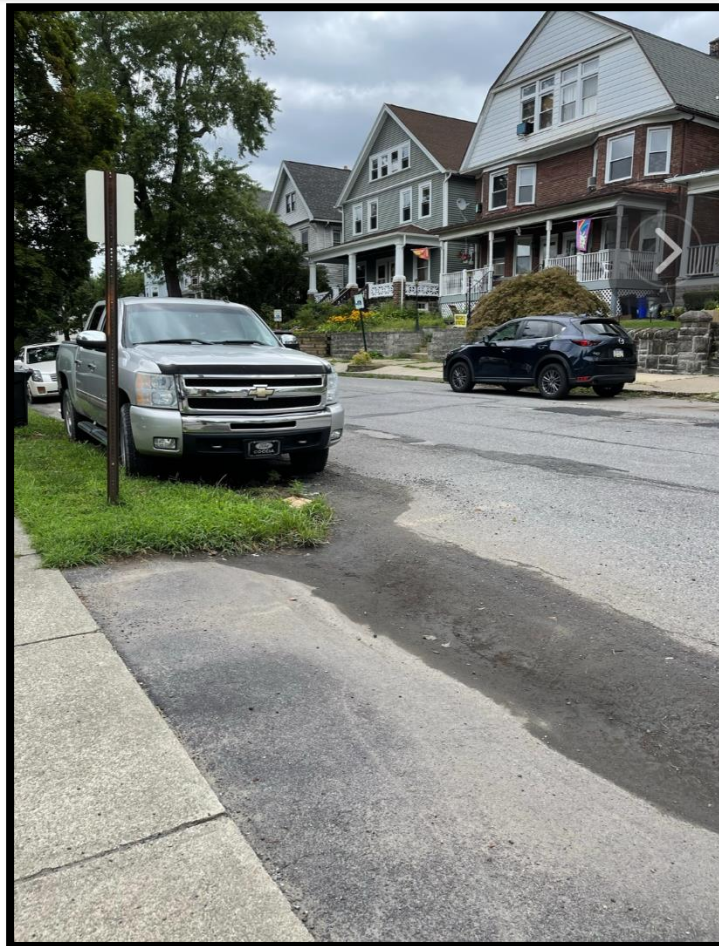
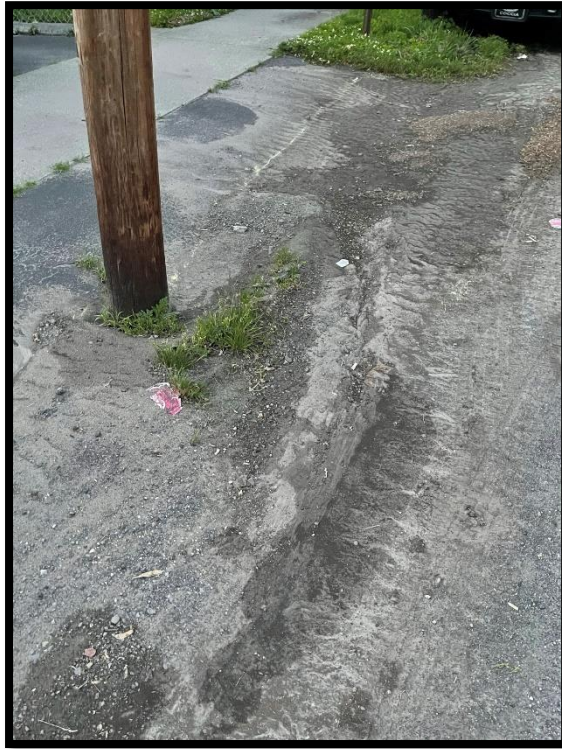
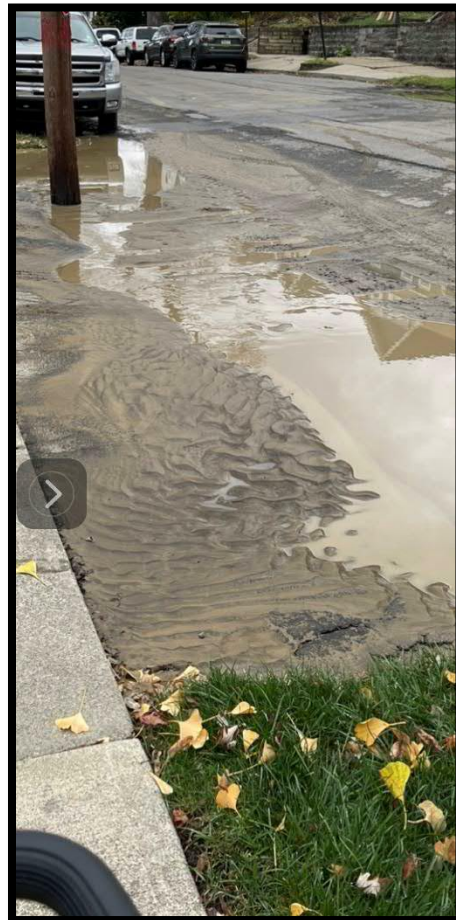
## PUBLIC COMMENT: FLD-10

IS THIS ISSUE ADDRESSED BY THE DRAINAGE STUDY?  
NO - Site is not located within East Mountain

**Describe flooding issue in detail:** A storm drain has been removed from the middle of the block and water sits in front of the driveway at 919 Monroe Ave. Water drains through Mallard and has washed away countless tons of gravel and has left litter and debris in the yard and in front of my house. David Decadmo did a story on channel 22 about the flooding issue. The city has done nothing to improve the situation by continuously, adding pavement to the middle of the road raising the middle of the road. Also, they have removed all of the curbs, which intern increase the issue that has been in the newspaper numerous times I have been to City Council numerous times to no avail. I have sent numerous letters photographs to the mayors 311 program to no avail. The city employees from DPW service stated they do not have the money to fix the problem Â simple task grind down the road and slope the road so it's flat and drains properly down Ash Street

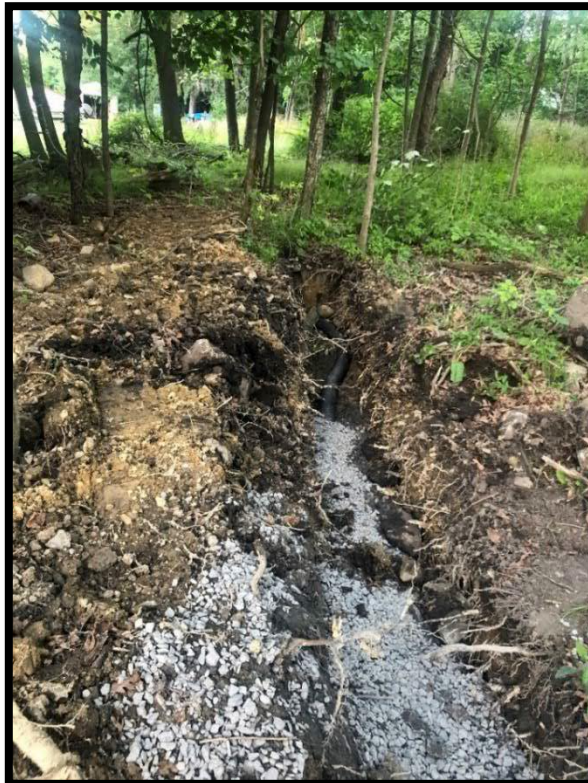
## PUBLIC COMMENT: FLD-11

IS THIS ISSUE ADDRESSED BY THE DRAINAGE STUDY?  
NO – Site is within East Mountain, but not within an area studied.

**Describe flooding issue in detail:** Water coming from Howard Gardner rear parking lot and rushing to the back of my house. I have had to put in 2 drainage pipes so far which still has not helped the issue much. My neighbor tells me that this was not always a problem and arose during the last few years
