# FINAL REPORT

## EAST MOUNTAIN STORMWATER AND DRAINAGE STUDY

Submitted to: City of Scranton  
Lackawanna Co., PA

January 9, 2024

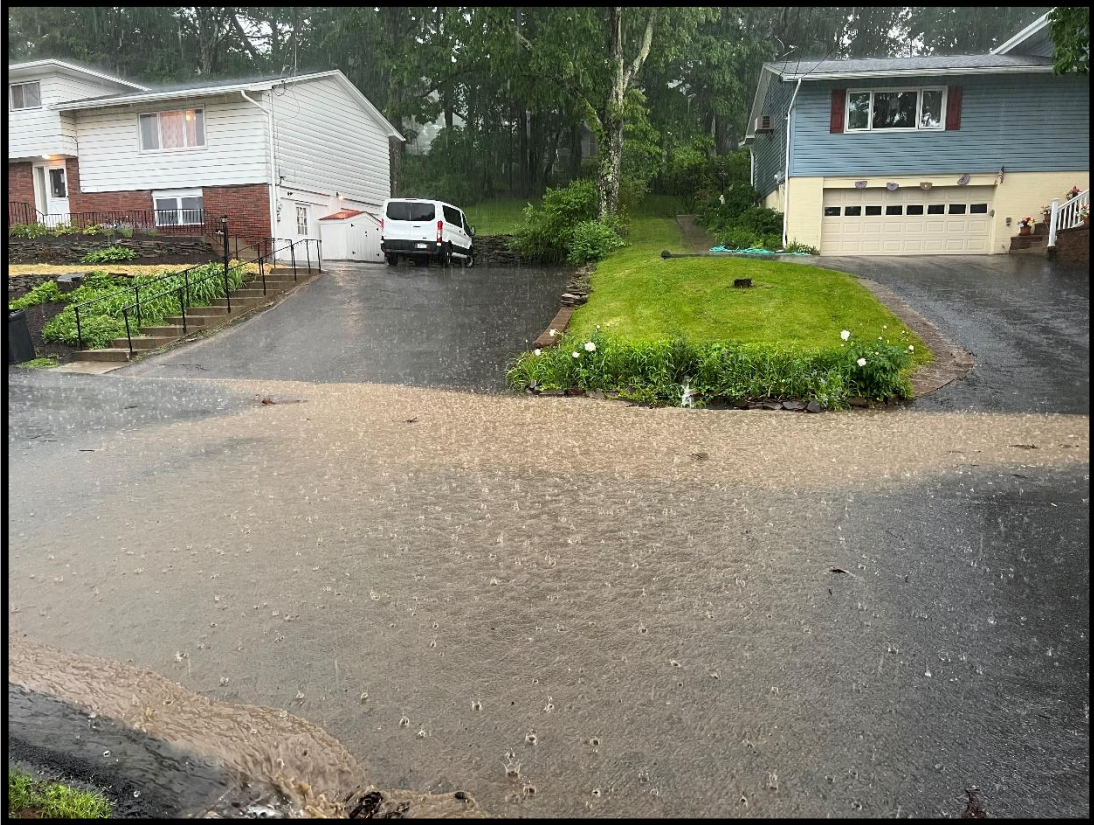
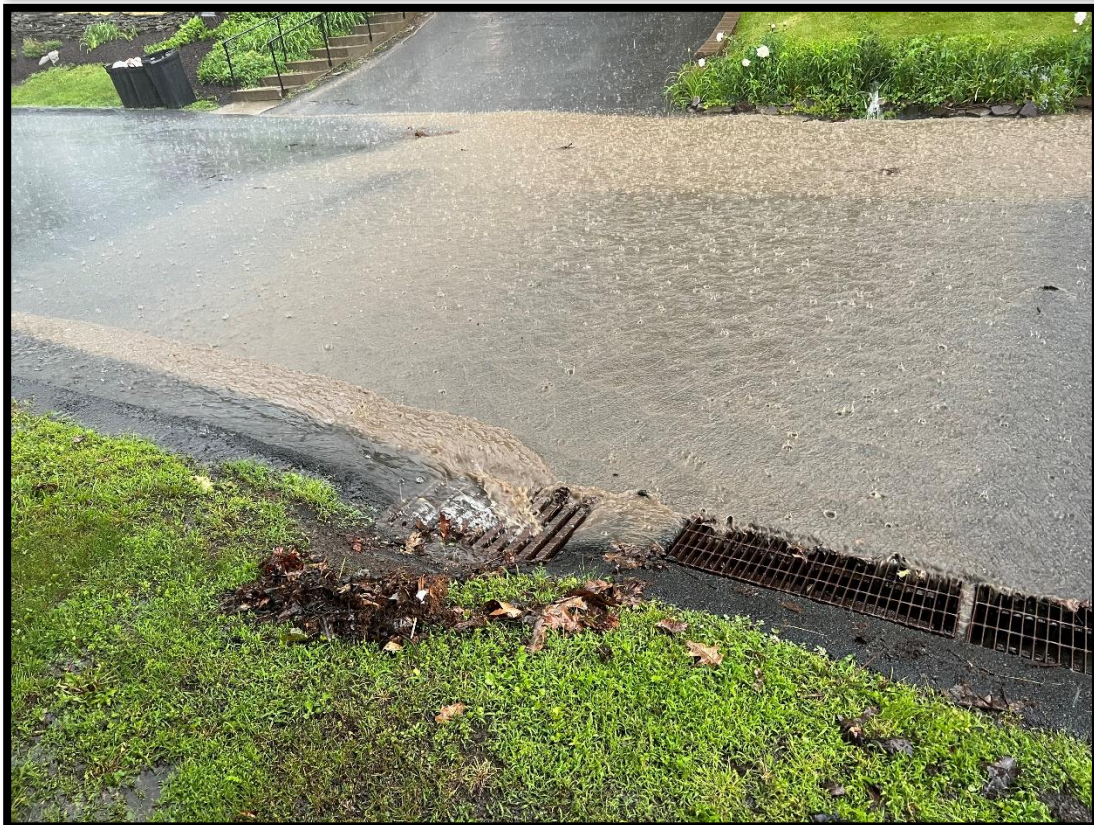
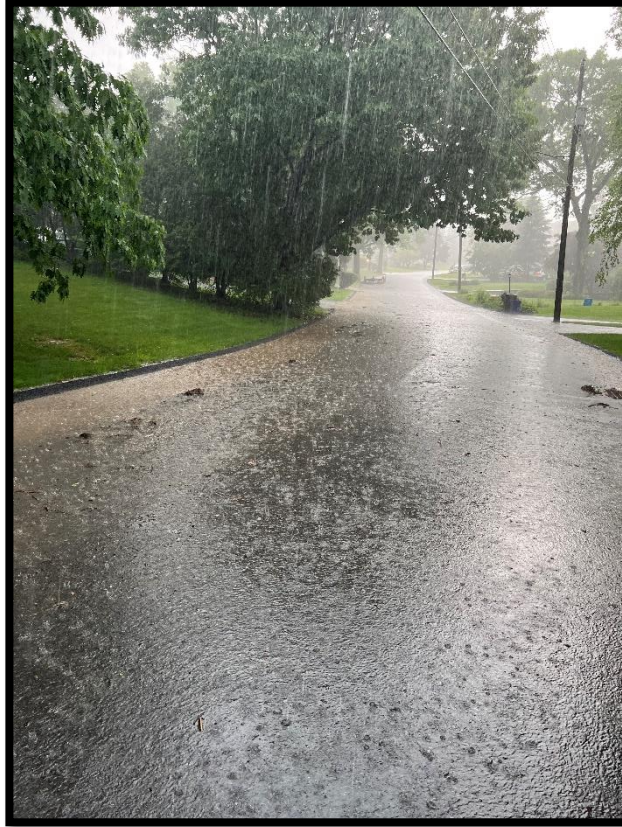
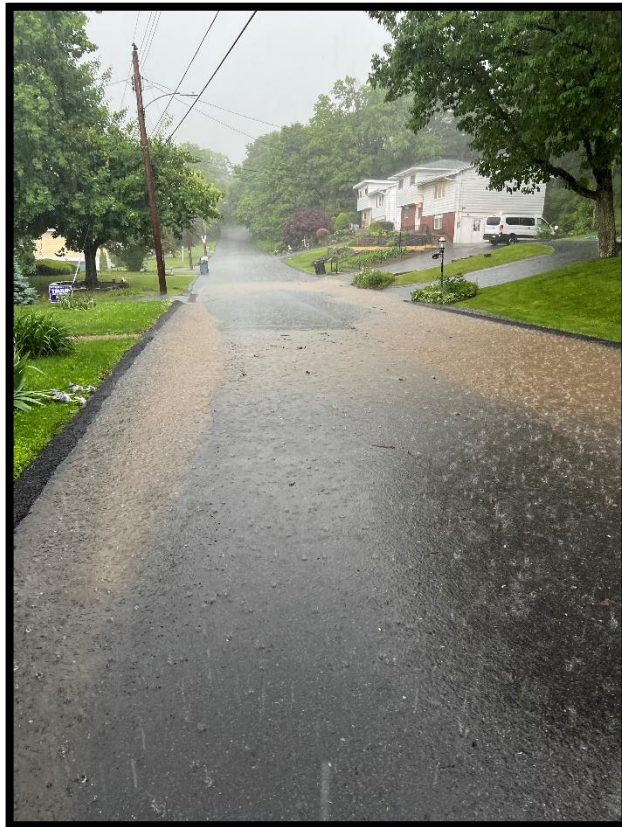
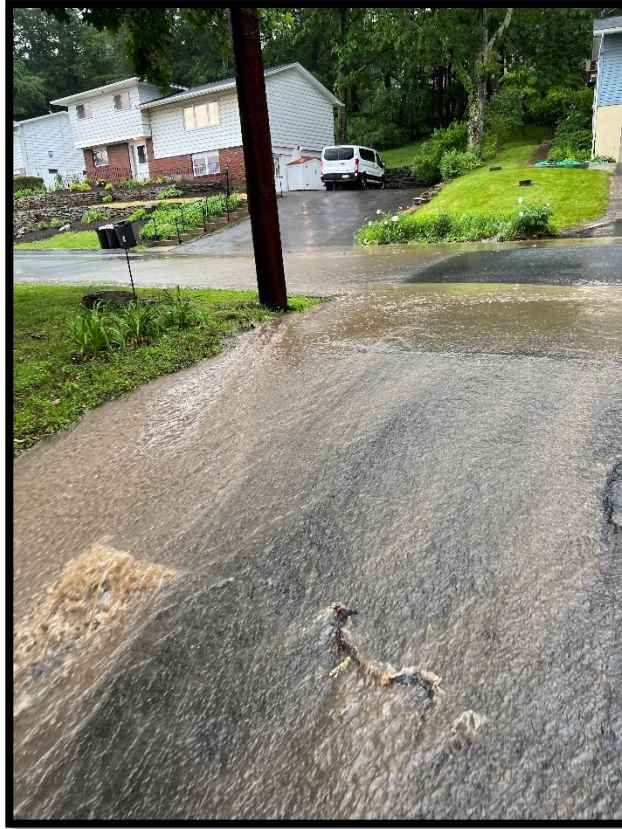
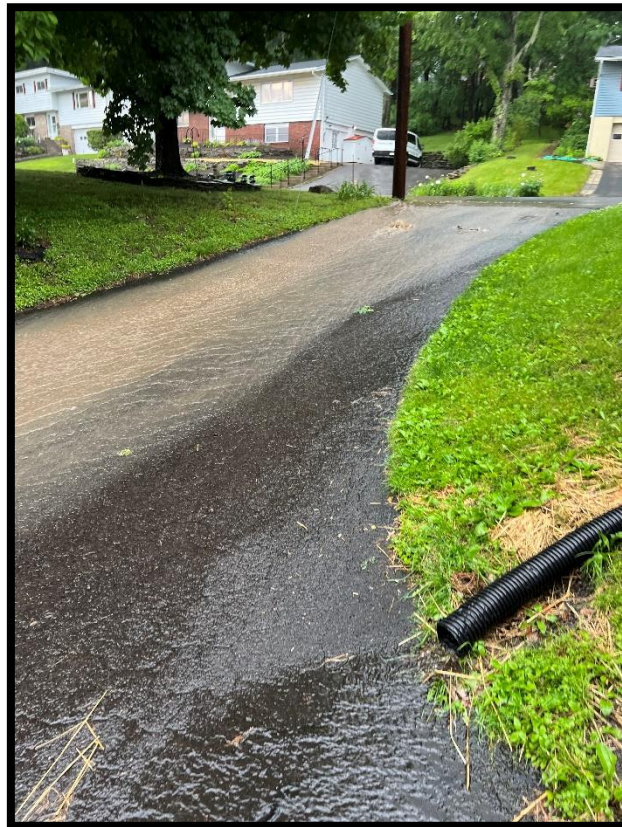
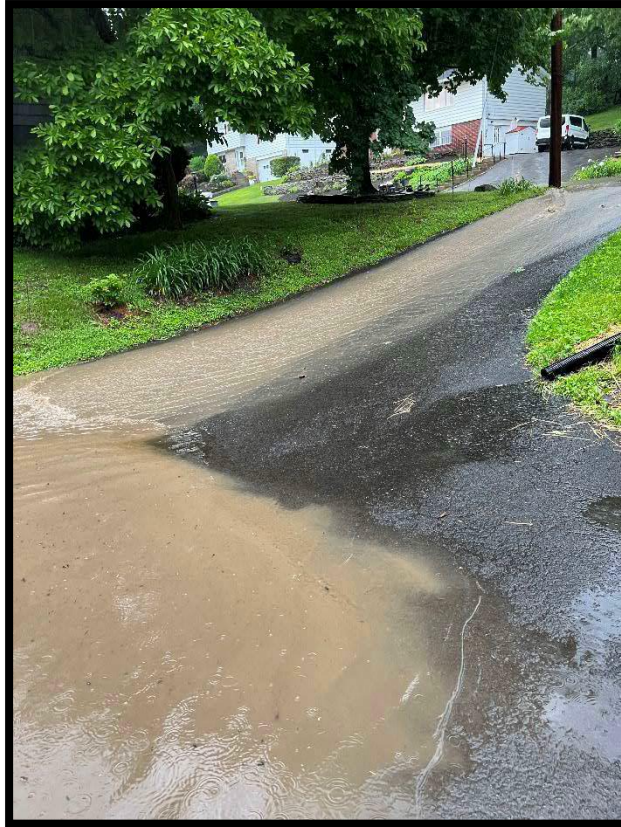
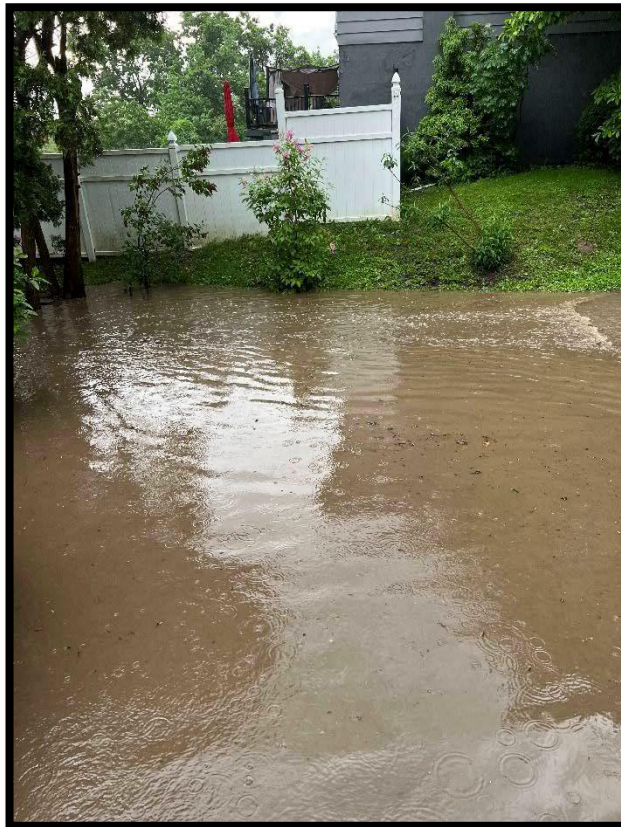
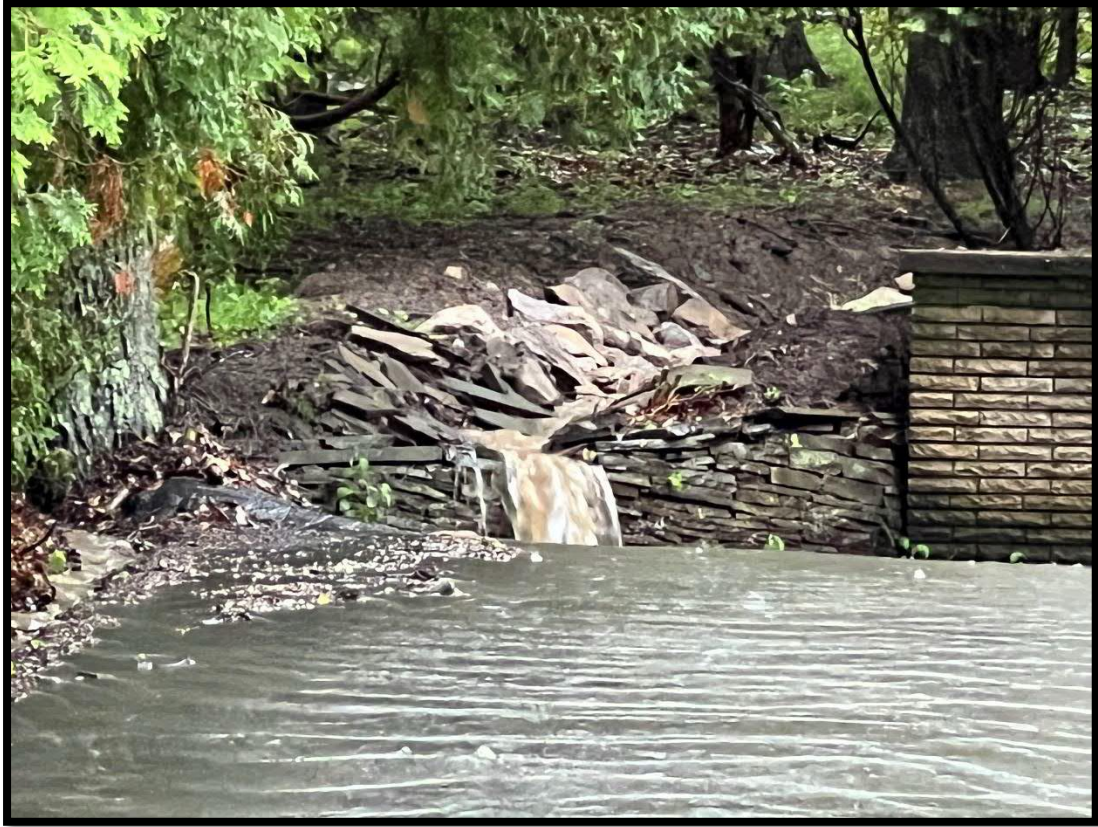
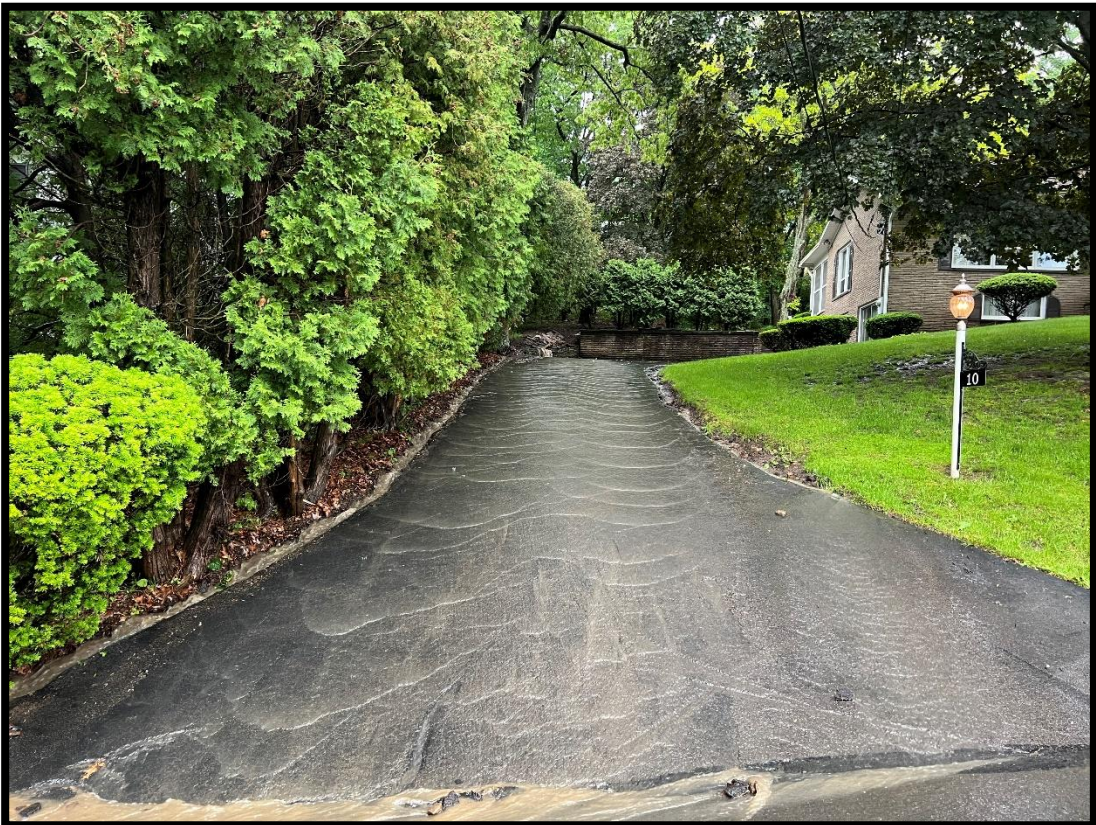
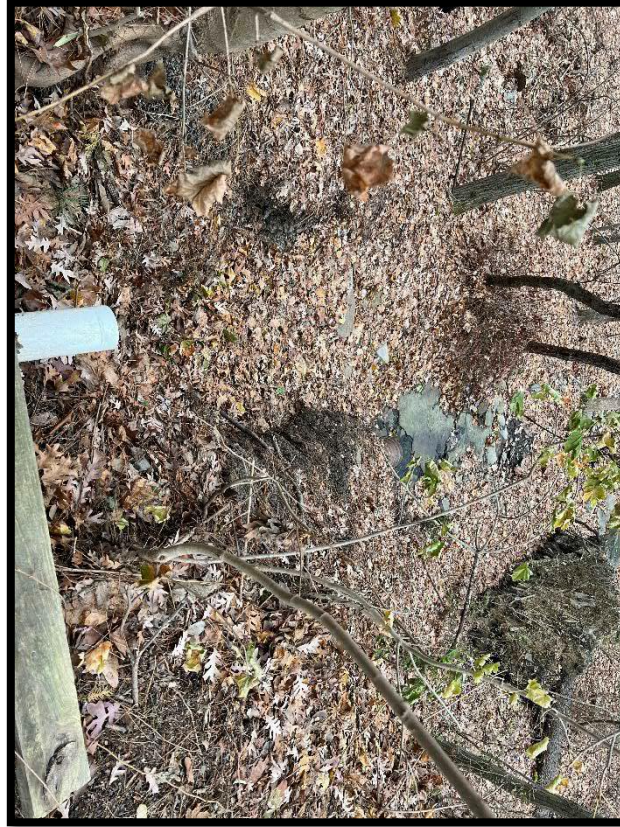
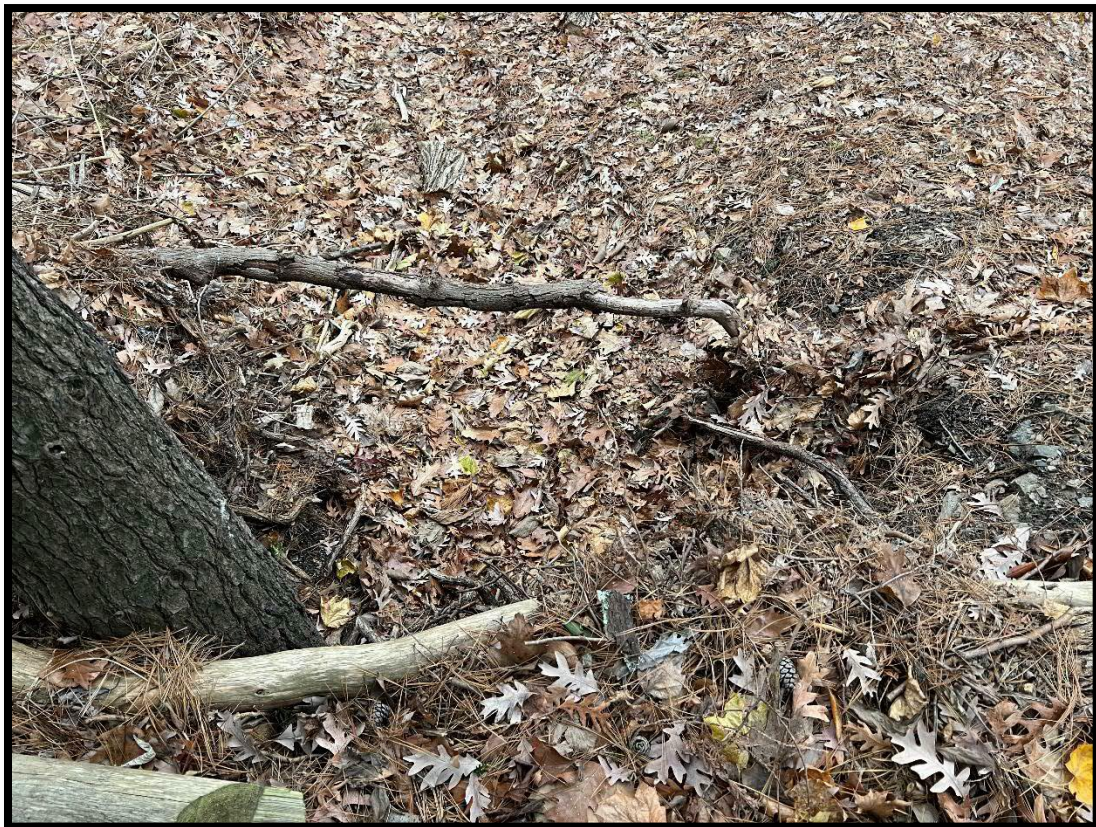
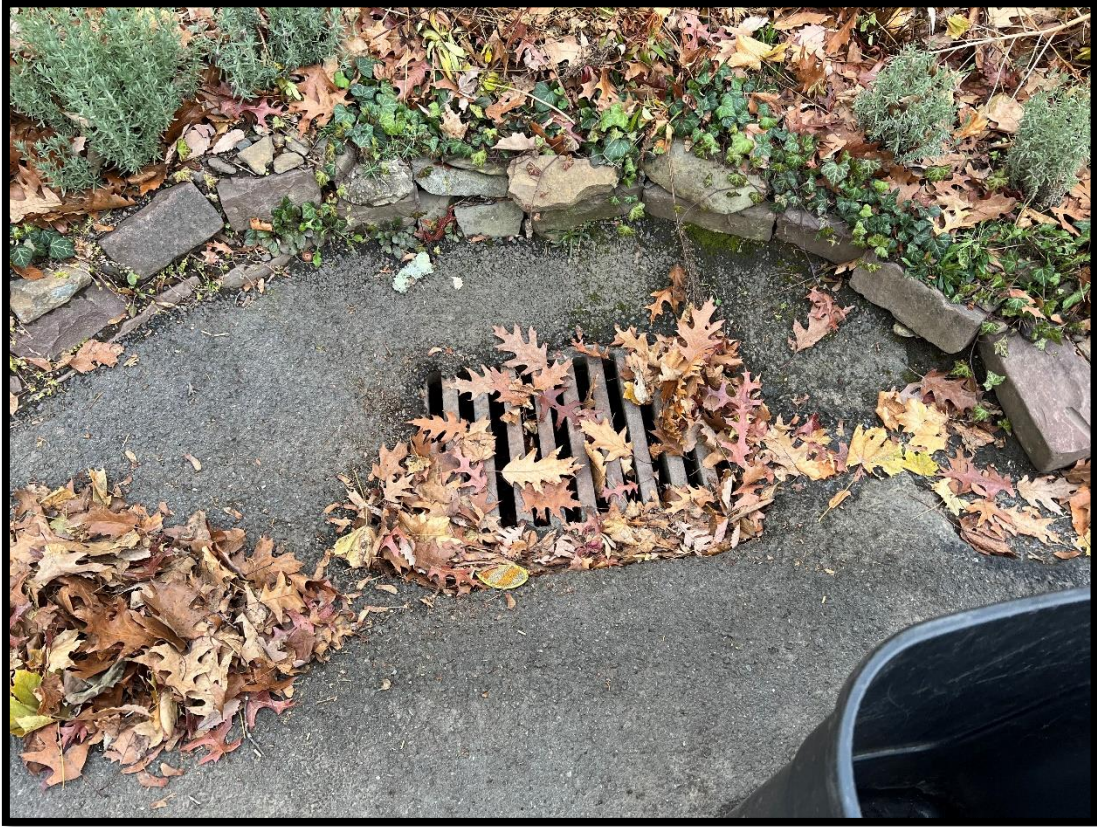
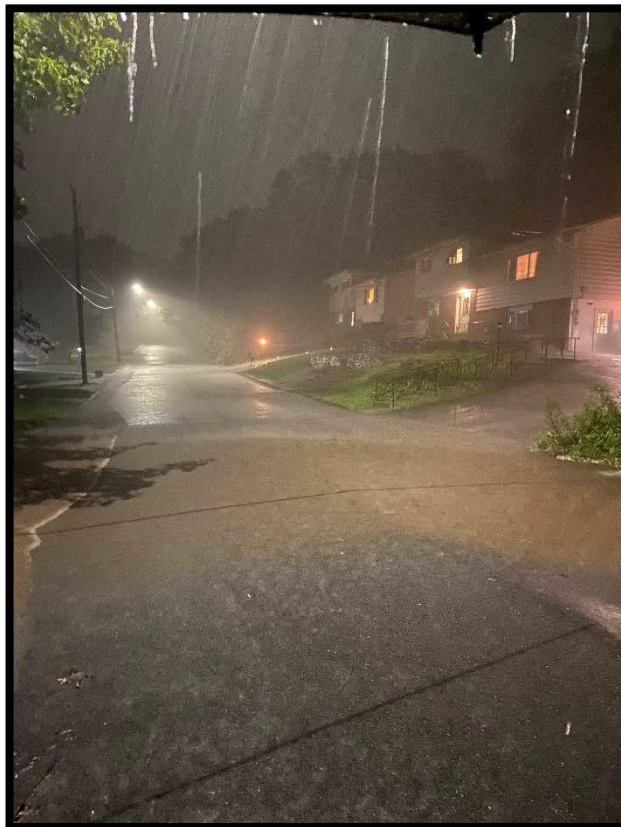
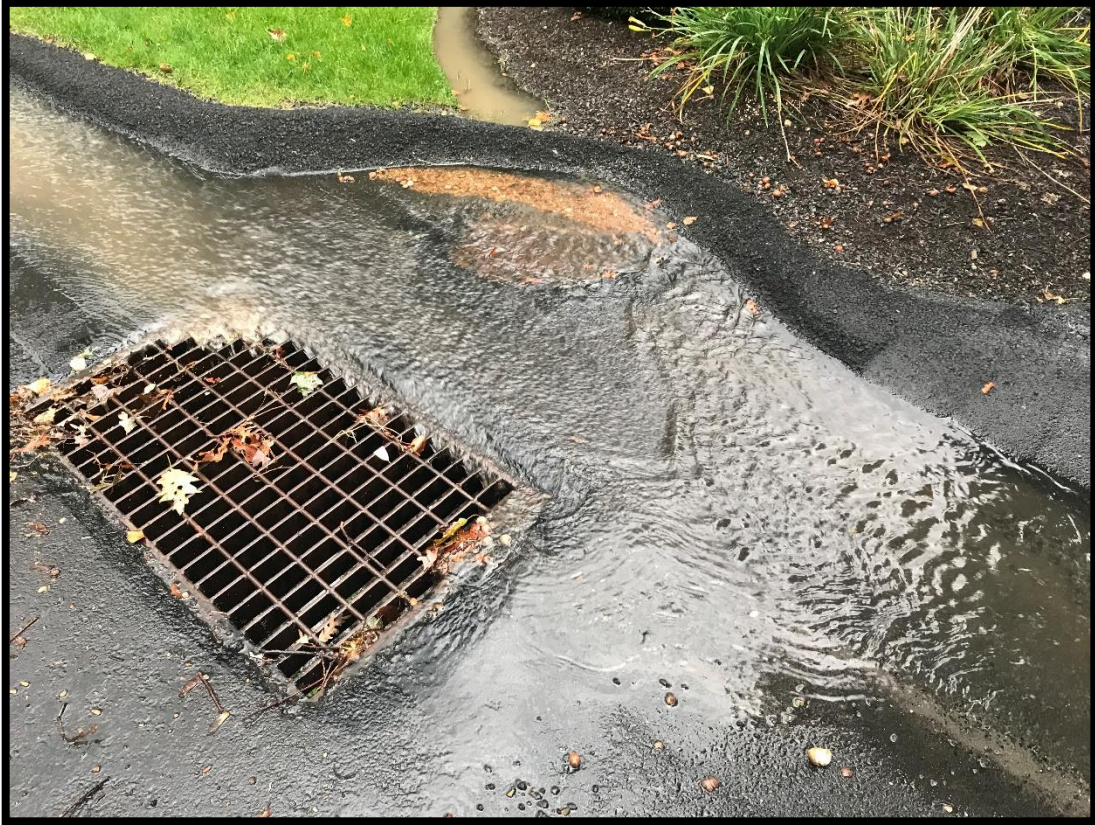
## **PUBLIC COMMENT: FLD-12**

**IS THIS ISSUE ADDRESSED BY THE DRAINAGE STUDY?**  
NO – Site is within East Mountain, but not within an area studied.

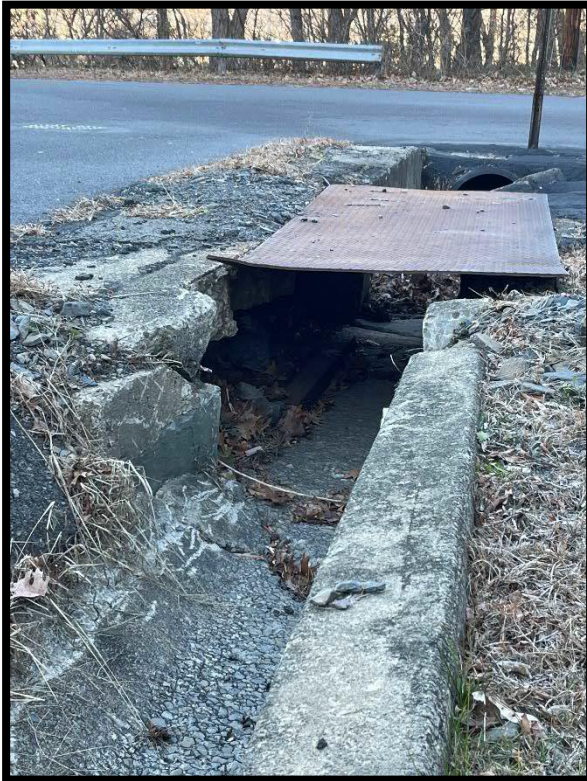
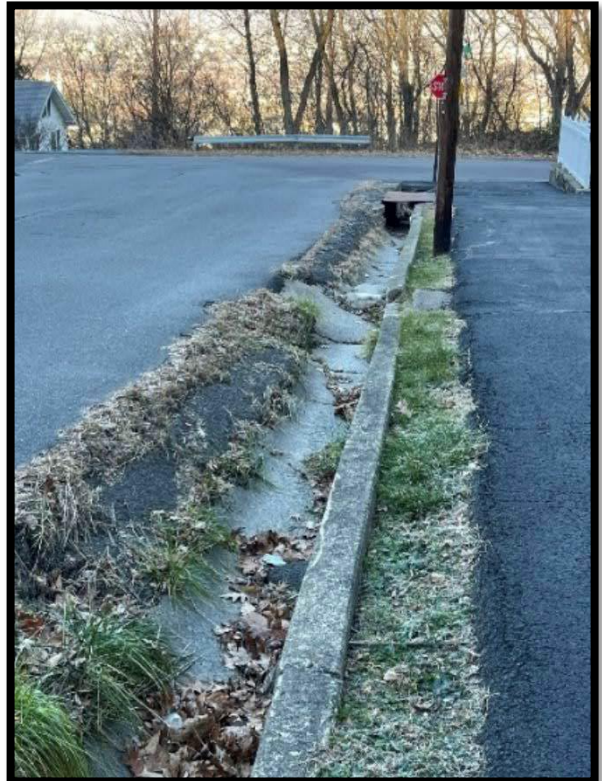
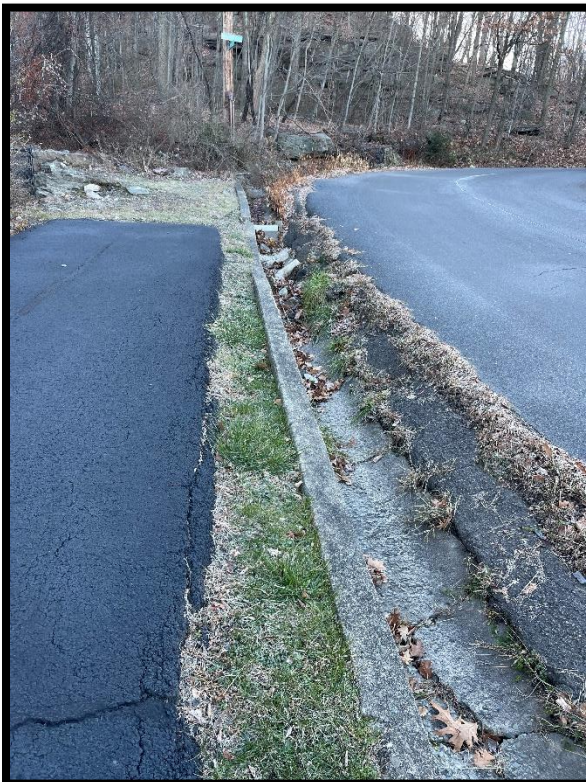
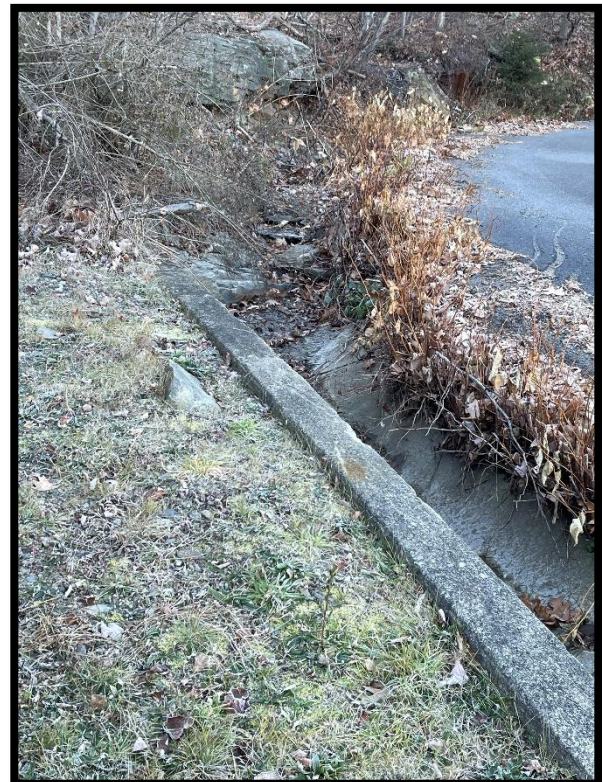
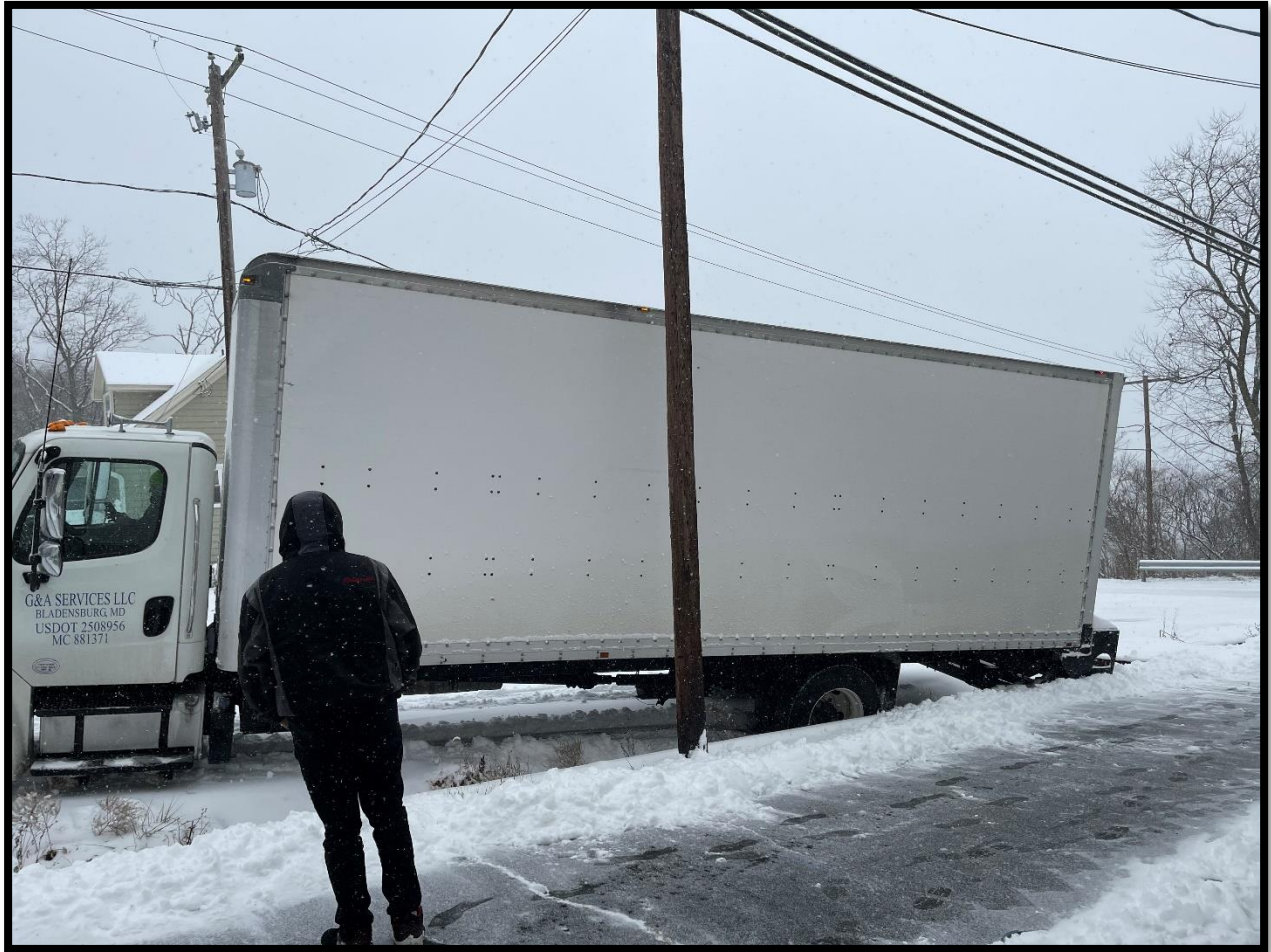
## **PUBLIC COMMENT: FLD-13**

**Describe flooding issue in detail:** This is an open concrete stormwater ditch that runs down E Elm St, turns the corner at Blucher and connects with the storm water channel on Beech St before entering a stormwater tunnel under the road. The stormwater ditch is in considerable disrepair and is crumbling on the sides, causing the road bed to erode and narrowing the safe drivable area of the road. This corner is already a safety hazard, especially during winter when snow and ice force cars into the middle of the intersection. The unsafe passage of the stormwater is making this issue worse. Many cars get stuck in the stormwater ditch when they slide off the road. The open nature of the ditch means it is not possible to put a guard rail up to keep cars from sliding off the road. The crumbling nature of the storm water ditch means the concrete walls are falling into the ditch. As the ditch fills with the crumbling concrete cars are more likely to skid off the road and into the adjoining property - which is our preschool housing 60 children aged 3-6. Managing the storm water in this location - preferably through drainage tunnels under paved road - would allow for more safe traffic management as well as better storm water management.

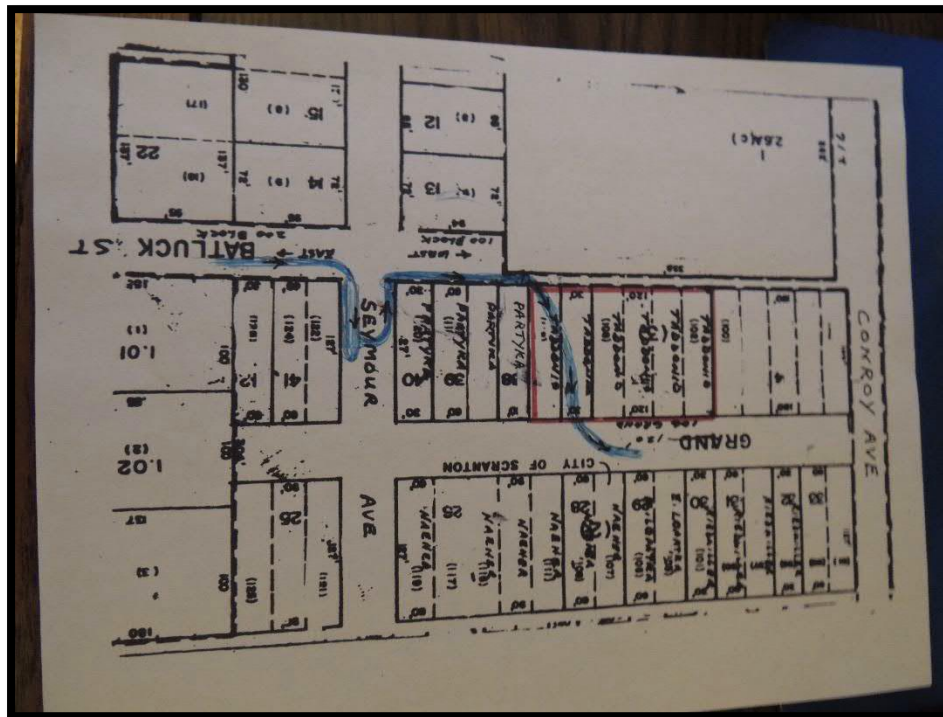
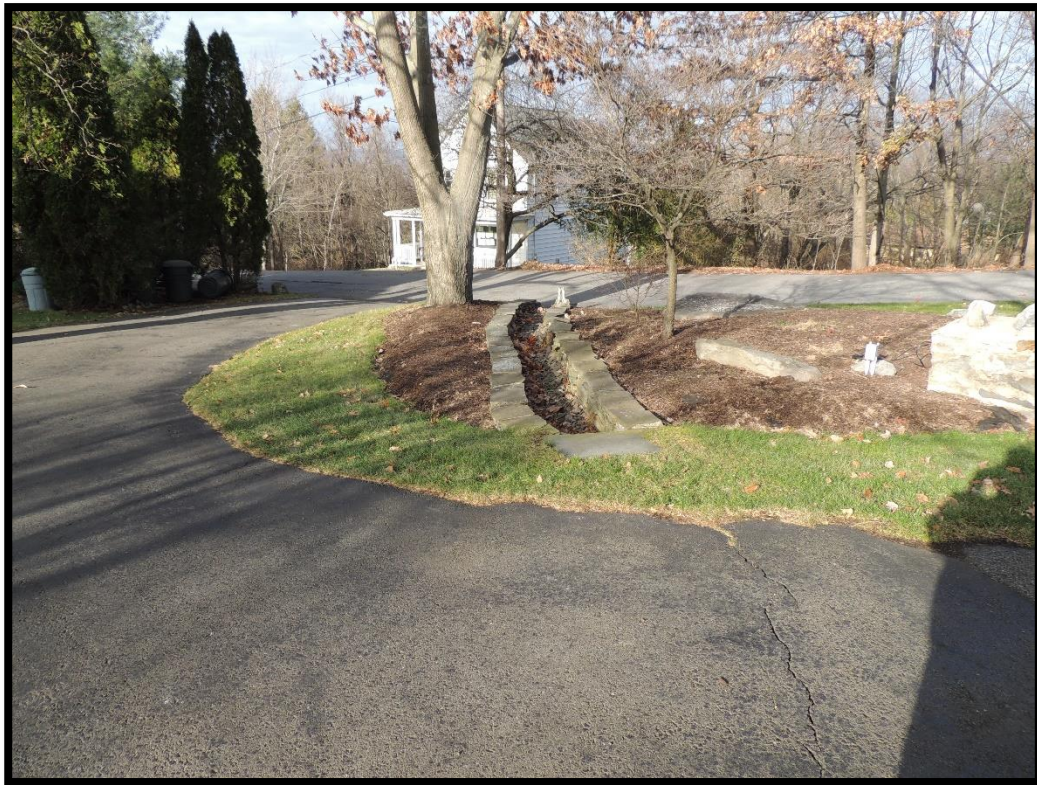
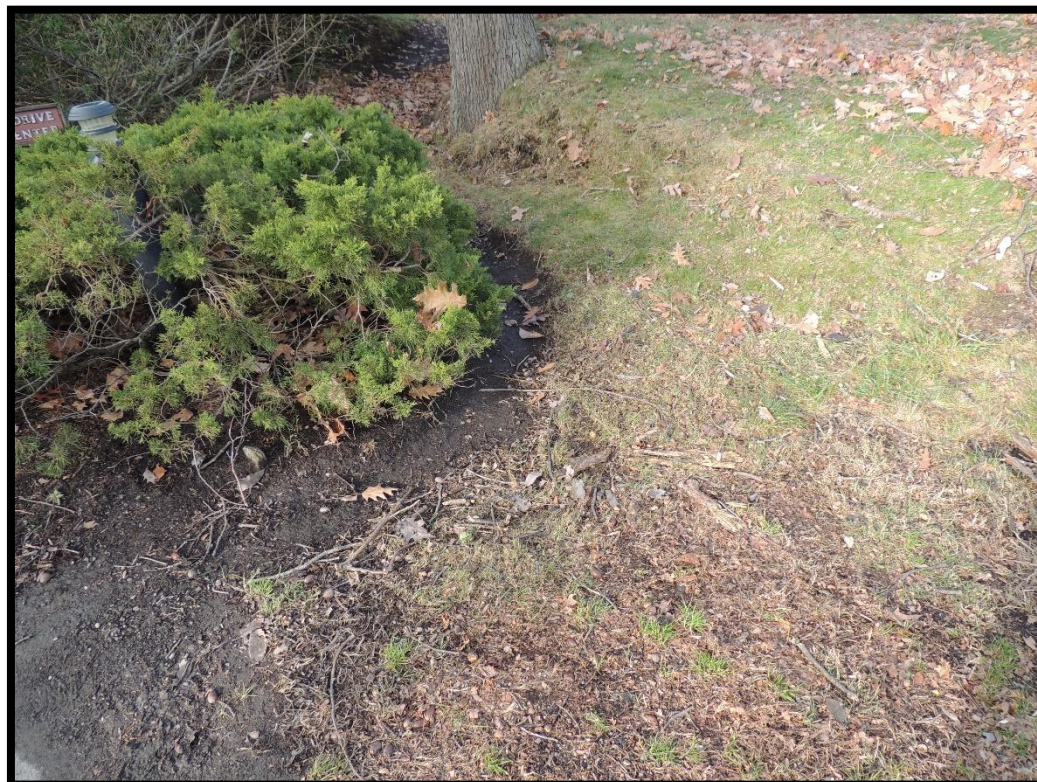
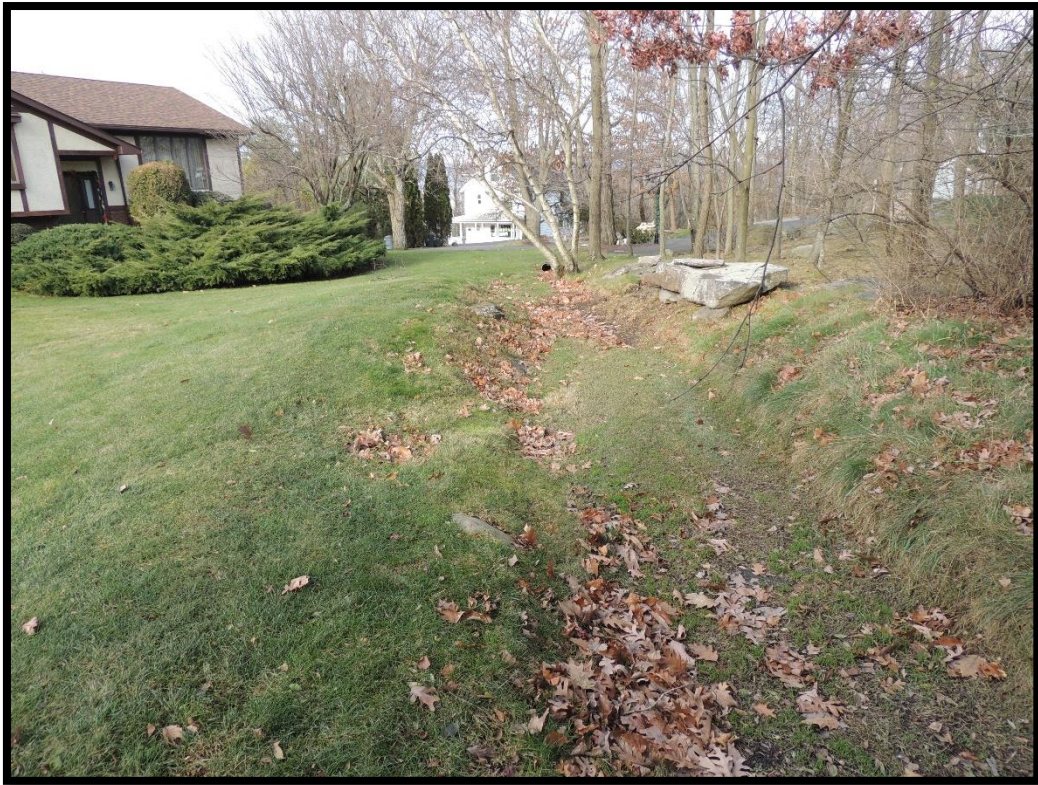
## PUBLIC COMMENT: FLD-14

**IS THIS ISSUE ADDRESSED BY THE DRAINAGE STUDY?**  
YES - Proposed drainage improvements on Snook Street would improve this drainage issue.

**Describe flooding issue in detail:** There is no stormwater drain to collect rain water so it continues down Batluck St and enters the rear of my property and continues across my property and exits on the front of Grand Ave. After storm there is some water left in ditch and creates a breeding ground for mosquitos. I have a professional exterminator come throughout the summer every year to spray for mosquitos and insects because of problem with stormwater.

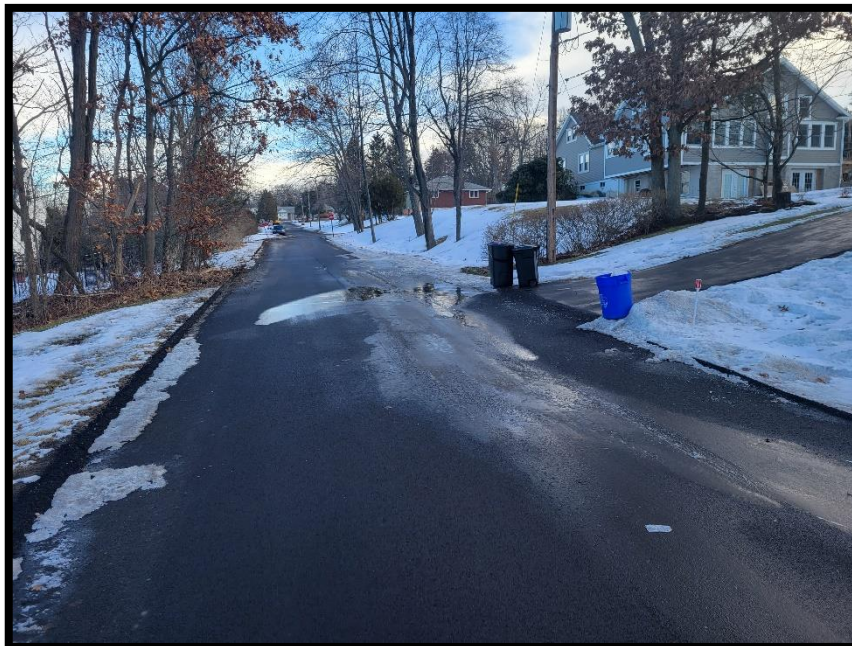
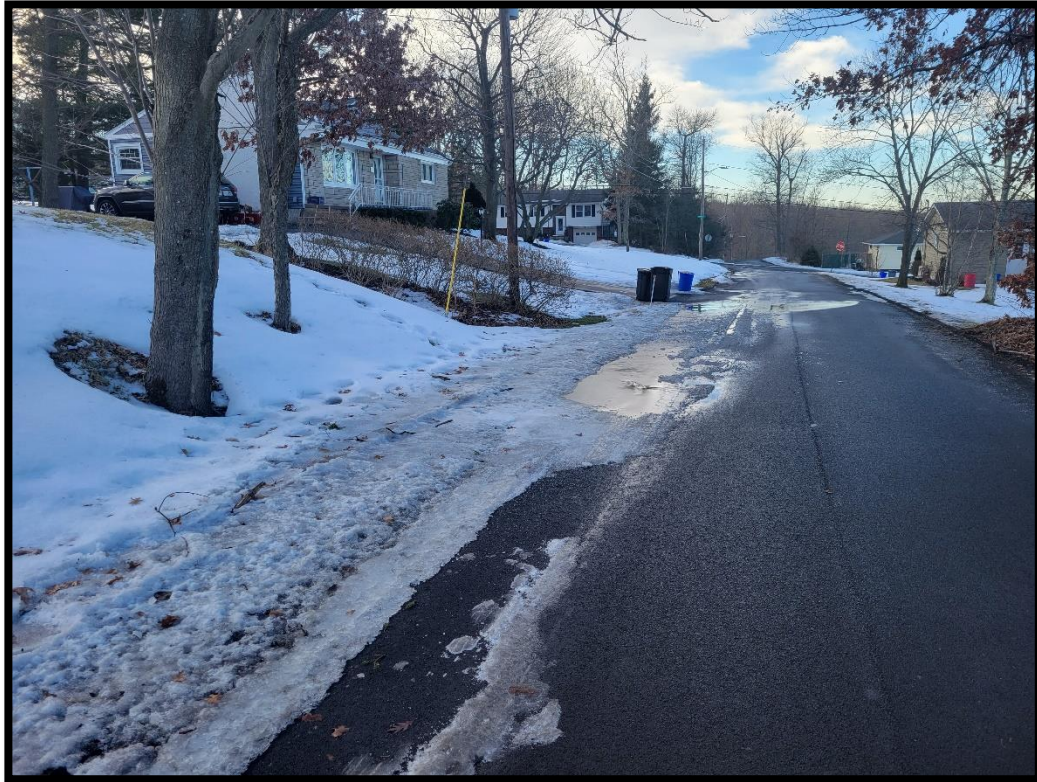
## **PUBLIC COMMENT: FLD-15**

**IS THIS ISSUE ADDRESSED BY THE DRAINAGE STUDY?**  
NO – Site is within East Mountain, but not within an area studied.

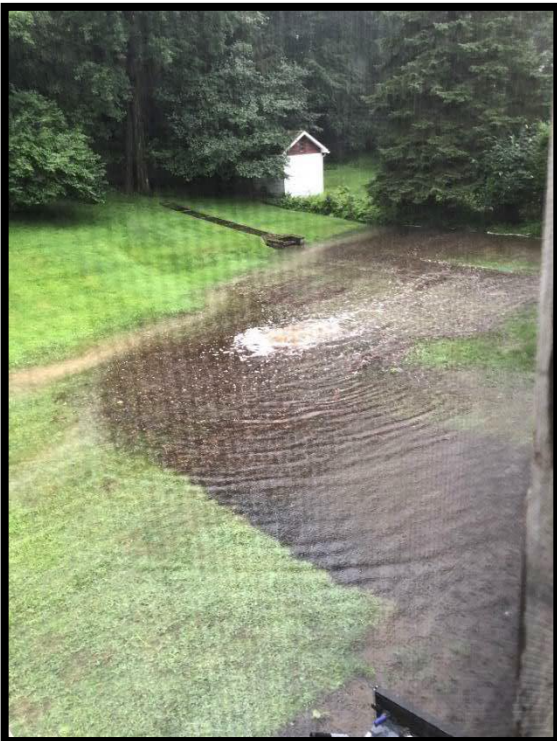
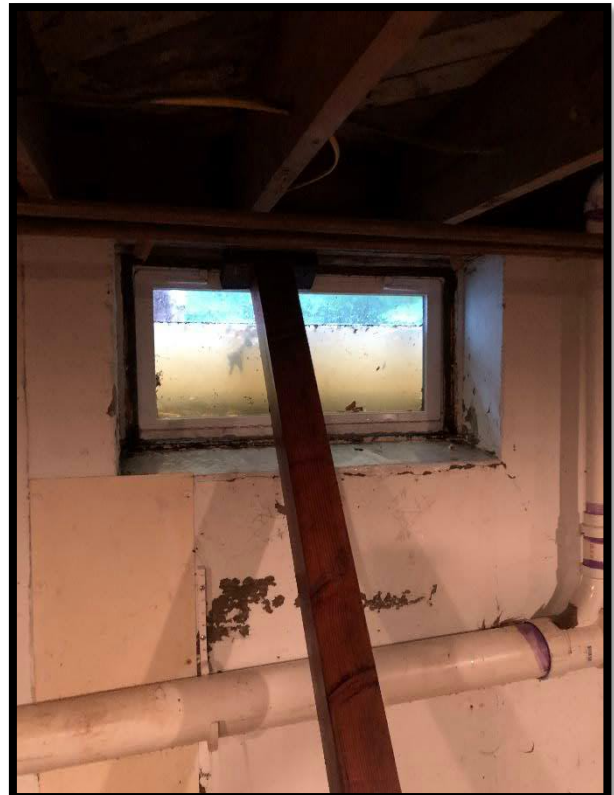
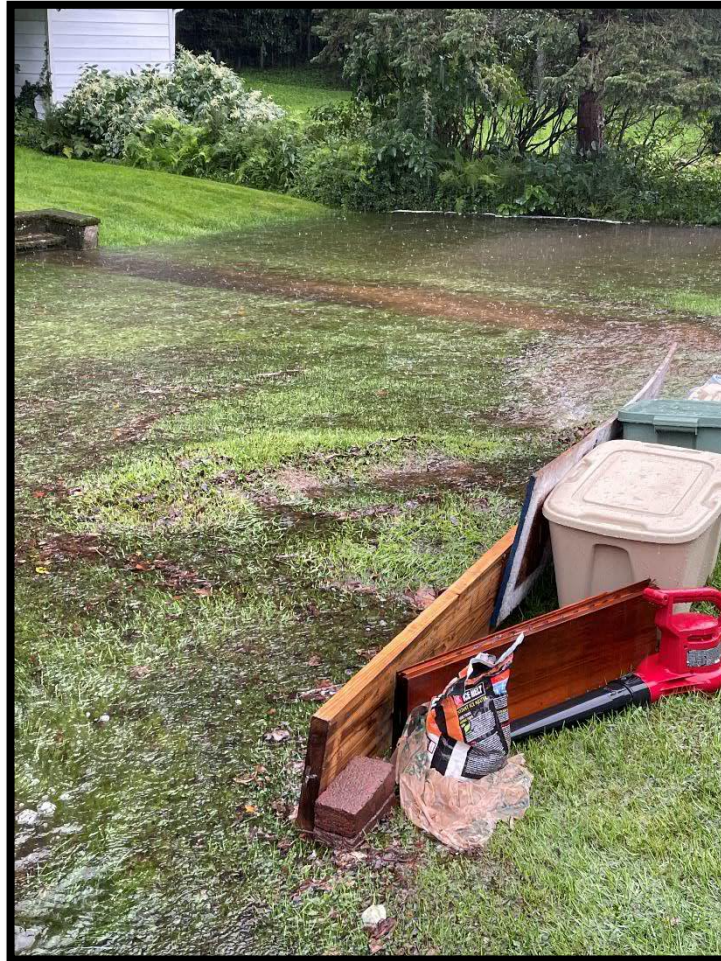
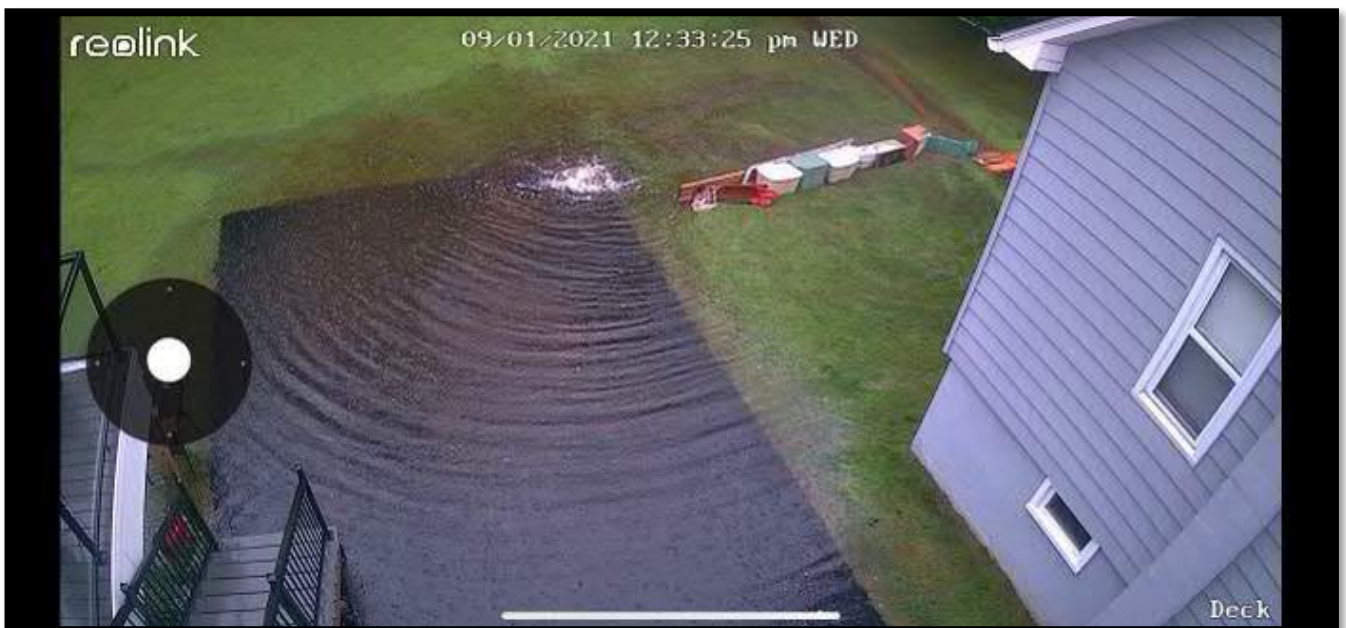
## PUBLIC COMMENT: FLD-16

**Describe flooding issue in detail:** During heavier rainfall, the storm drain that runs along the back property lines of houses located 1774-1800 E Mtn Rd, back up and the resulting water causes property damage in the basements and foundations of these houses. We have had several thousands of dollars of damage each time these storm waters reach my basement. I have several photos and videos for documentation.
