# FINAL REPORT

## EAST MOUNTAIN STORMWATER AND DRAINAGE STUDY

Submitted to: City of Scranton  
Lackawanna Co., PA

January 9, 2024

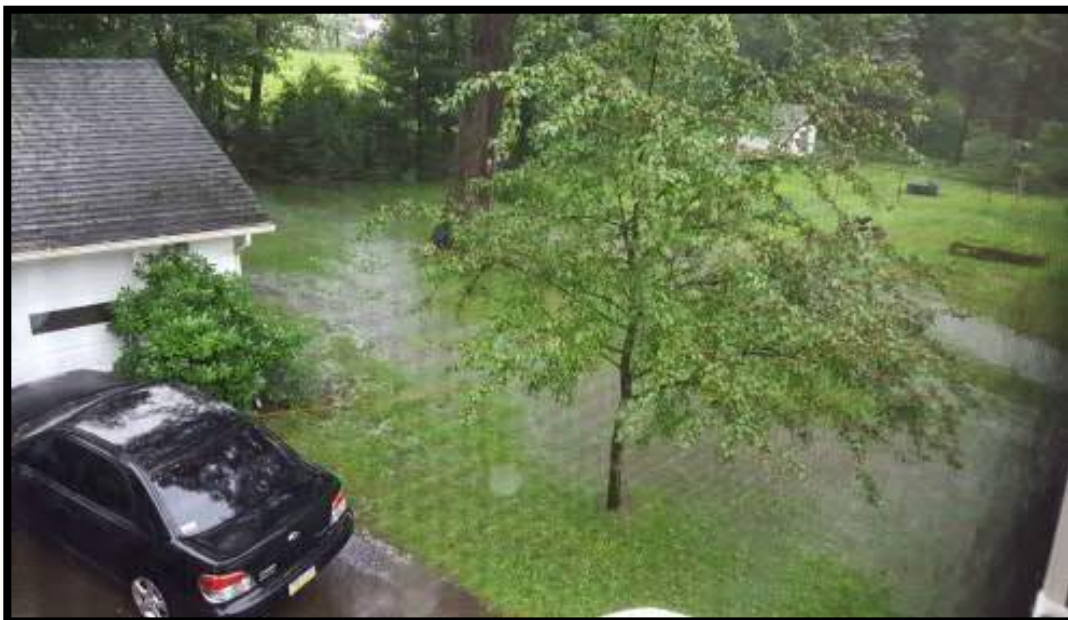
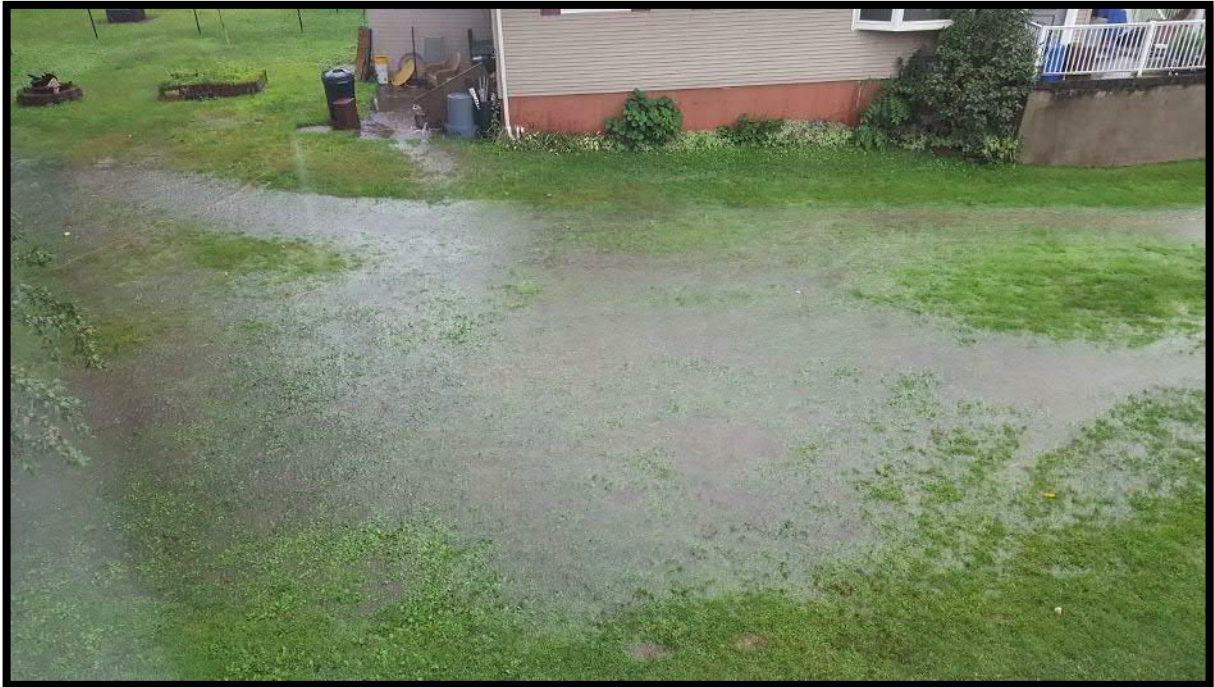
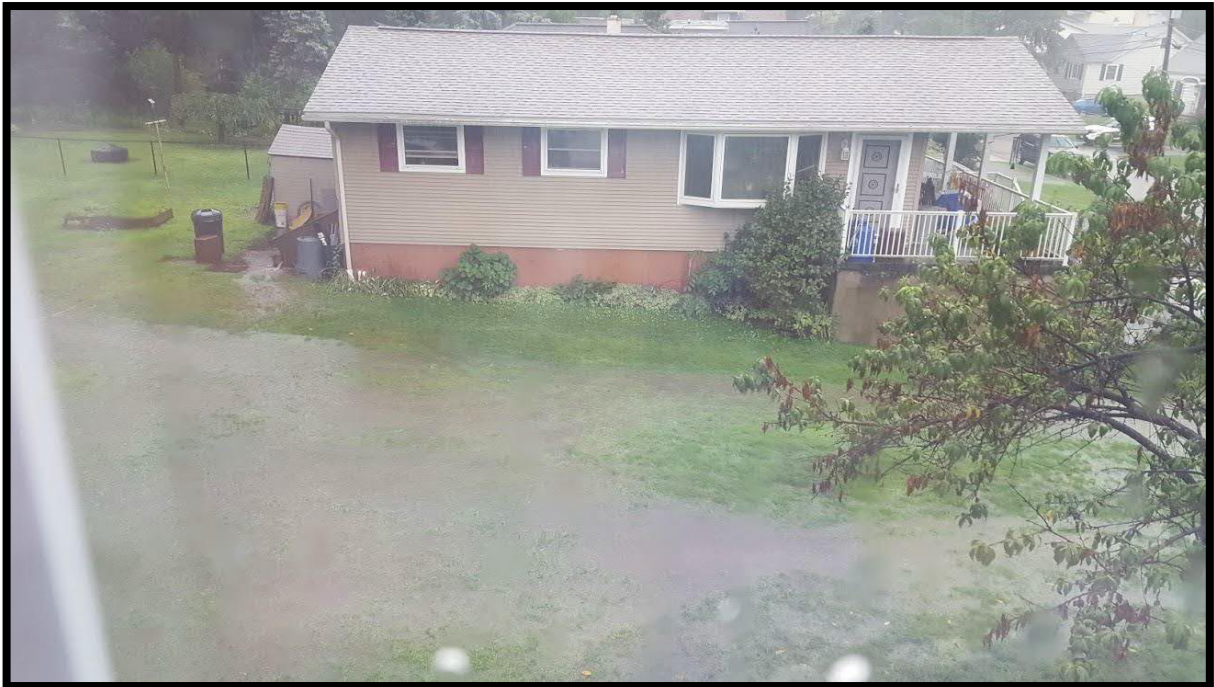
**Describe flooding issue in detail:** water floods property from Oswald Ave which is in rear or above 101 Florida Ave. The wooded lot on 114 Oswald is the lowest point with no curb so ends up flowing to rear of garage and yard of 101 florida ave. Water enters from 114 Oswald Ave., hits the back of our garage, enters rear of 101 Florida Ave., yard gets flooded, swampy, doesn't dry out, neighbors are affected also. It killed our 150 year old oak tree.

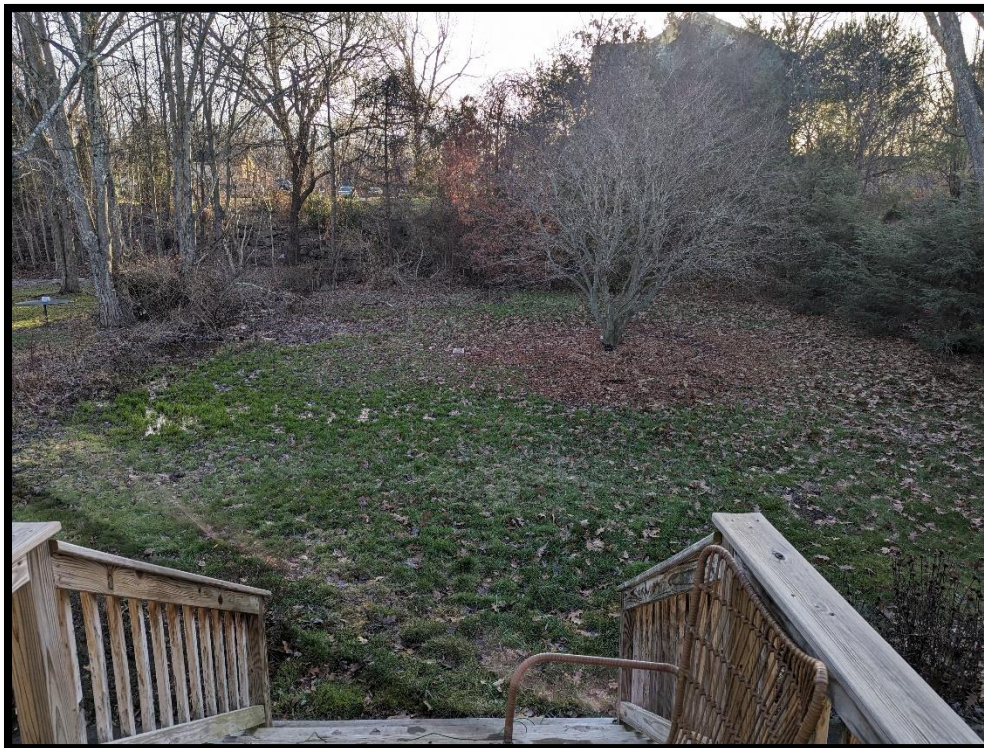
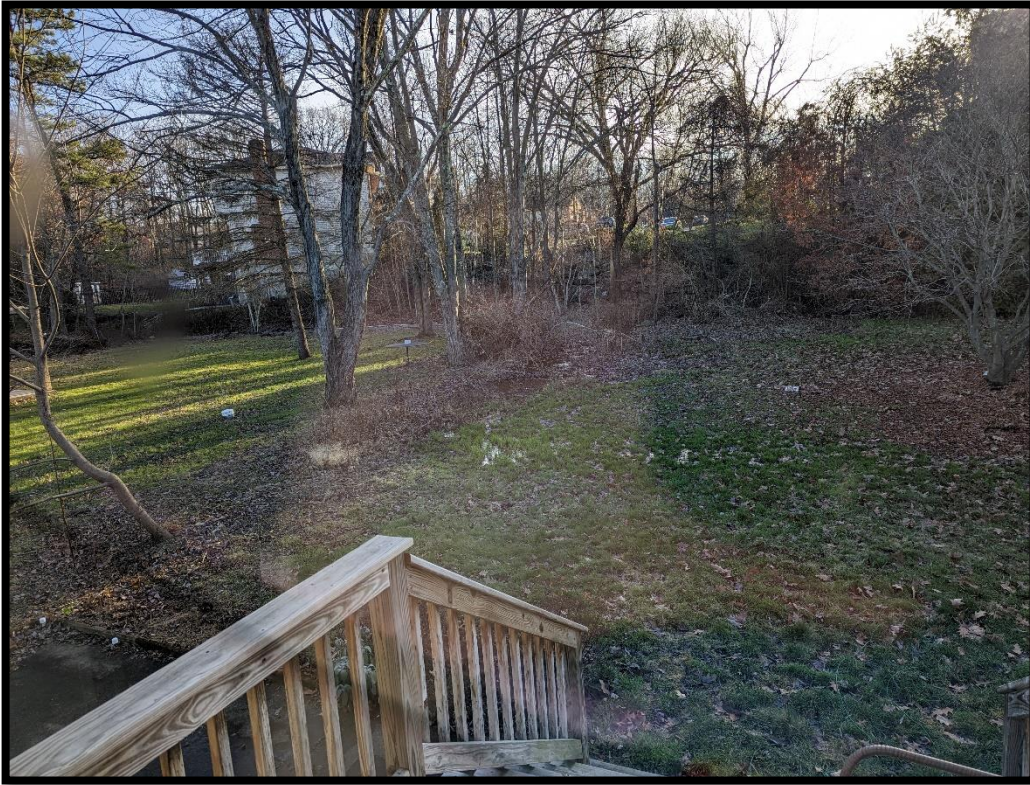
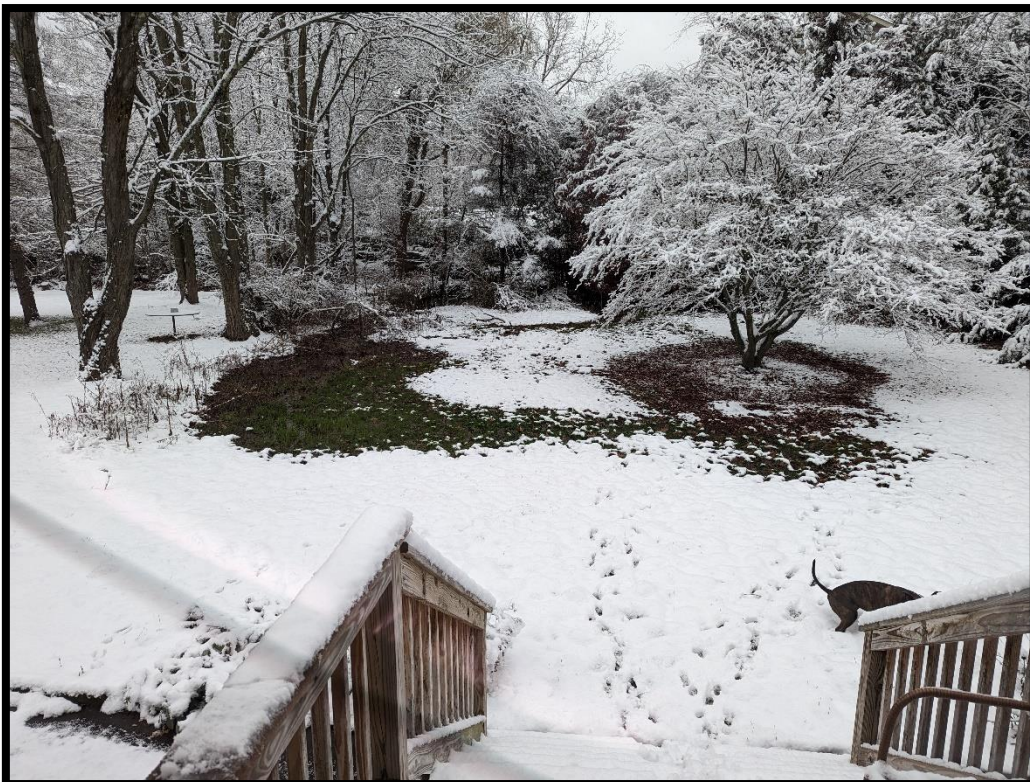
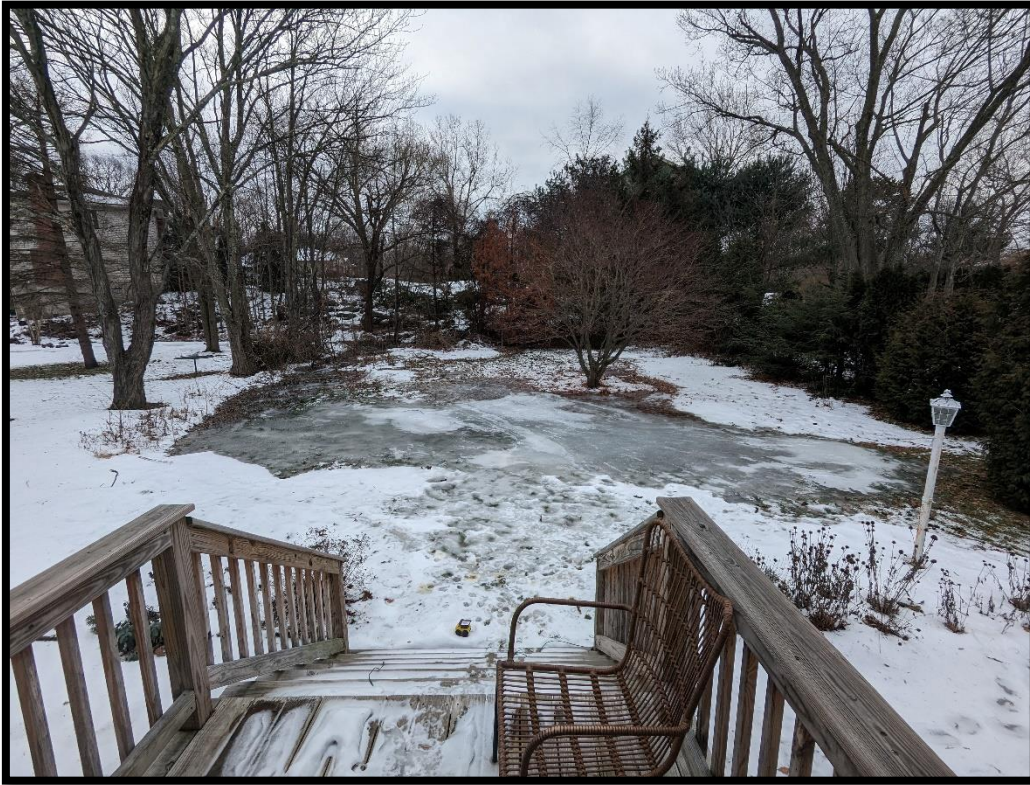
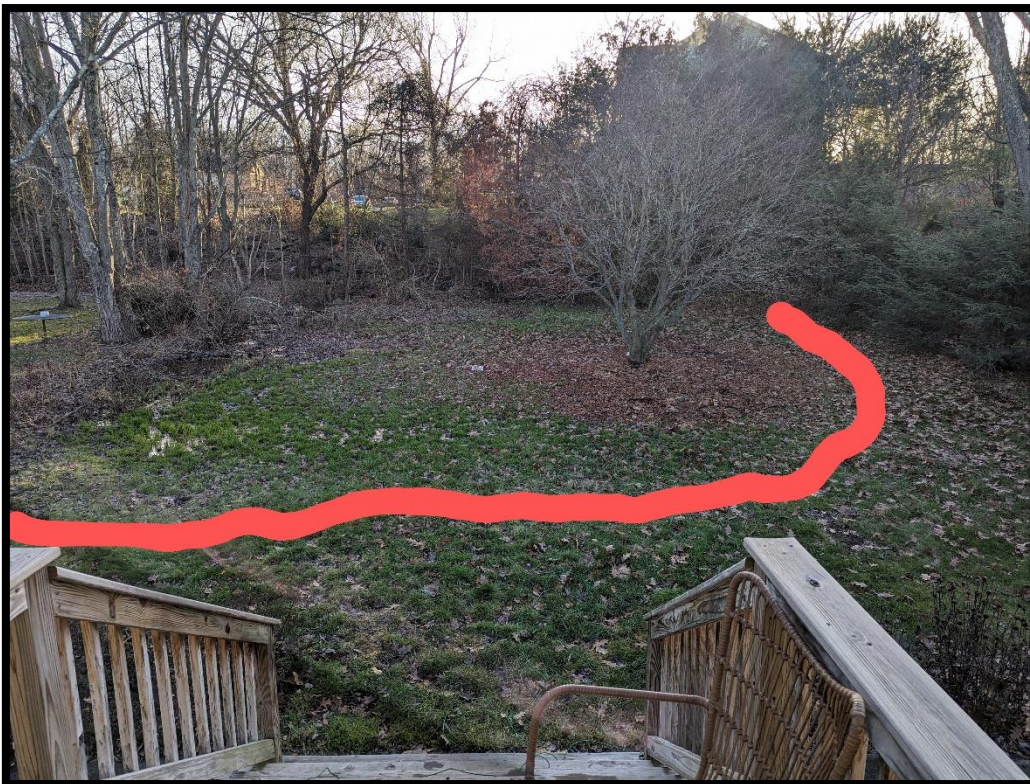
**Describe flooding issue in detail:** Next door neighbor has dug a channel that directs all storm water run off on his property onto my property, which has flooded my yard and turned it into a swamp rendering food property essentially unusable.

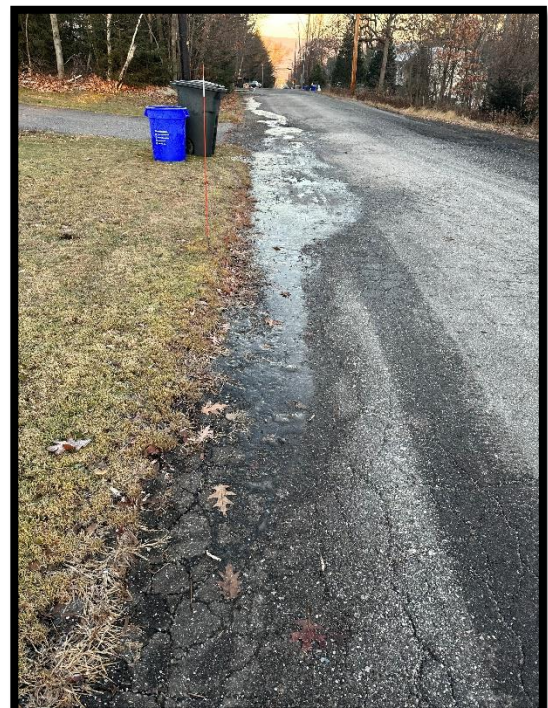
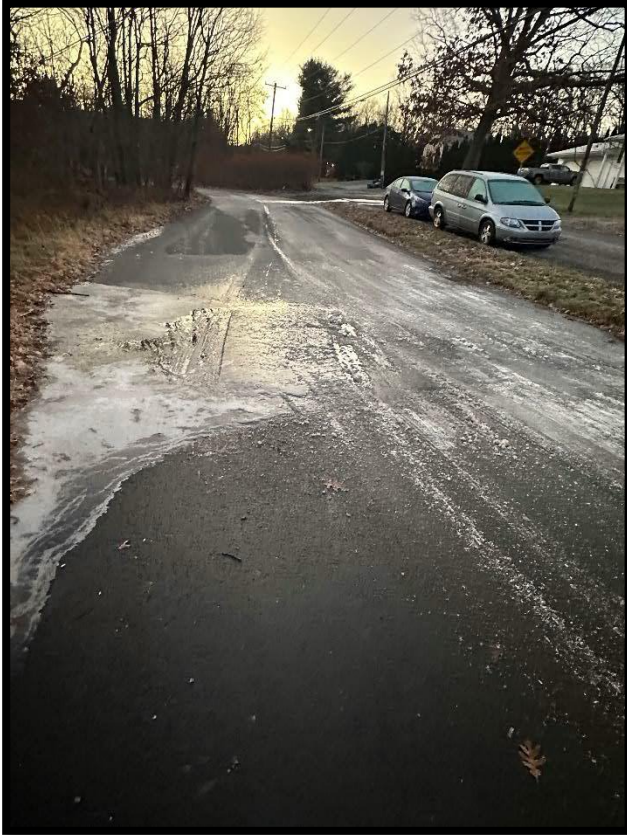
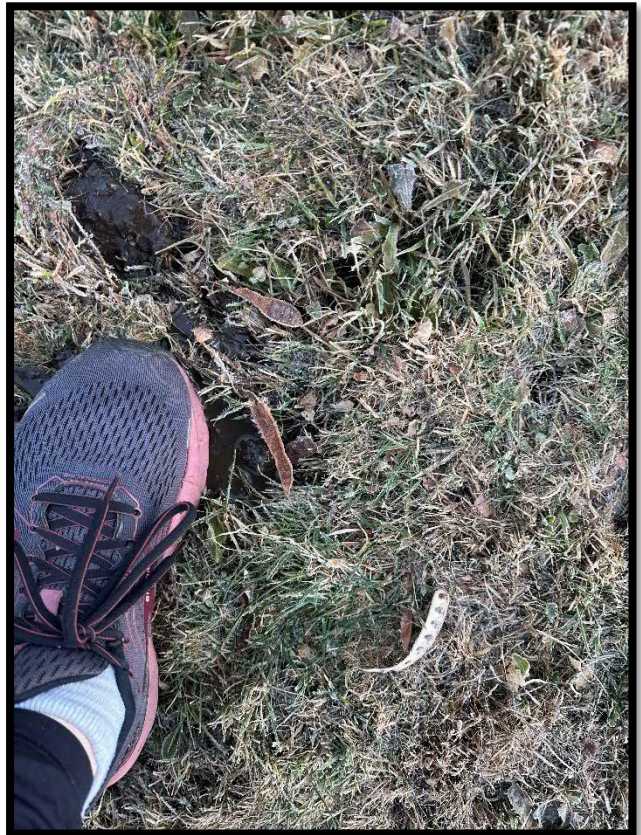
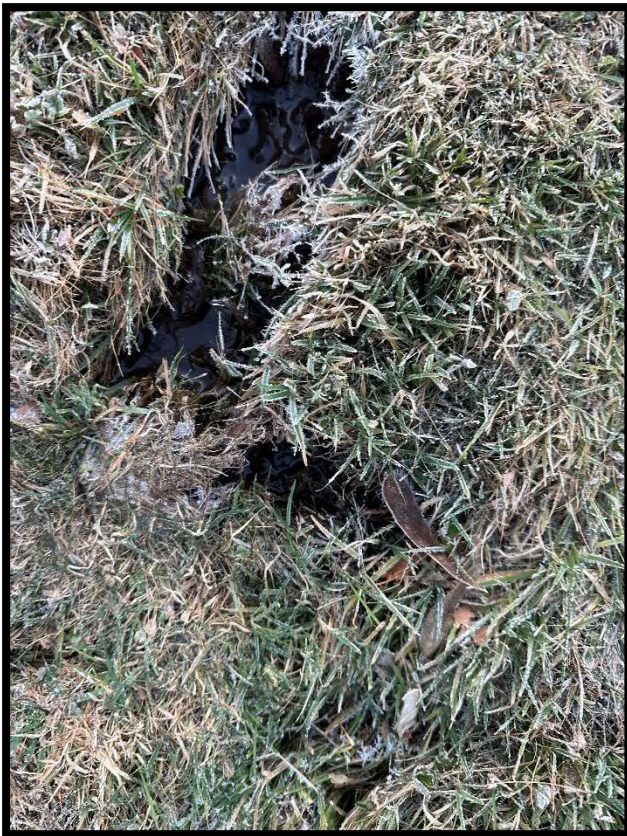
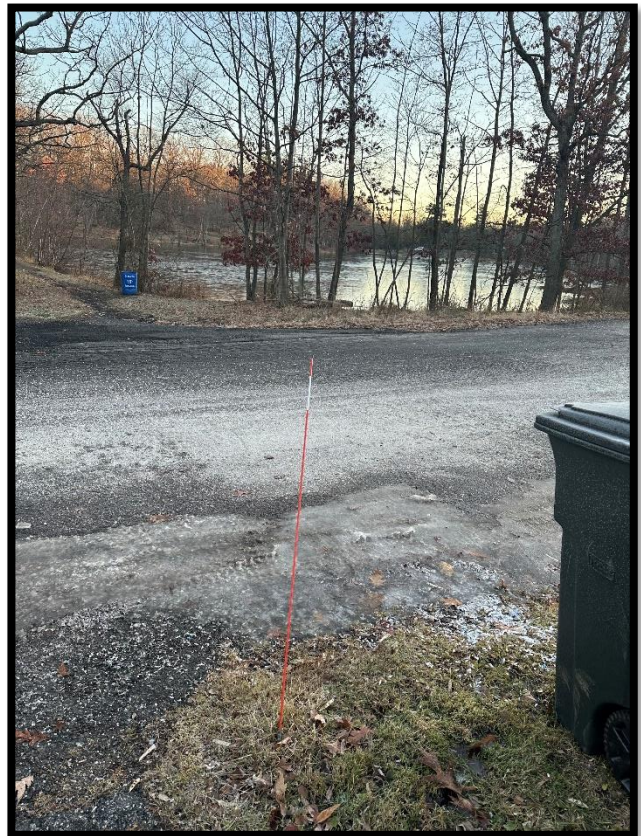
**Describe flooding issue in detail:** We have no drainage system in front of Mountain Lake. We get water from behind our houses and travels down our lawns to the road where it pools in our lawns and in the street. During the winter it ices over and everyday DPW needs to salt. Our front lawn is level with the road and its always wet. We can sink right in and becomes mud after mowing. When our lawn is soaking wet it allows water to back up into our basement and when it rains we get water. We moved into our house in July 2021 and since then we have had floods in our basement four times. There should be stormwater or ditches to pull the water away from our houses. Most of the city has some kind of stormwater system but we don't have any.

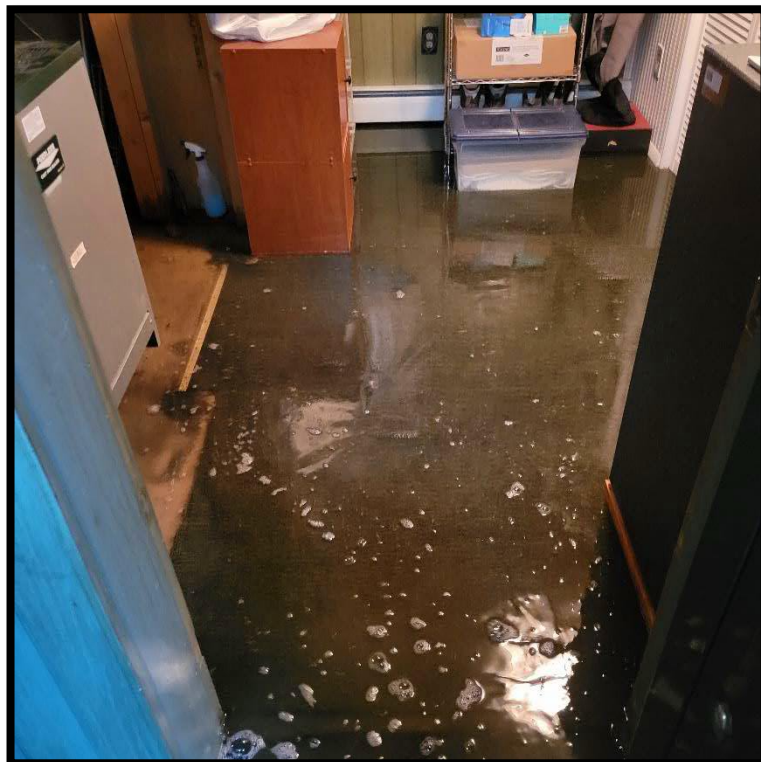
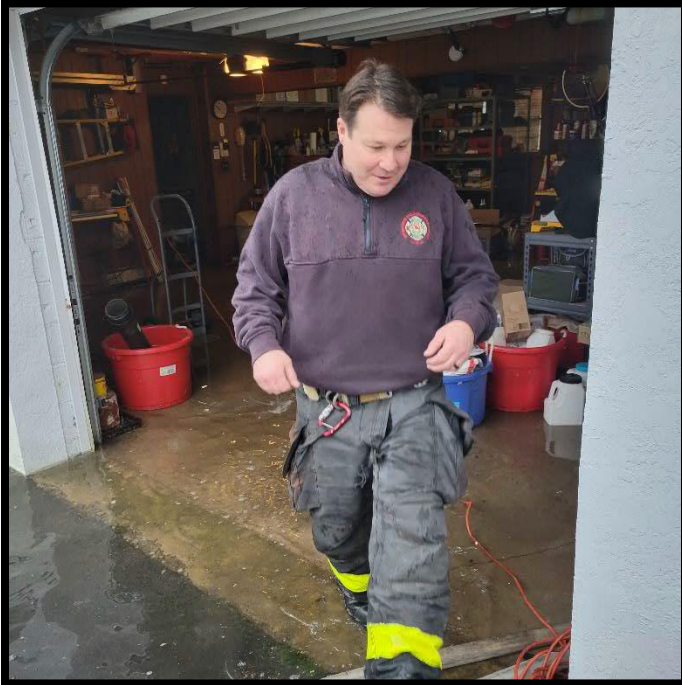
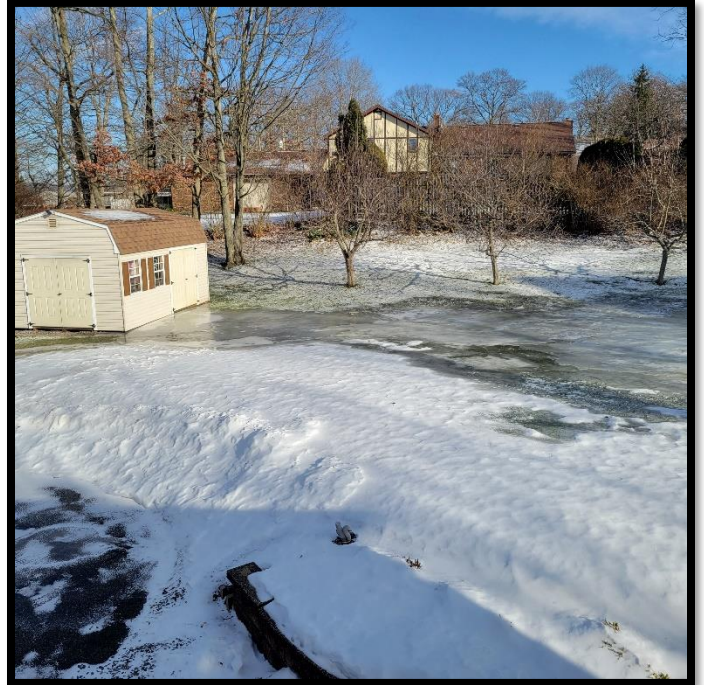
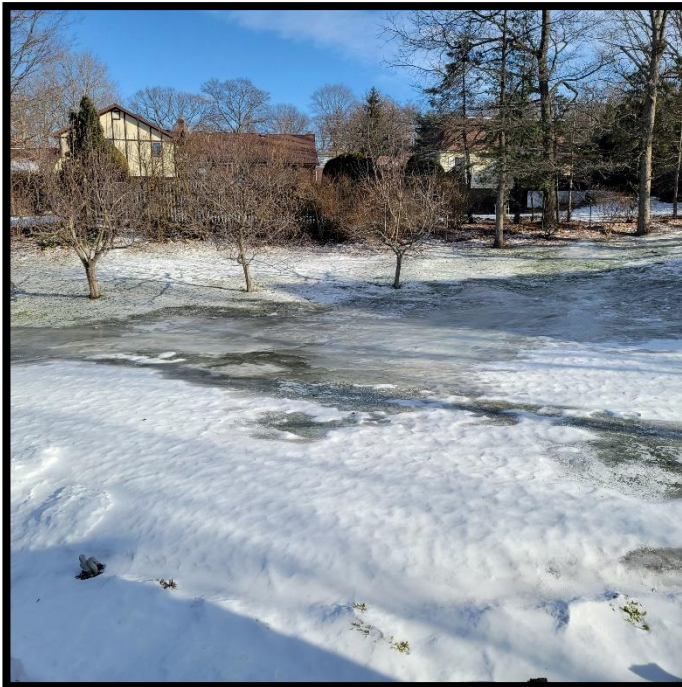
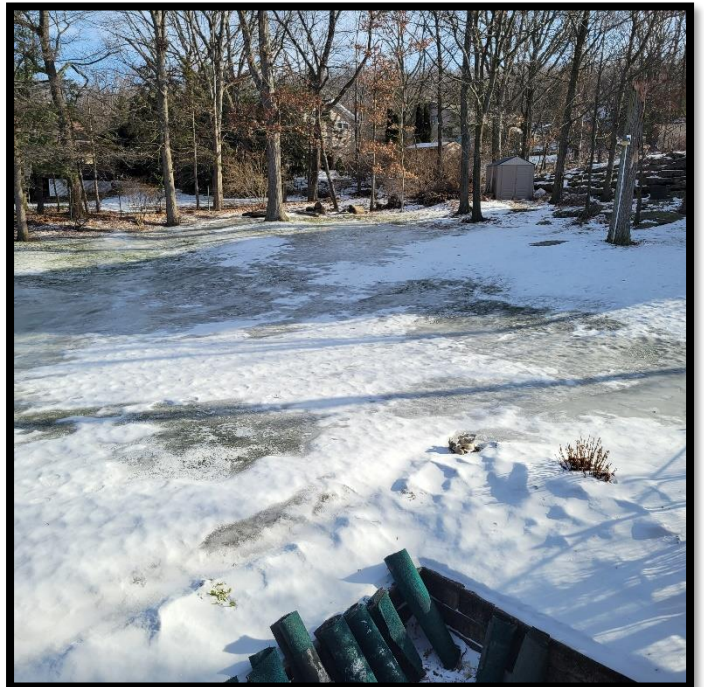
**Describe flooding issue in detail:** Run off redirected and now flows through my yard, bringing debris into drainage pipe. Resulted in blockage in Cherry St (According to Rossi Rooter). This is not a storm drain or sewer. Pipe was installed by city. Blockage under Cherry St caused water to back up and flood basement and garage.

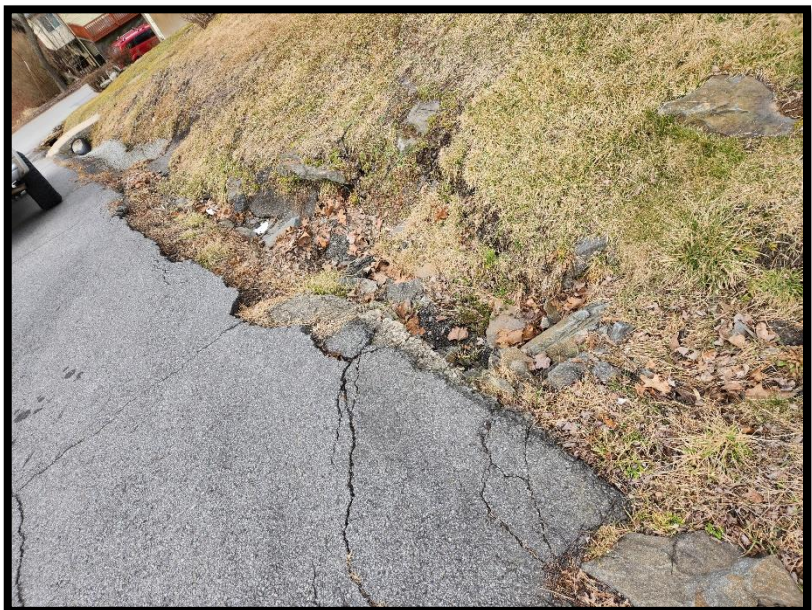
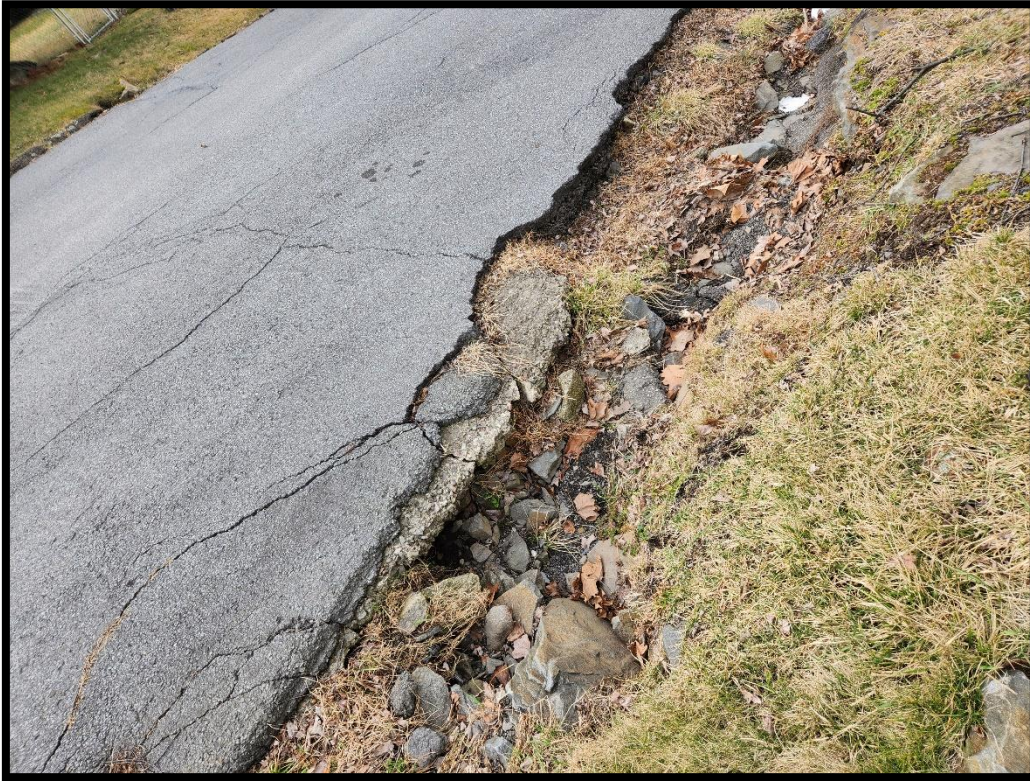
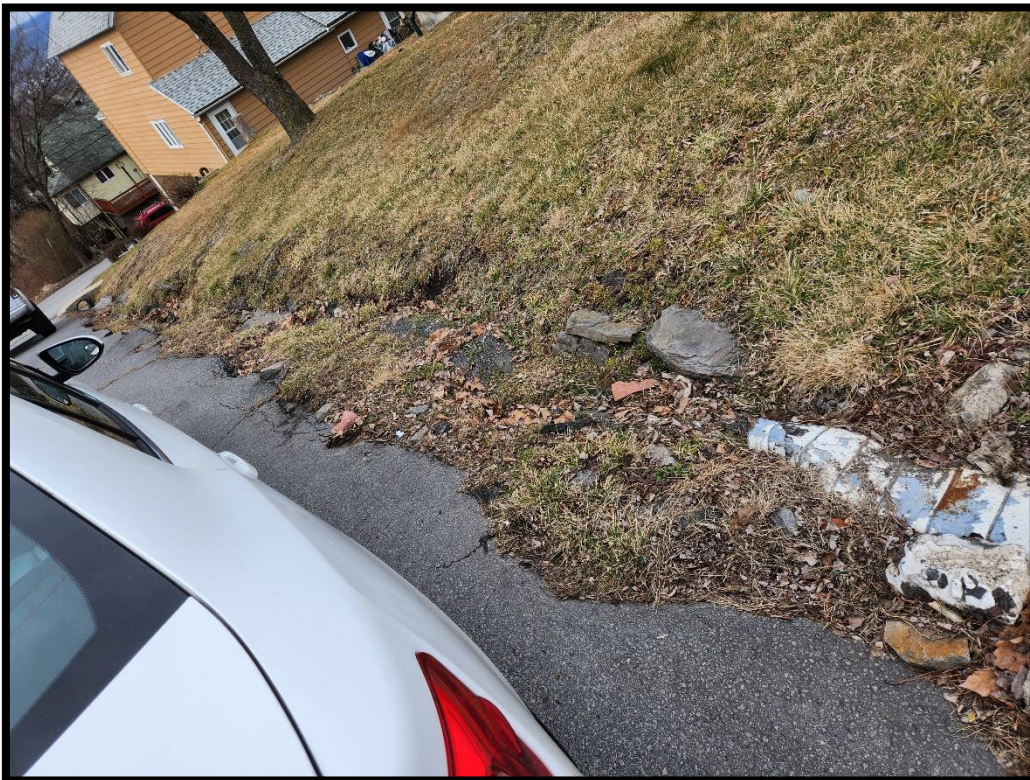
**Describe flooding issue in detail:** When first purchasing this property I noticed that the storm drain is completely missing, and dilapidated at the start of the alley way where my property is located, down to the end of the street where it intersects with Moltke avenue (approximately 1/2 a street long). This issue is causing the street and the lot to break a part, creating a huge ditch ( approximately 1.5-2 ft. deep, and 2.5-3ft wide) that may become a danger if someone falls. The accumulation of garbage has also been an issue because of this. I would greatly appreciate if someone can come and check this out for me. If this is not something that can be rectified through this department I would be so appreciative if you would kindly direct me to someone that has the ability to assist. I have contacted the city of Scranton several times since purchasing the property, and I have not received any assistance so far.
